CONTRACT NO. N62473-07-D-3211
CTO No. 0008

FINAL
FALL 2010 & WINTER 2011 ANNUAL POST-CLOSURE
INSPECTION AND MAINTENANCE REPORT
July 20, 2011

INSTALLATION RESTORATION PROGRAM SITE 7 AREA 1
(FORMER STATION LANDFILL)
NAVAL WEAPONS STATION SEAL BEACH
SEAL BEACH, CALIFORNIA

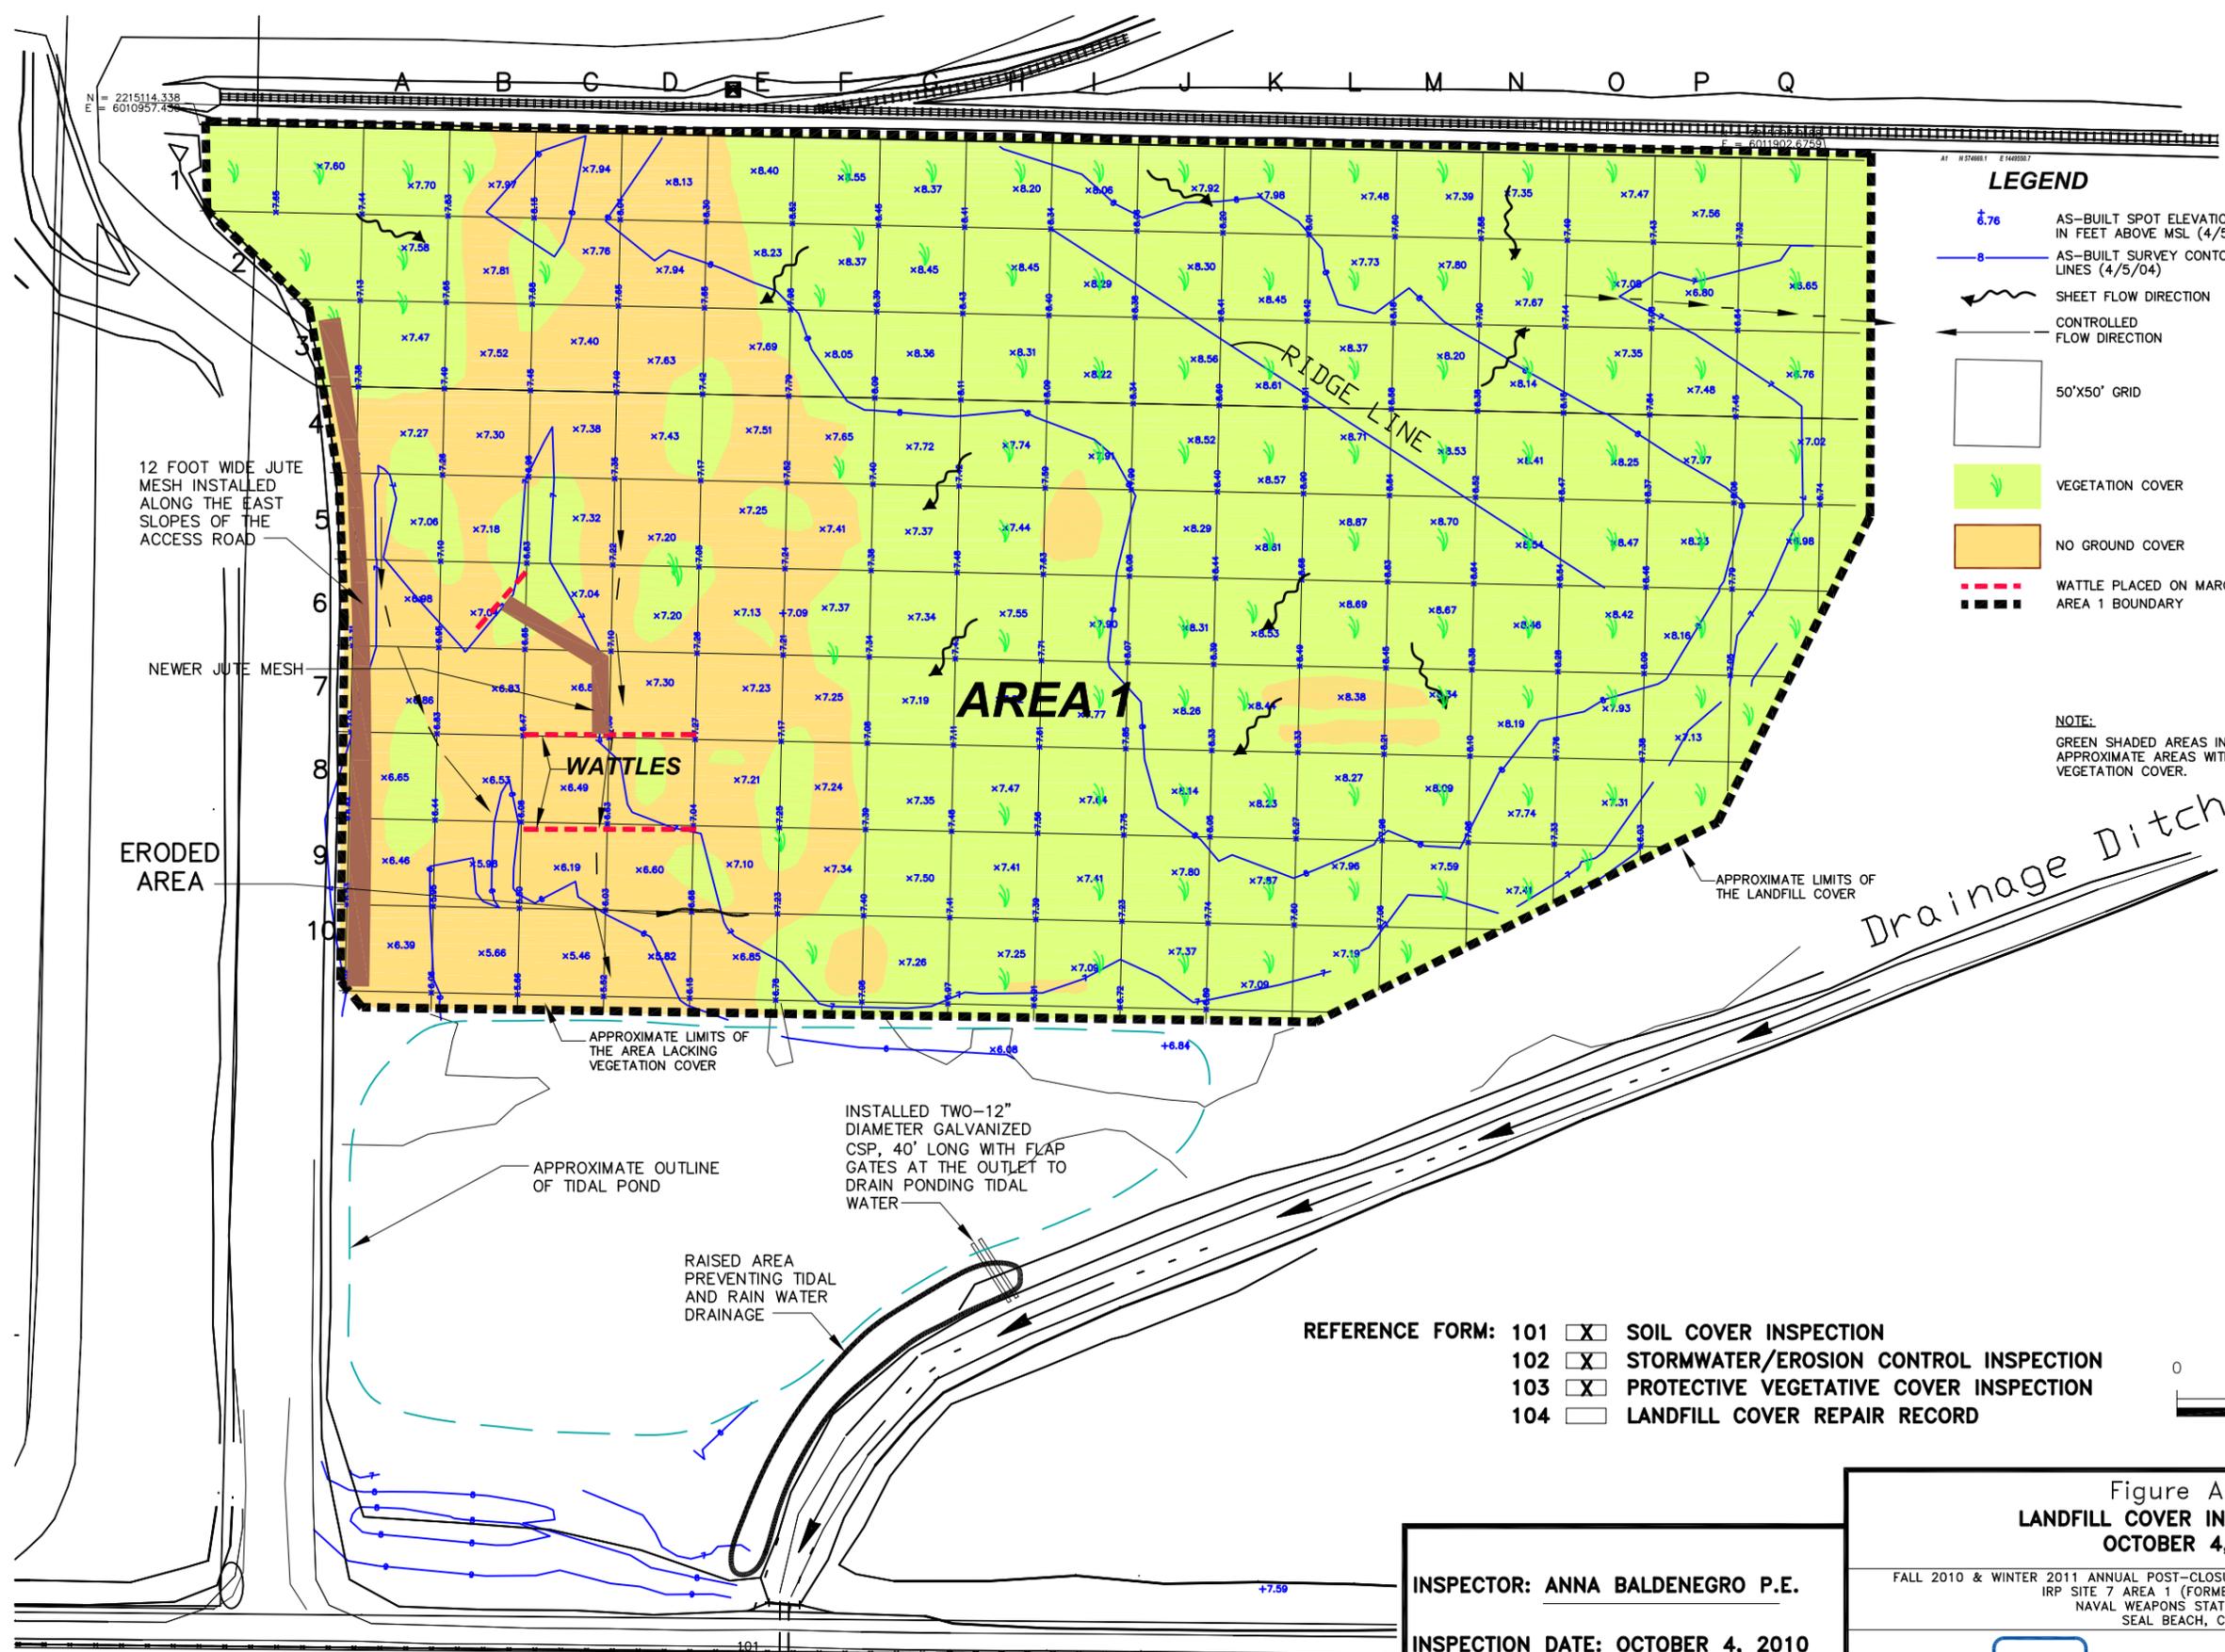
Figure A-1A
LANDFILL COVER INSPECTION MAP
 OCTOBER 4, 2010

Minor erosion was observed near the southern most wattle located on the landfill.

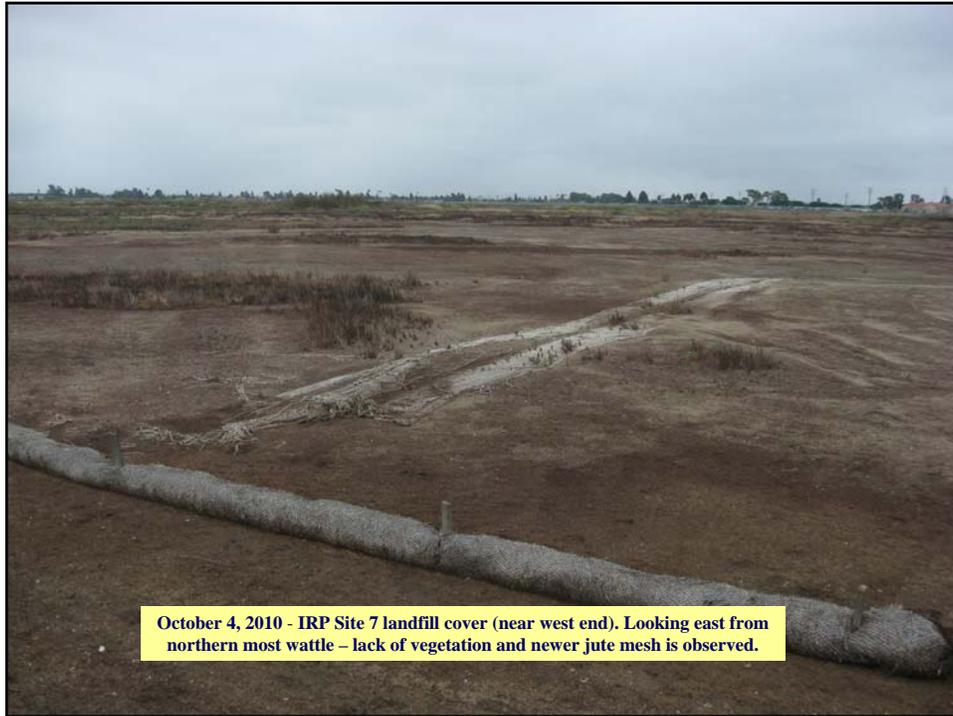
October 4, 2010 - IRP Site 7 landfill cover (near west end). Looking east from northern most wattle – lack of vegetation and newer jute mesh is observed.

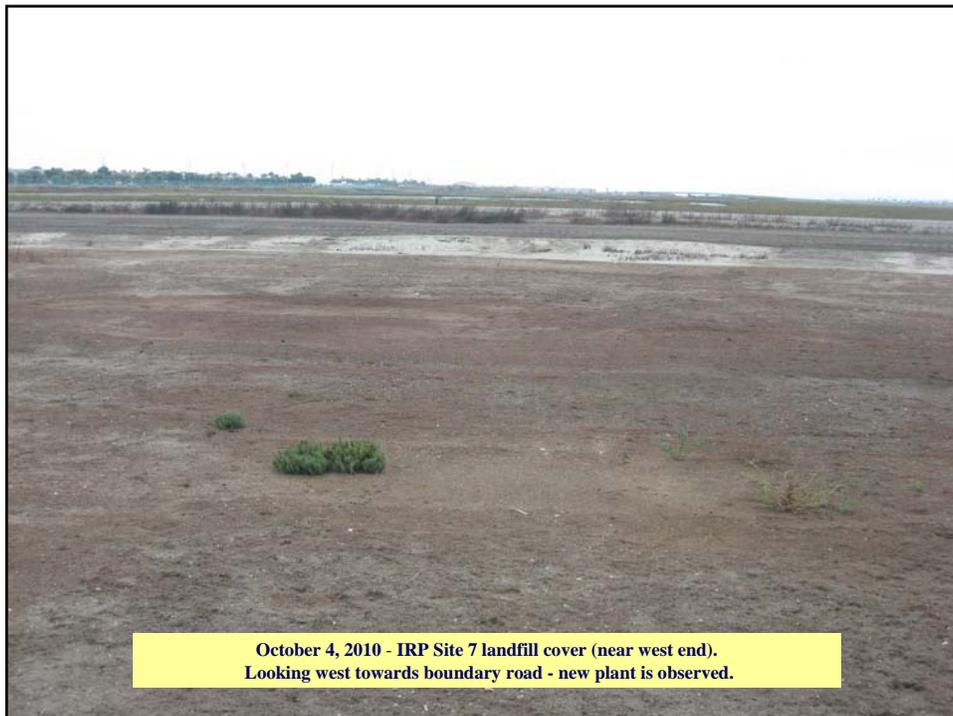
October 4, 2010 - IRP Site 7 landfill cover (near west end). Looking west towards boundary road - new plant is observed.

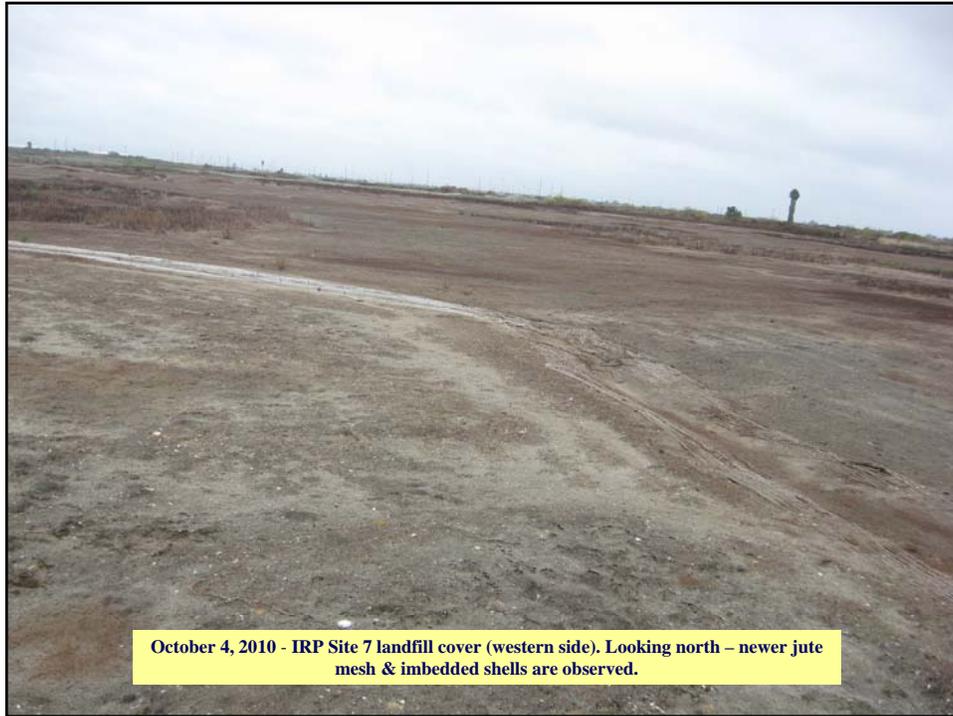
October 4, 2010 - IRP Site 7 landfill cover (western side). Looking north – newer jute mesh & imbedded shells are observed.

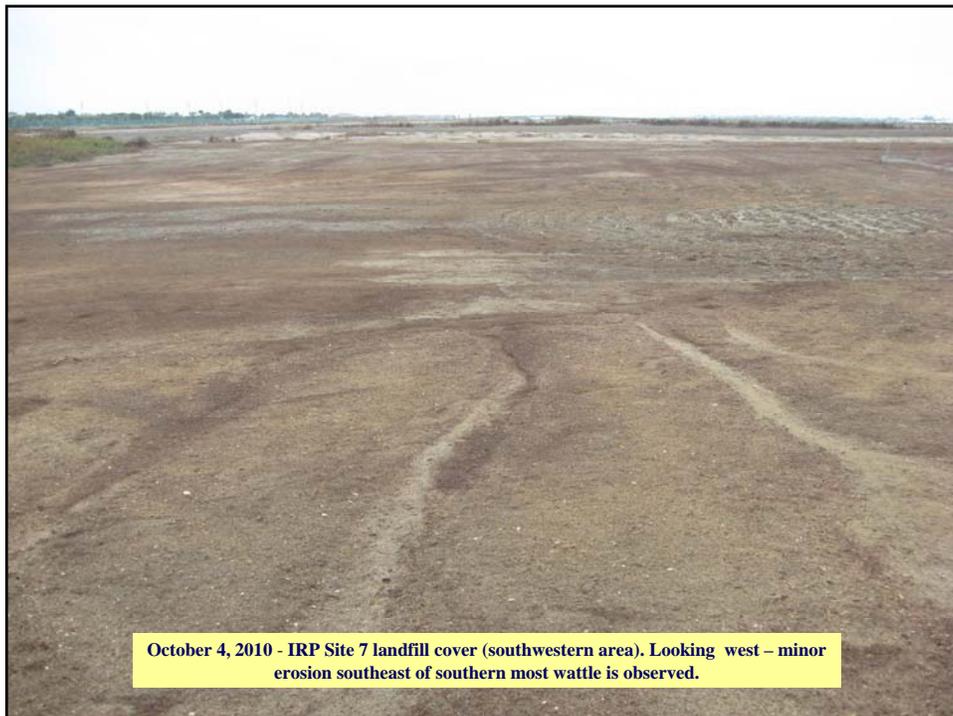
The soil was moist due to the light rain that occurred on 10/1, 10/2, and during the morning of the inspection on 10/4/10. Minor erosion was found southeast of the southern most wattle in the western area of the landfill. Shell fragments were noticeable imbedded on the top of the soil.

October 4, 2010 - IRP Site 7 landfill cover (southwestern area). Looking west – minor erosion southeast of southern most wattle is observed.

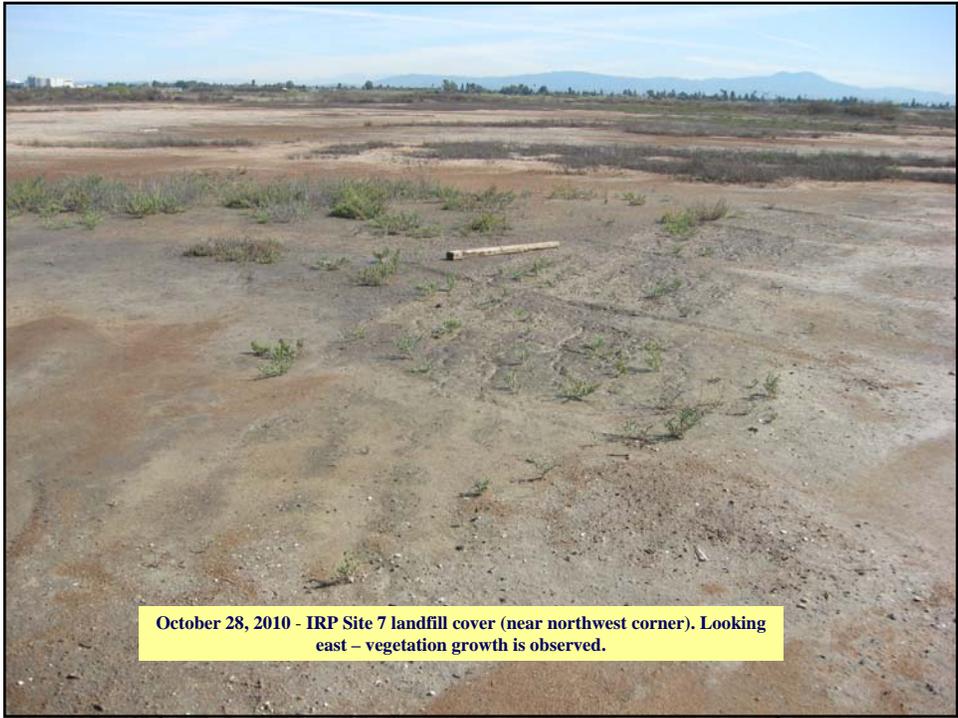
October 28, 2010 - IRP Site 7 landfill cover (near northwest corner). Looking east – vegetation growth is observed.

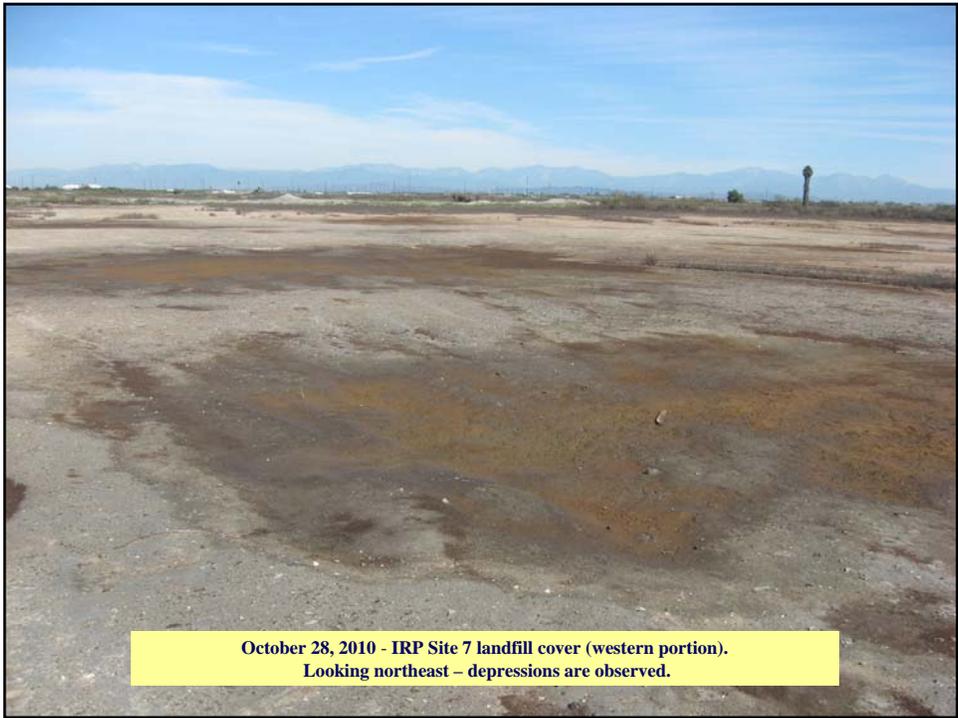
October 28, 2010 - IRP Site 7 landfill cover (western portion). Looking northeast – depressions are observed.

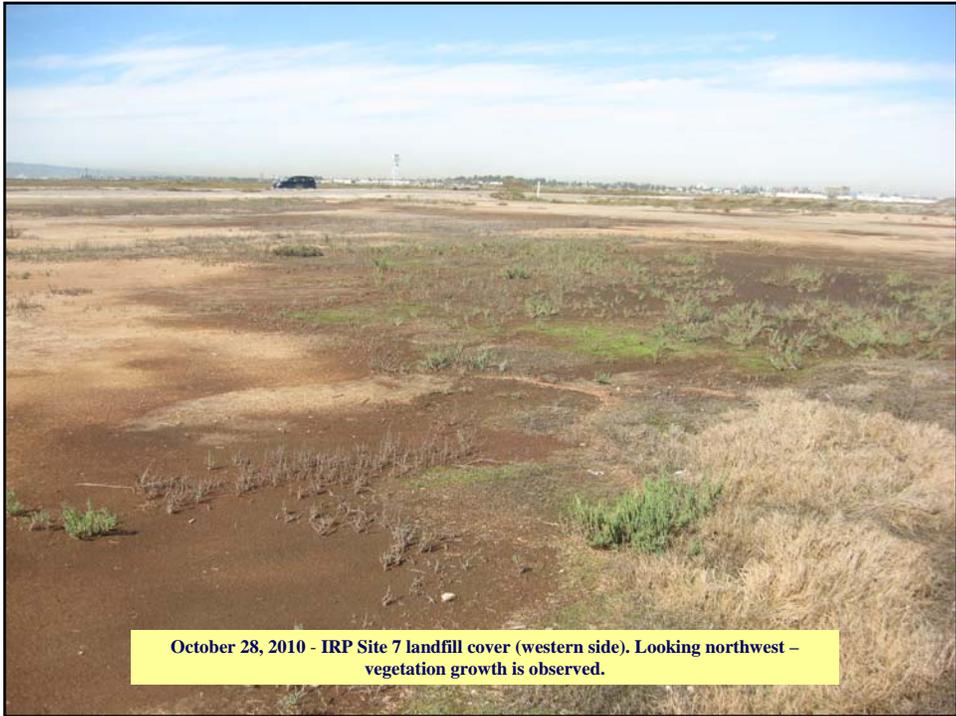
October 28, 2010 - IRP Site 7 landfill cover (western side). Looking northwest – vegetation growth is observed.

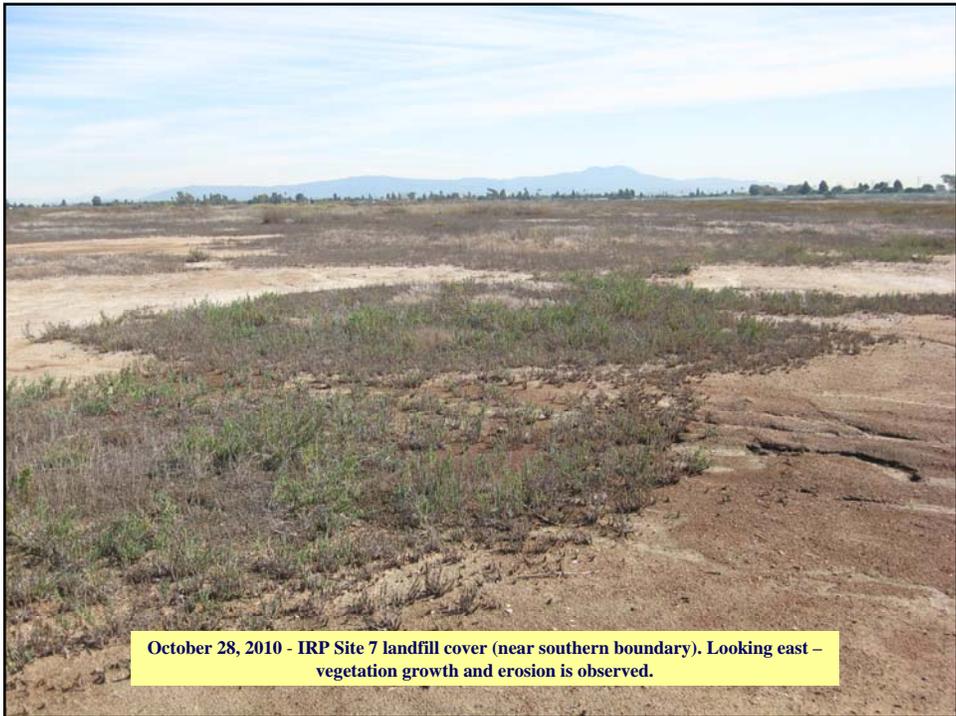
October 28, 2010 - IRP Site 7 landfill cover (near southern boundary). Looking east – vegetation growth and erosion is observed.

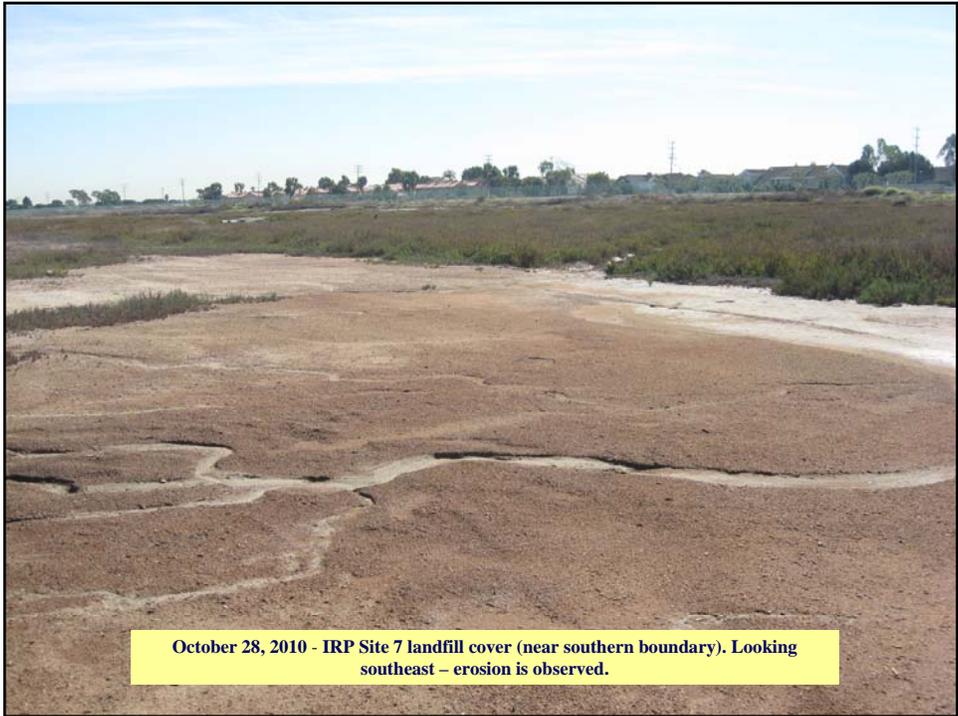
October 28, 2010 - IRP Site 7 landfill cover (near southern boundary). Looking southeast – erosion is observed.

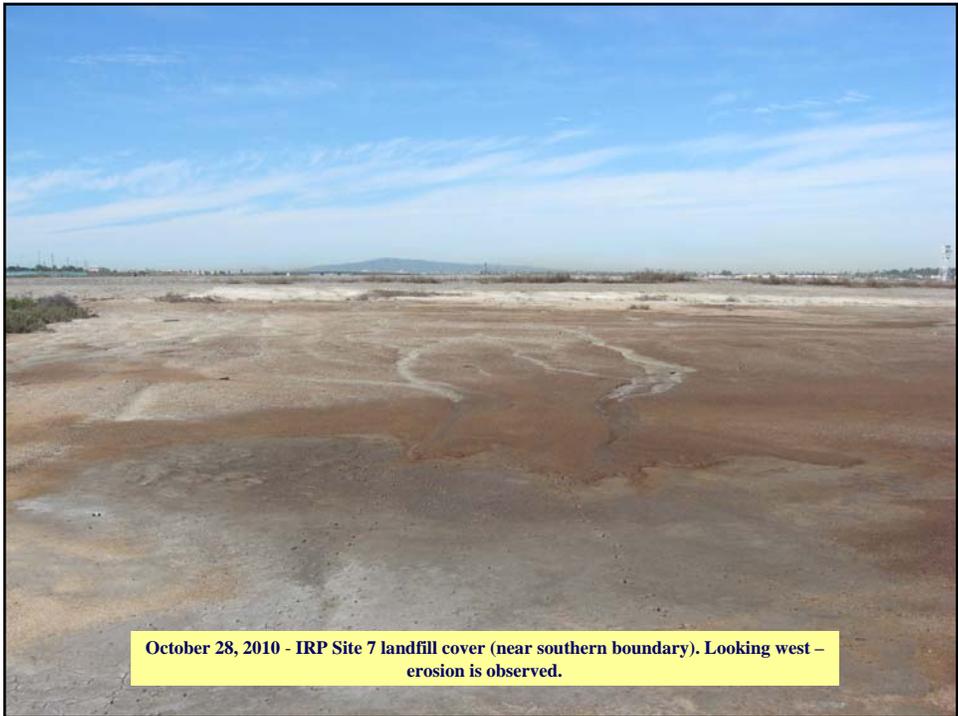
October 28, 2010 - IRP Site 7 landfill cover (near southern boundary). Looking west – erosion is observed.

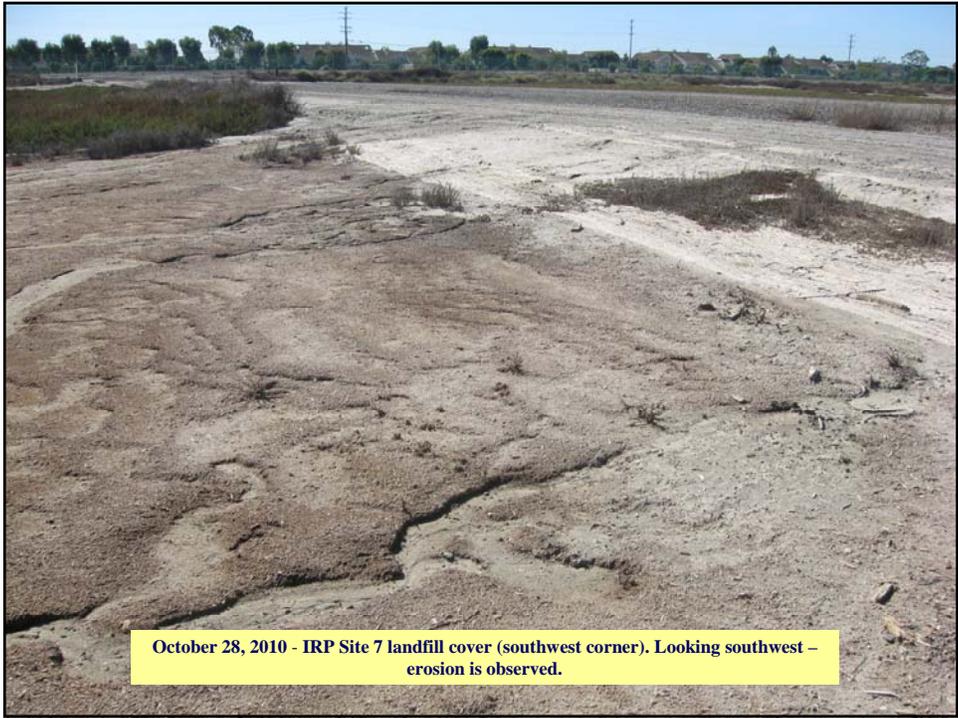
October 28, 2010 - IRP Site 7 landfill cover (southwest corner). Looking southwest – erosion is observed.

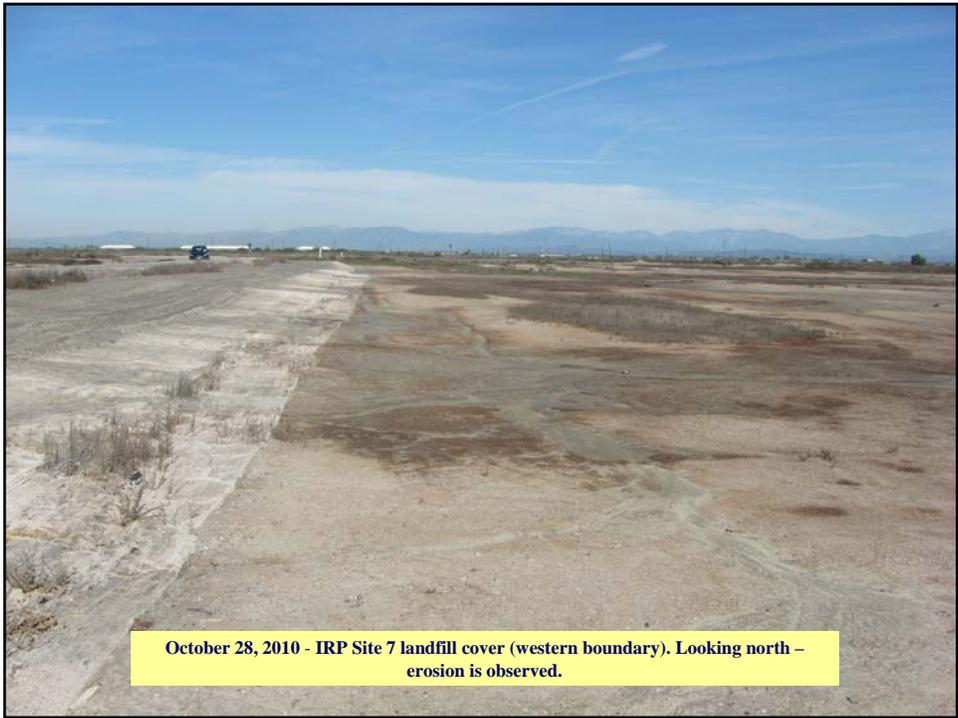
October 28, 2010 - IRP Site 7 landfill cover (western boundary). Looking north – erosion is observed.

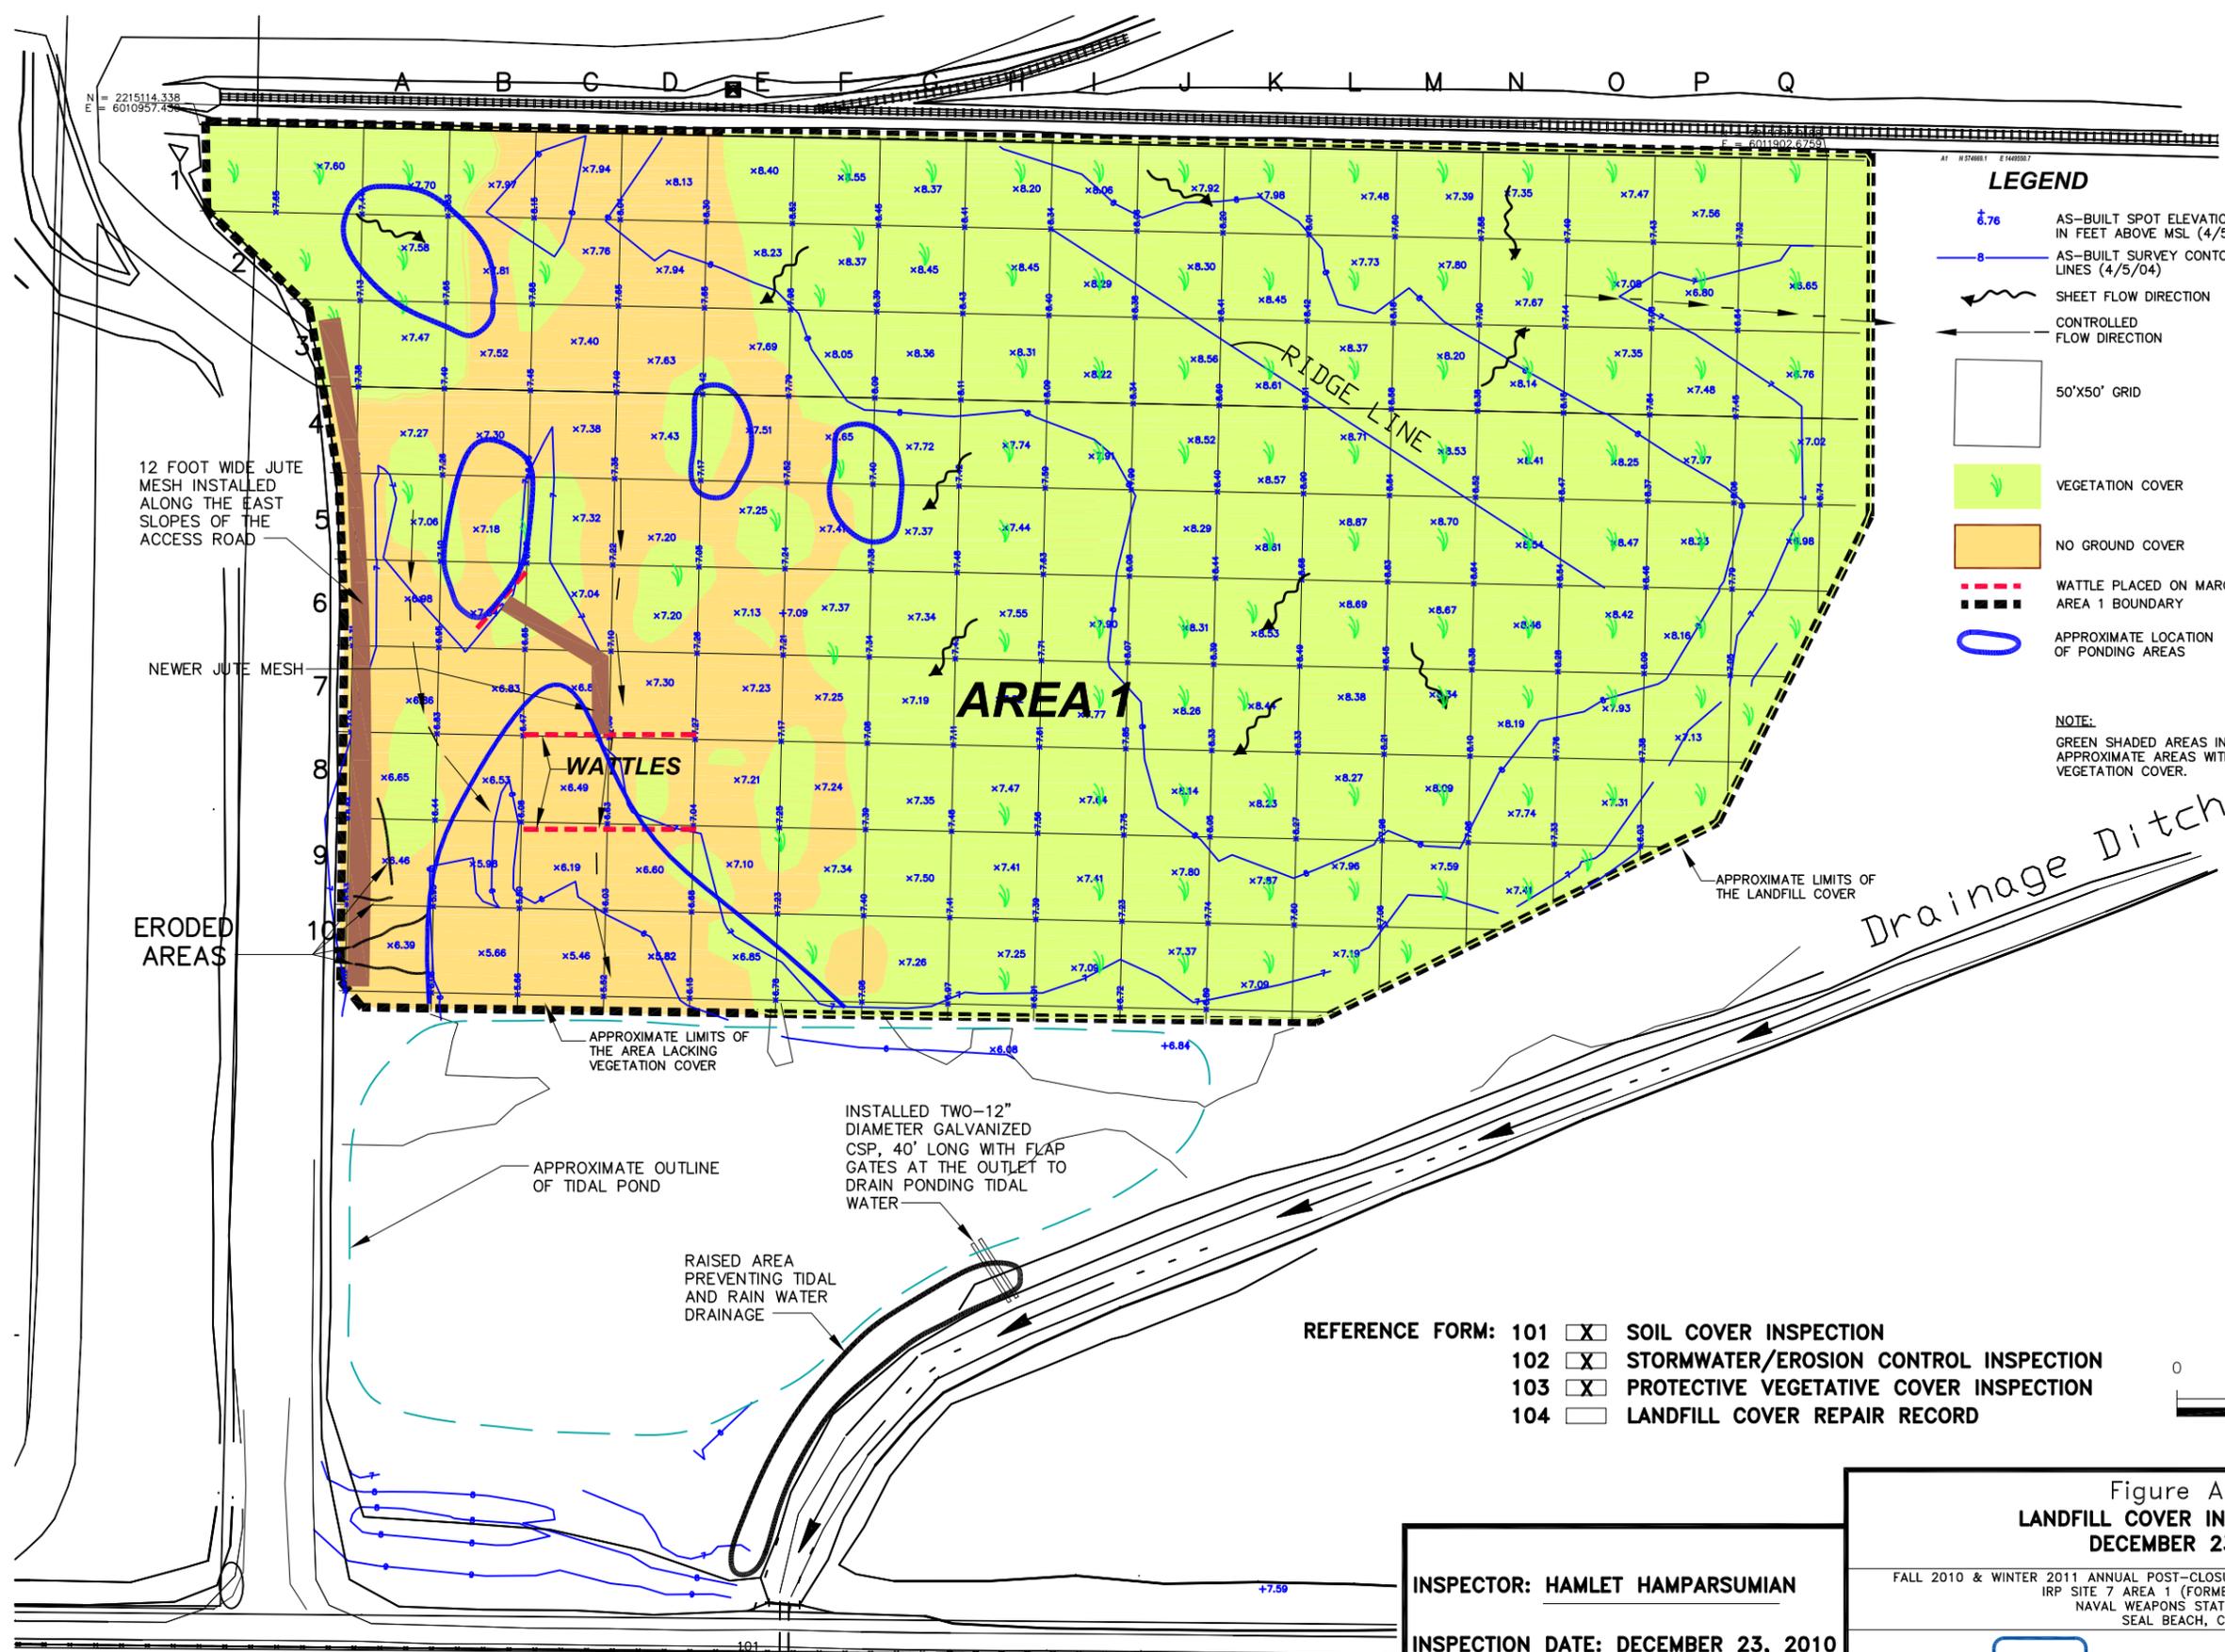
Figure A-1C
LANDFILL COVER INSPECTION MAP
DECEMBER 23, 2010

Relatively minor ponding (less than 6 inches) was observed at some areas along the western portion of the landfill during the December 2010 and March 2011 inspections (Appendix A). The larger area of ponding at the southwestern corner of the landfill (Figure 2-1) was mainly due to high tide and problems with the drainage culvert at the flood control channel. Overall, the landfill cover has positive drainage that allows precipitation to drain to the south. Minor erosion (less than 2 inches deep) and shallow depressions (less than 4 inches deep) were observed along the western portion of the cover during each of the inspections. Observations for each inspection are documented on Form 102 in Appendix A.

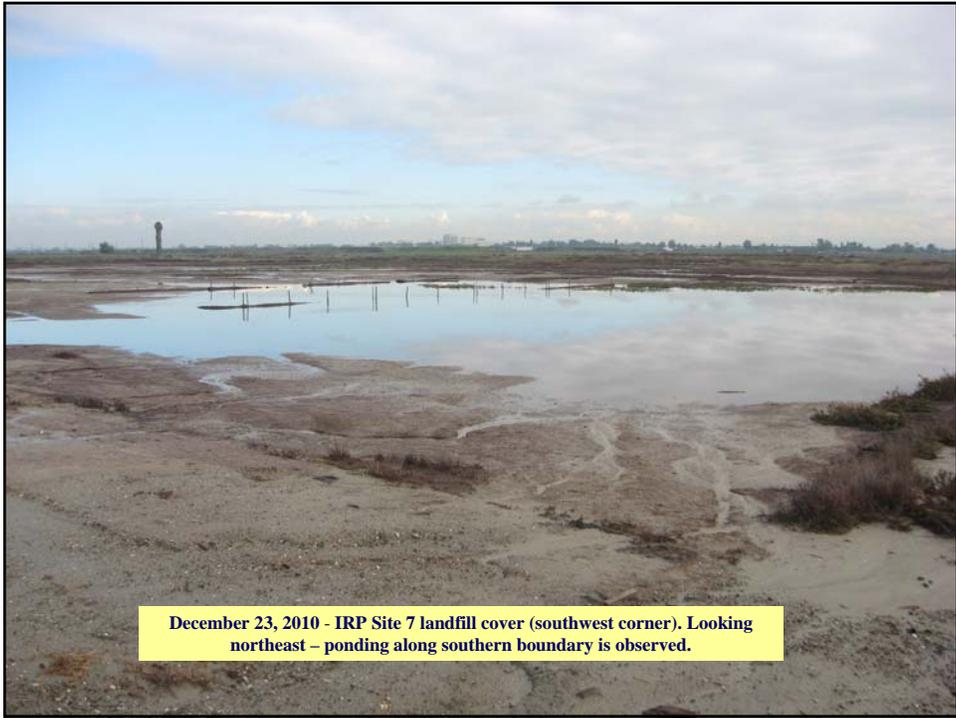
December 23, 2010 - IRP Site 7 landfill cover (southwest corner). Looking northeast – ponding along southern boundary is observed.

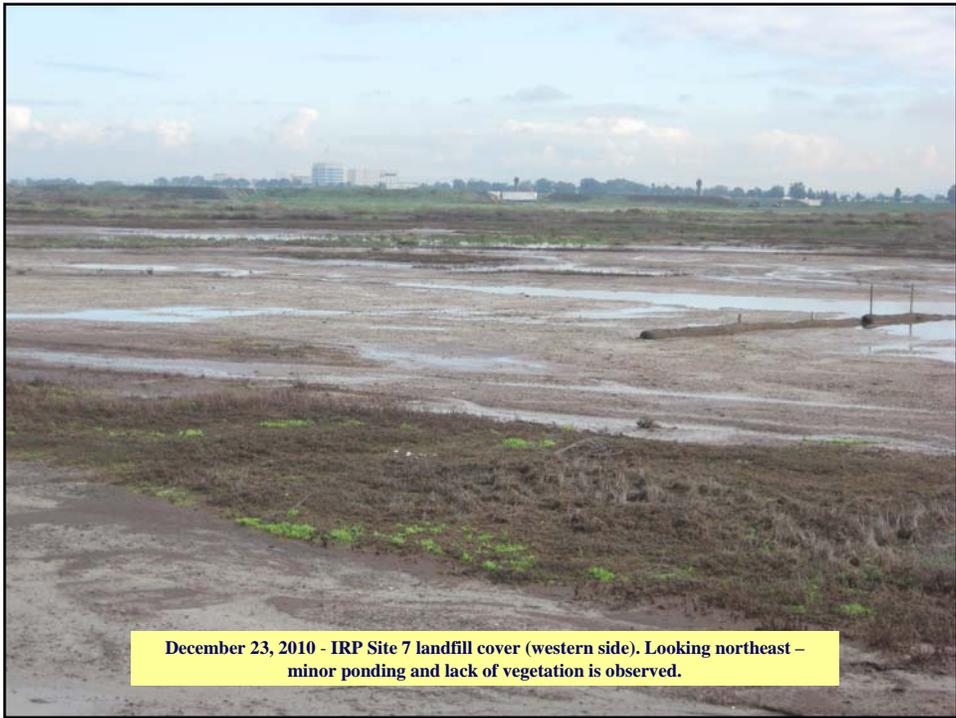
December 23, 2010 - IRP Site 7 landfill cover (western side). Looking northeast – minor ponding and lack of vegetation is observed.

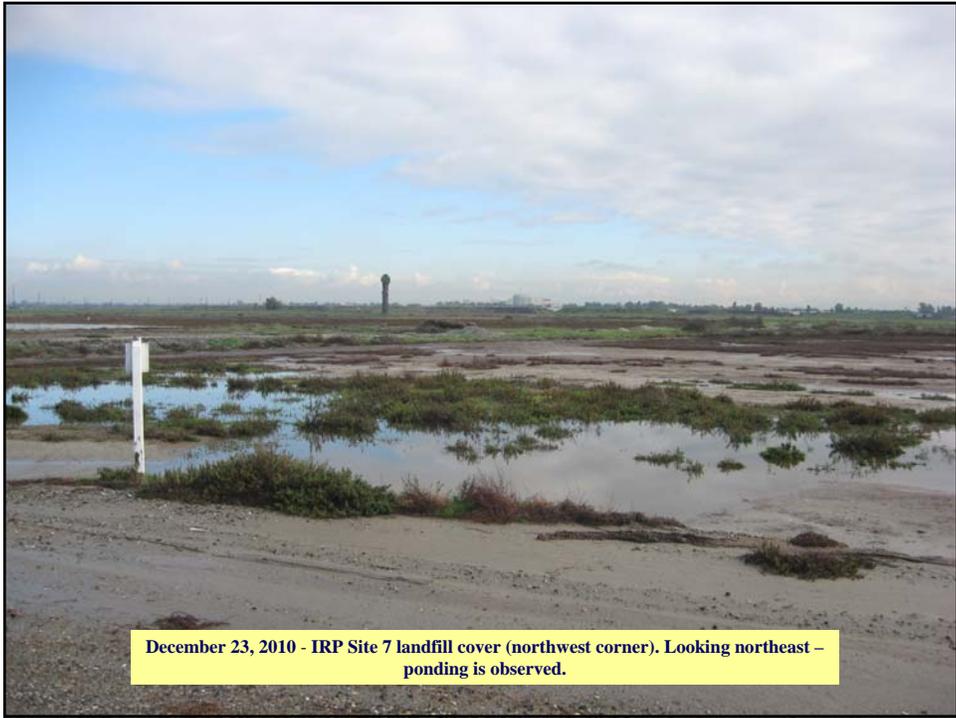
December 23, 2010 - IRP Site 7 landfill cover (northwest corner). Looking northeast – ponding is observed.

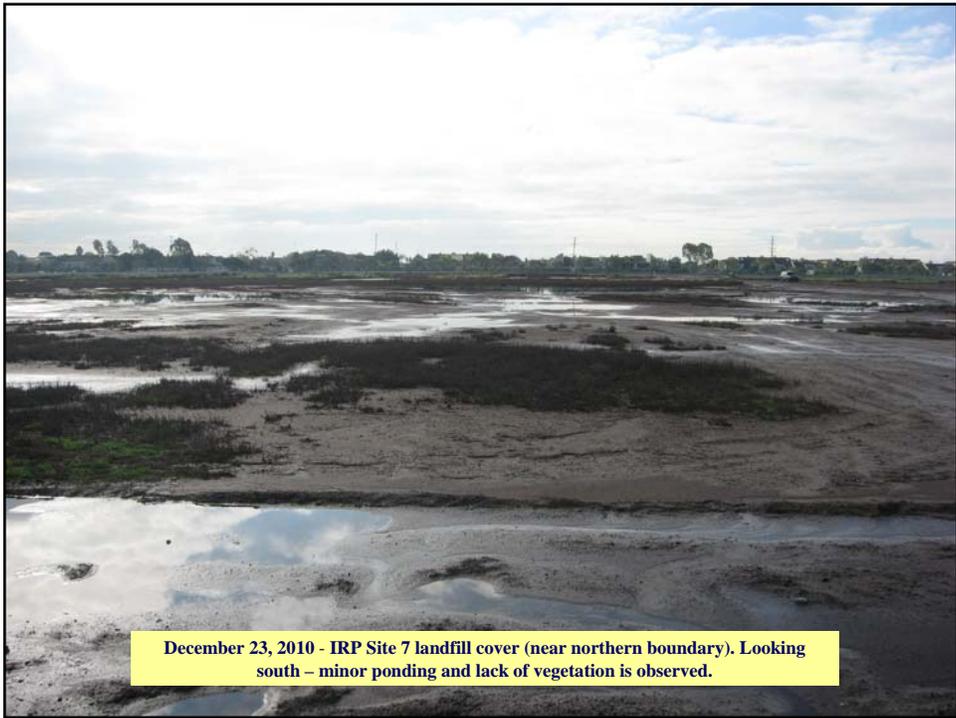
December 23, 2010 - IRP Site 7 landfill cover (near northern boundary). Looking south – minor ponding and lack of vegetation is observed.

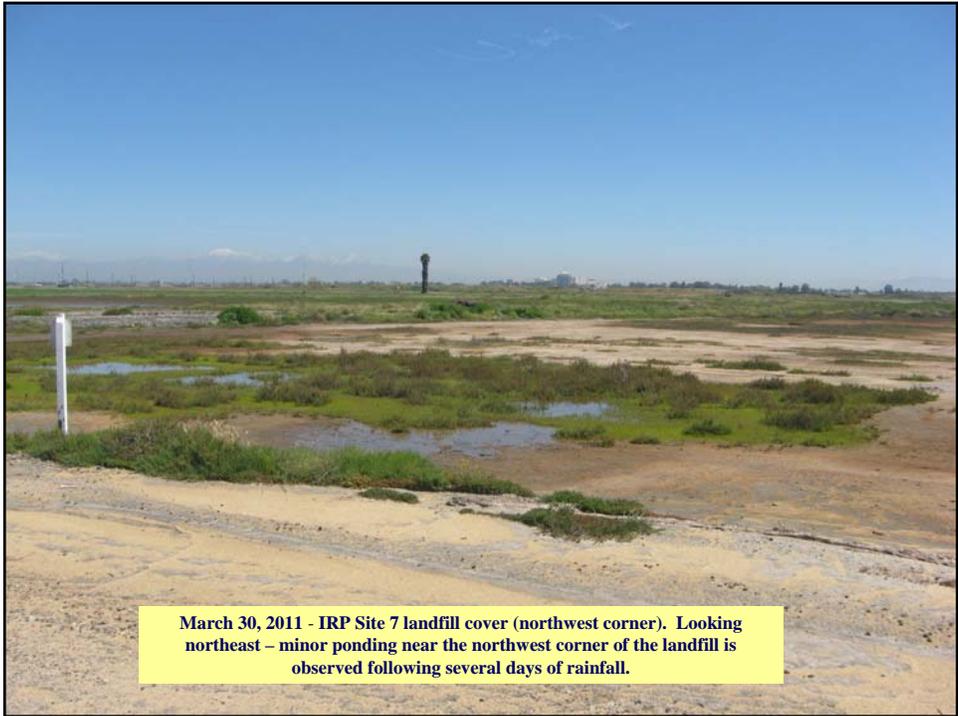
March 30, 2011 - IRP Site 7 landfill cover (northwest corner). Looking northeast – minor ponding near the northwest corner of the landfill is observed following several days of rainfall.

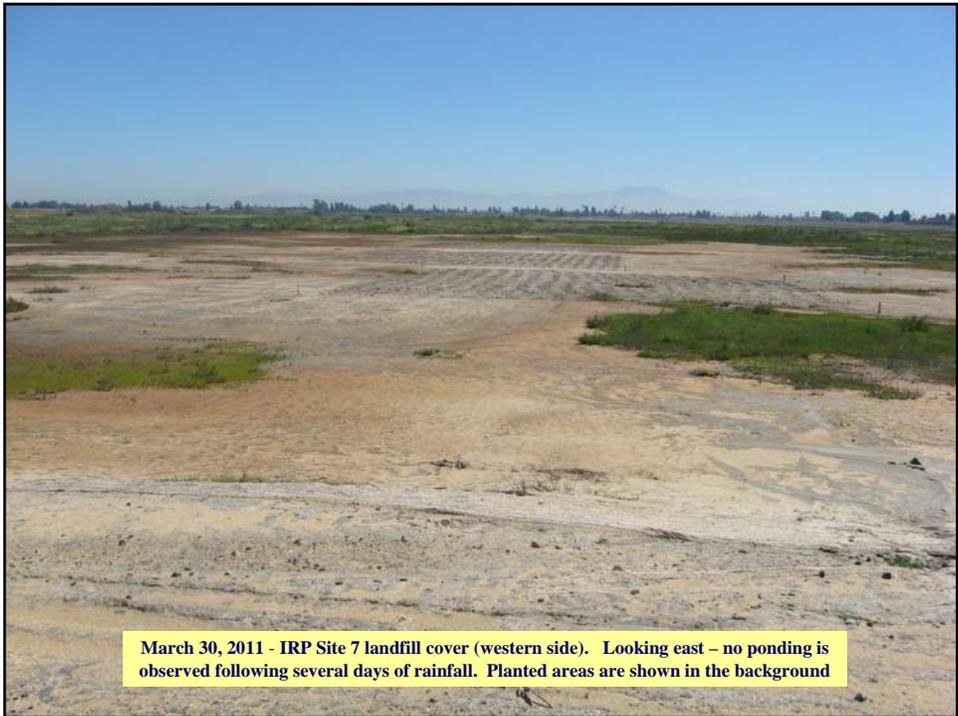
March 30, 2011 - IRP Site 7 landfill cover (western side). Looking east – no ponding is observed following several days of rainfall. Planted areas are shown in the background

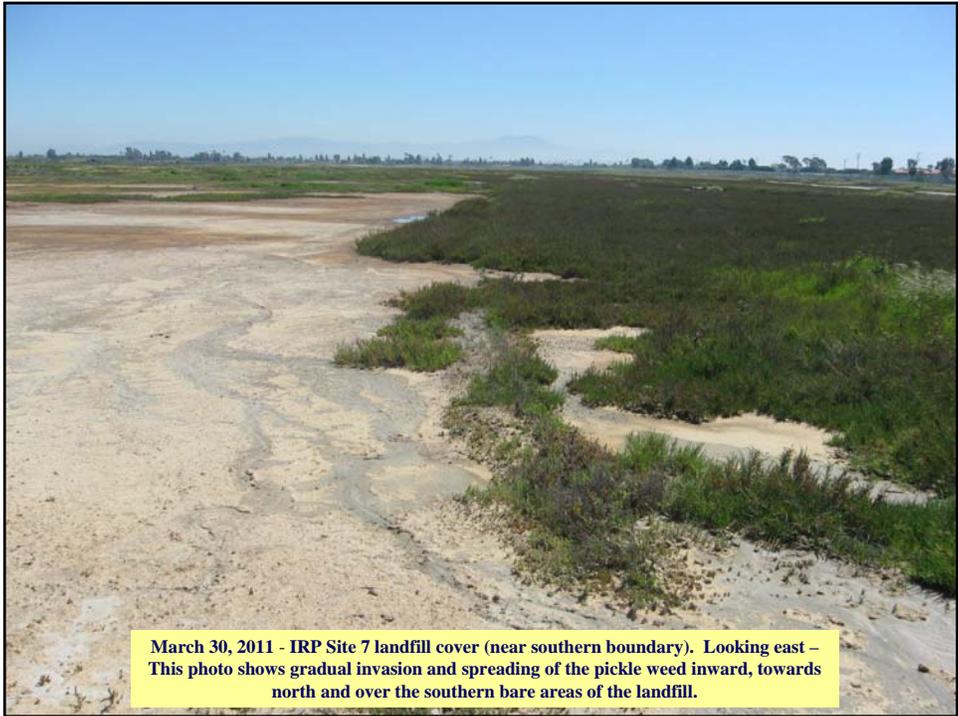
March 30, 2011 - IRP Site 7 landfill cover (near southern boundary). Looking east – This photo shows gradual invasion and spreading of the pickle weed inward, towards north and over the southern bare areas of the landfill.

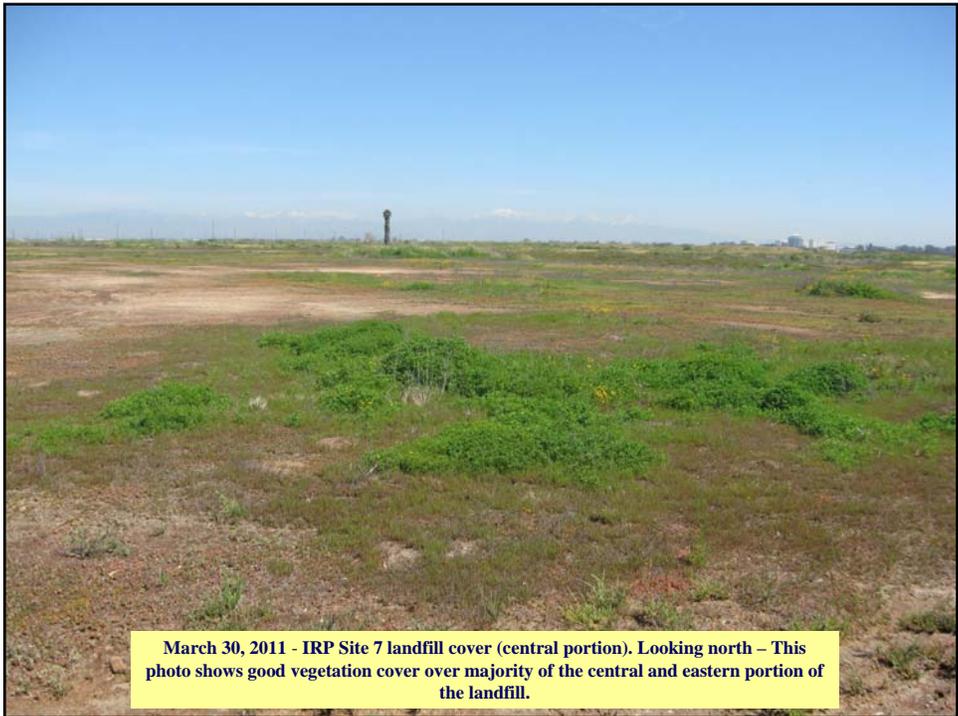
March 30, 2011 - IRP Site 7 landfill cover (central portion). Looking north – This photo shows good vegetation cover over majority of the central and eastern portion of the landfill.

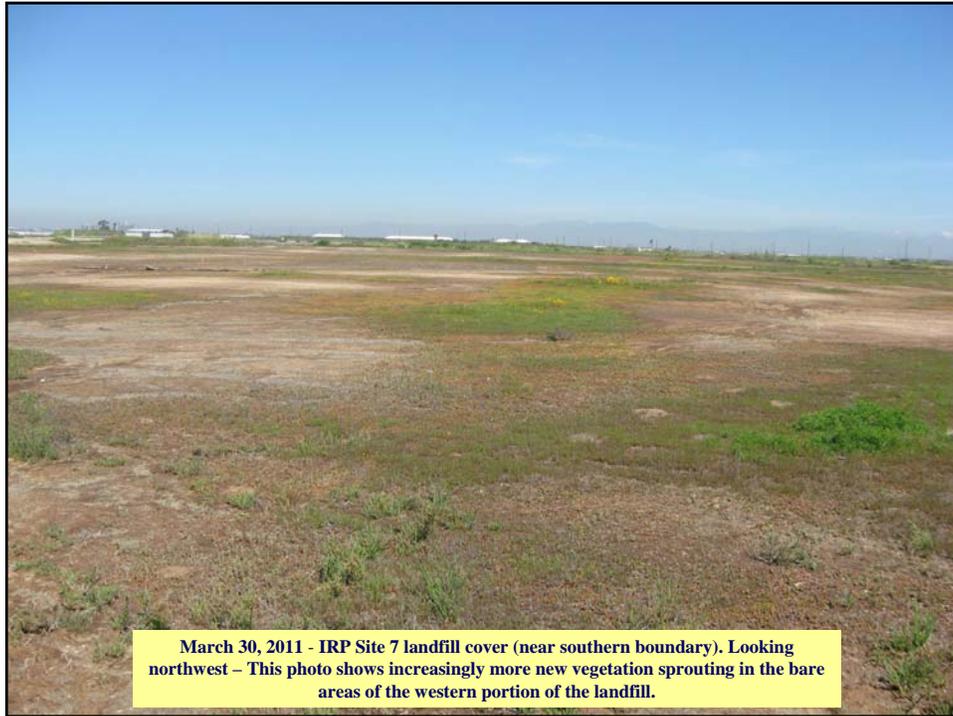
March 30, 2011 - IRP Site 7 landfill cover (near southern boundary). Looking northwest – This photo shows increasingly more new vegetation sprouting in the bare areas of the western portion of the landfill.
