CONTRACT NO. N62473-07-D-3211
CTO No. 0008

FINAL
FALL 2010 & WINTER 2011 ANNUAL POST-CLOSURE
INSPECTION AND MAINTENANCE REPORT
July 20, 2011

INSTALLATION RESTORATION PROGRAM SITE 7 AREA 1
(FORMER STATION LANDFILL)
NAVAL WEAPONS STATION SEAL BEACH
SEAL BEACH, CALIFORNIA

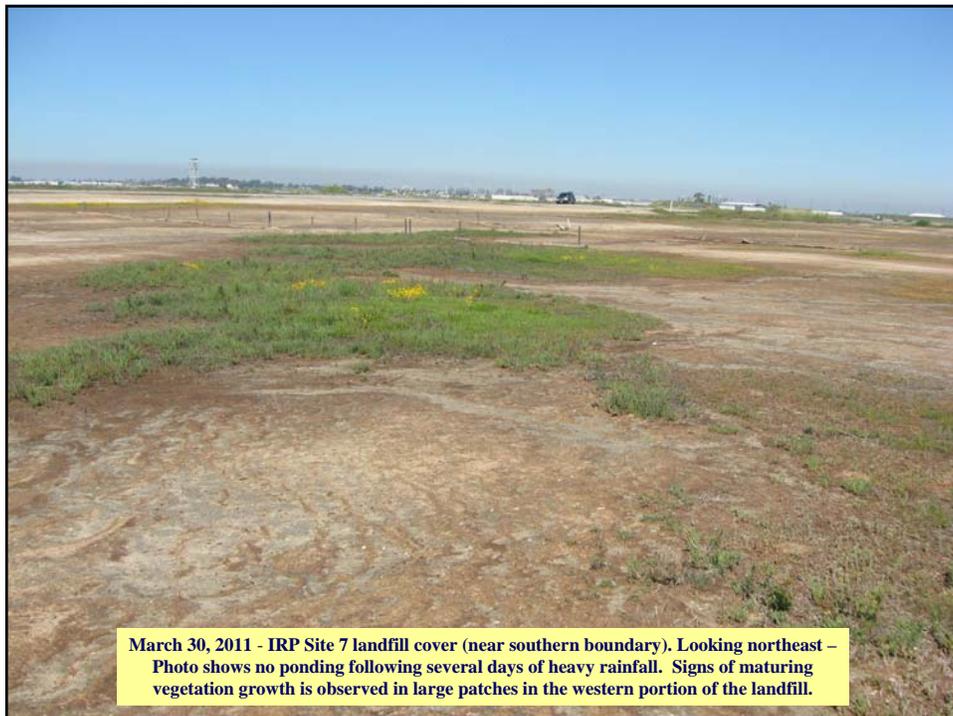
March 30, 2011 - IRP Site 7 landfill cover (near southern boundary). Looking northeast – Photo shows no ponding following several days of heavy rainfall. Signs of maturing vegetation growth is observed in large patches in the western portion of the landfill.

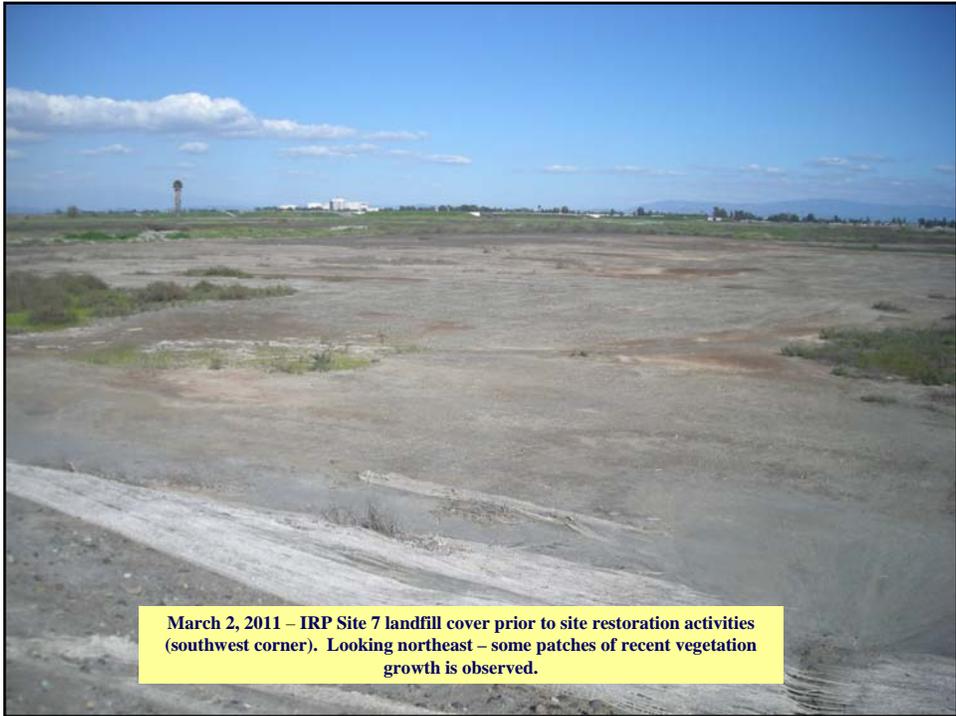
March 2, 2011 – IRP Site 7 landfill cover prior to site restoration activities (southwest corner). Looking northeast – some patches of recent vegetation growth is observed.

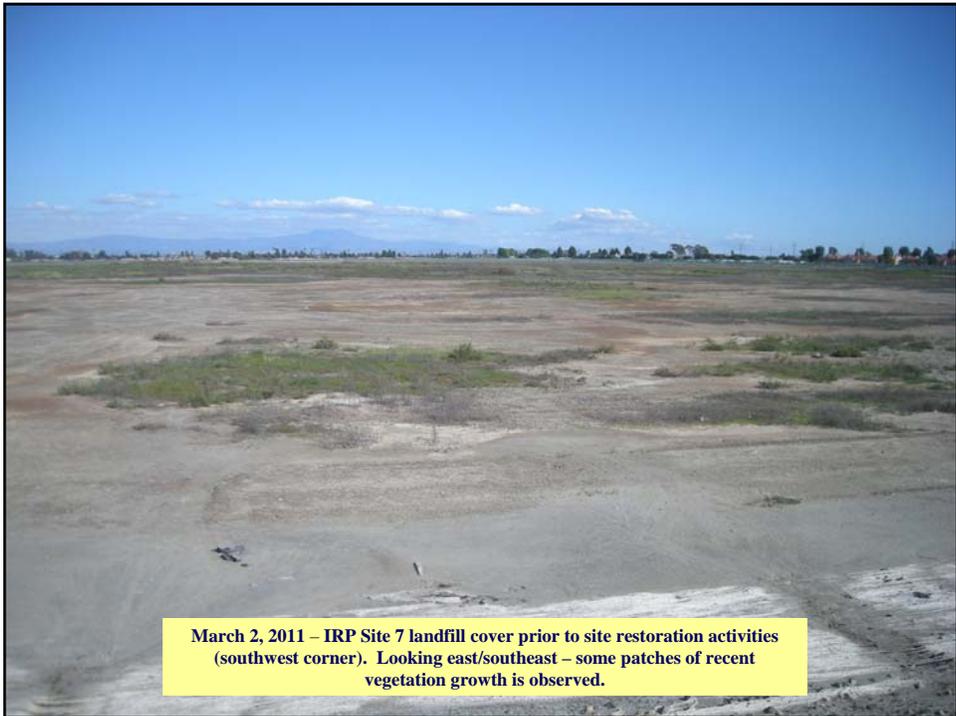
March 2, 2011 – IRP Site 7 landfill cover prior to site restoration activities (southwest corner). Looking east/southeast – some patches of recent vegetation growth is observed.

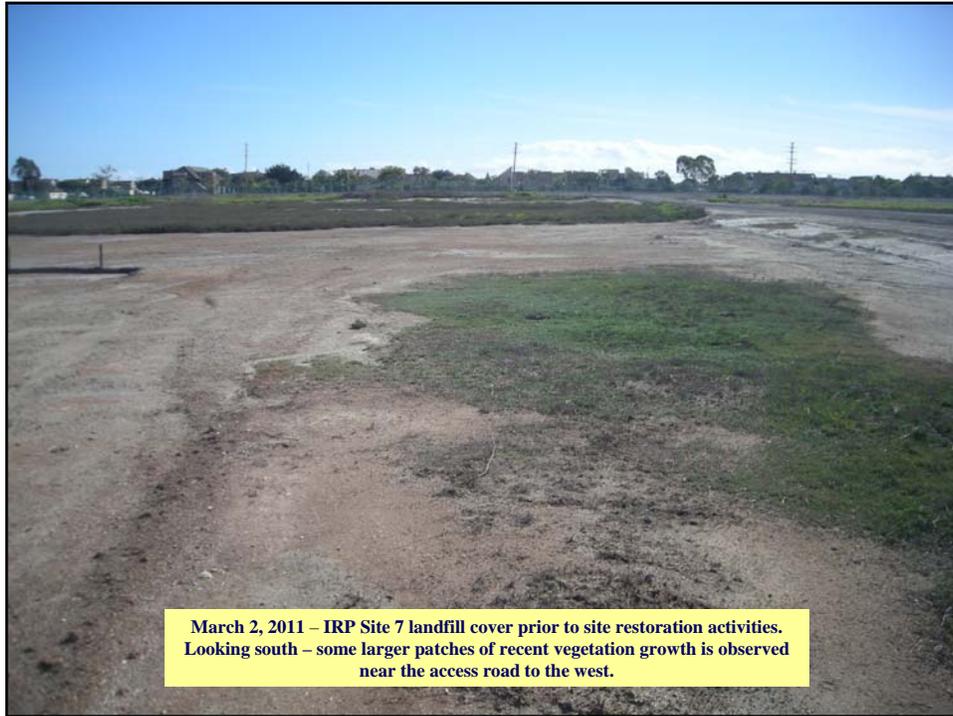
March 2, 2011 – IRP Site 7 landfill cover prior to site restoration activities. Looking south – some larger patches of recent vegetation growth is observed near the access road to the west.
