**FALL 2011 & WINTER 2012 ANNUAL POST-CLOSURE  
INSPECTION AND MAINTENANCE REPORT**

**August 8, 2012**

**INSTALLATION RESTORATION PROGRAM SITE 7 AREA 1  
(FORMER STATION LANDFILL)**

**NAVAL WEAPONS STATION SEAL BEACH  
SEAL BEACH, CALIFORNIA**

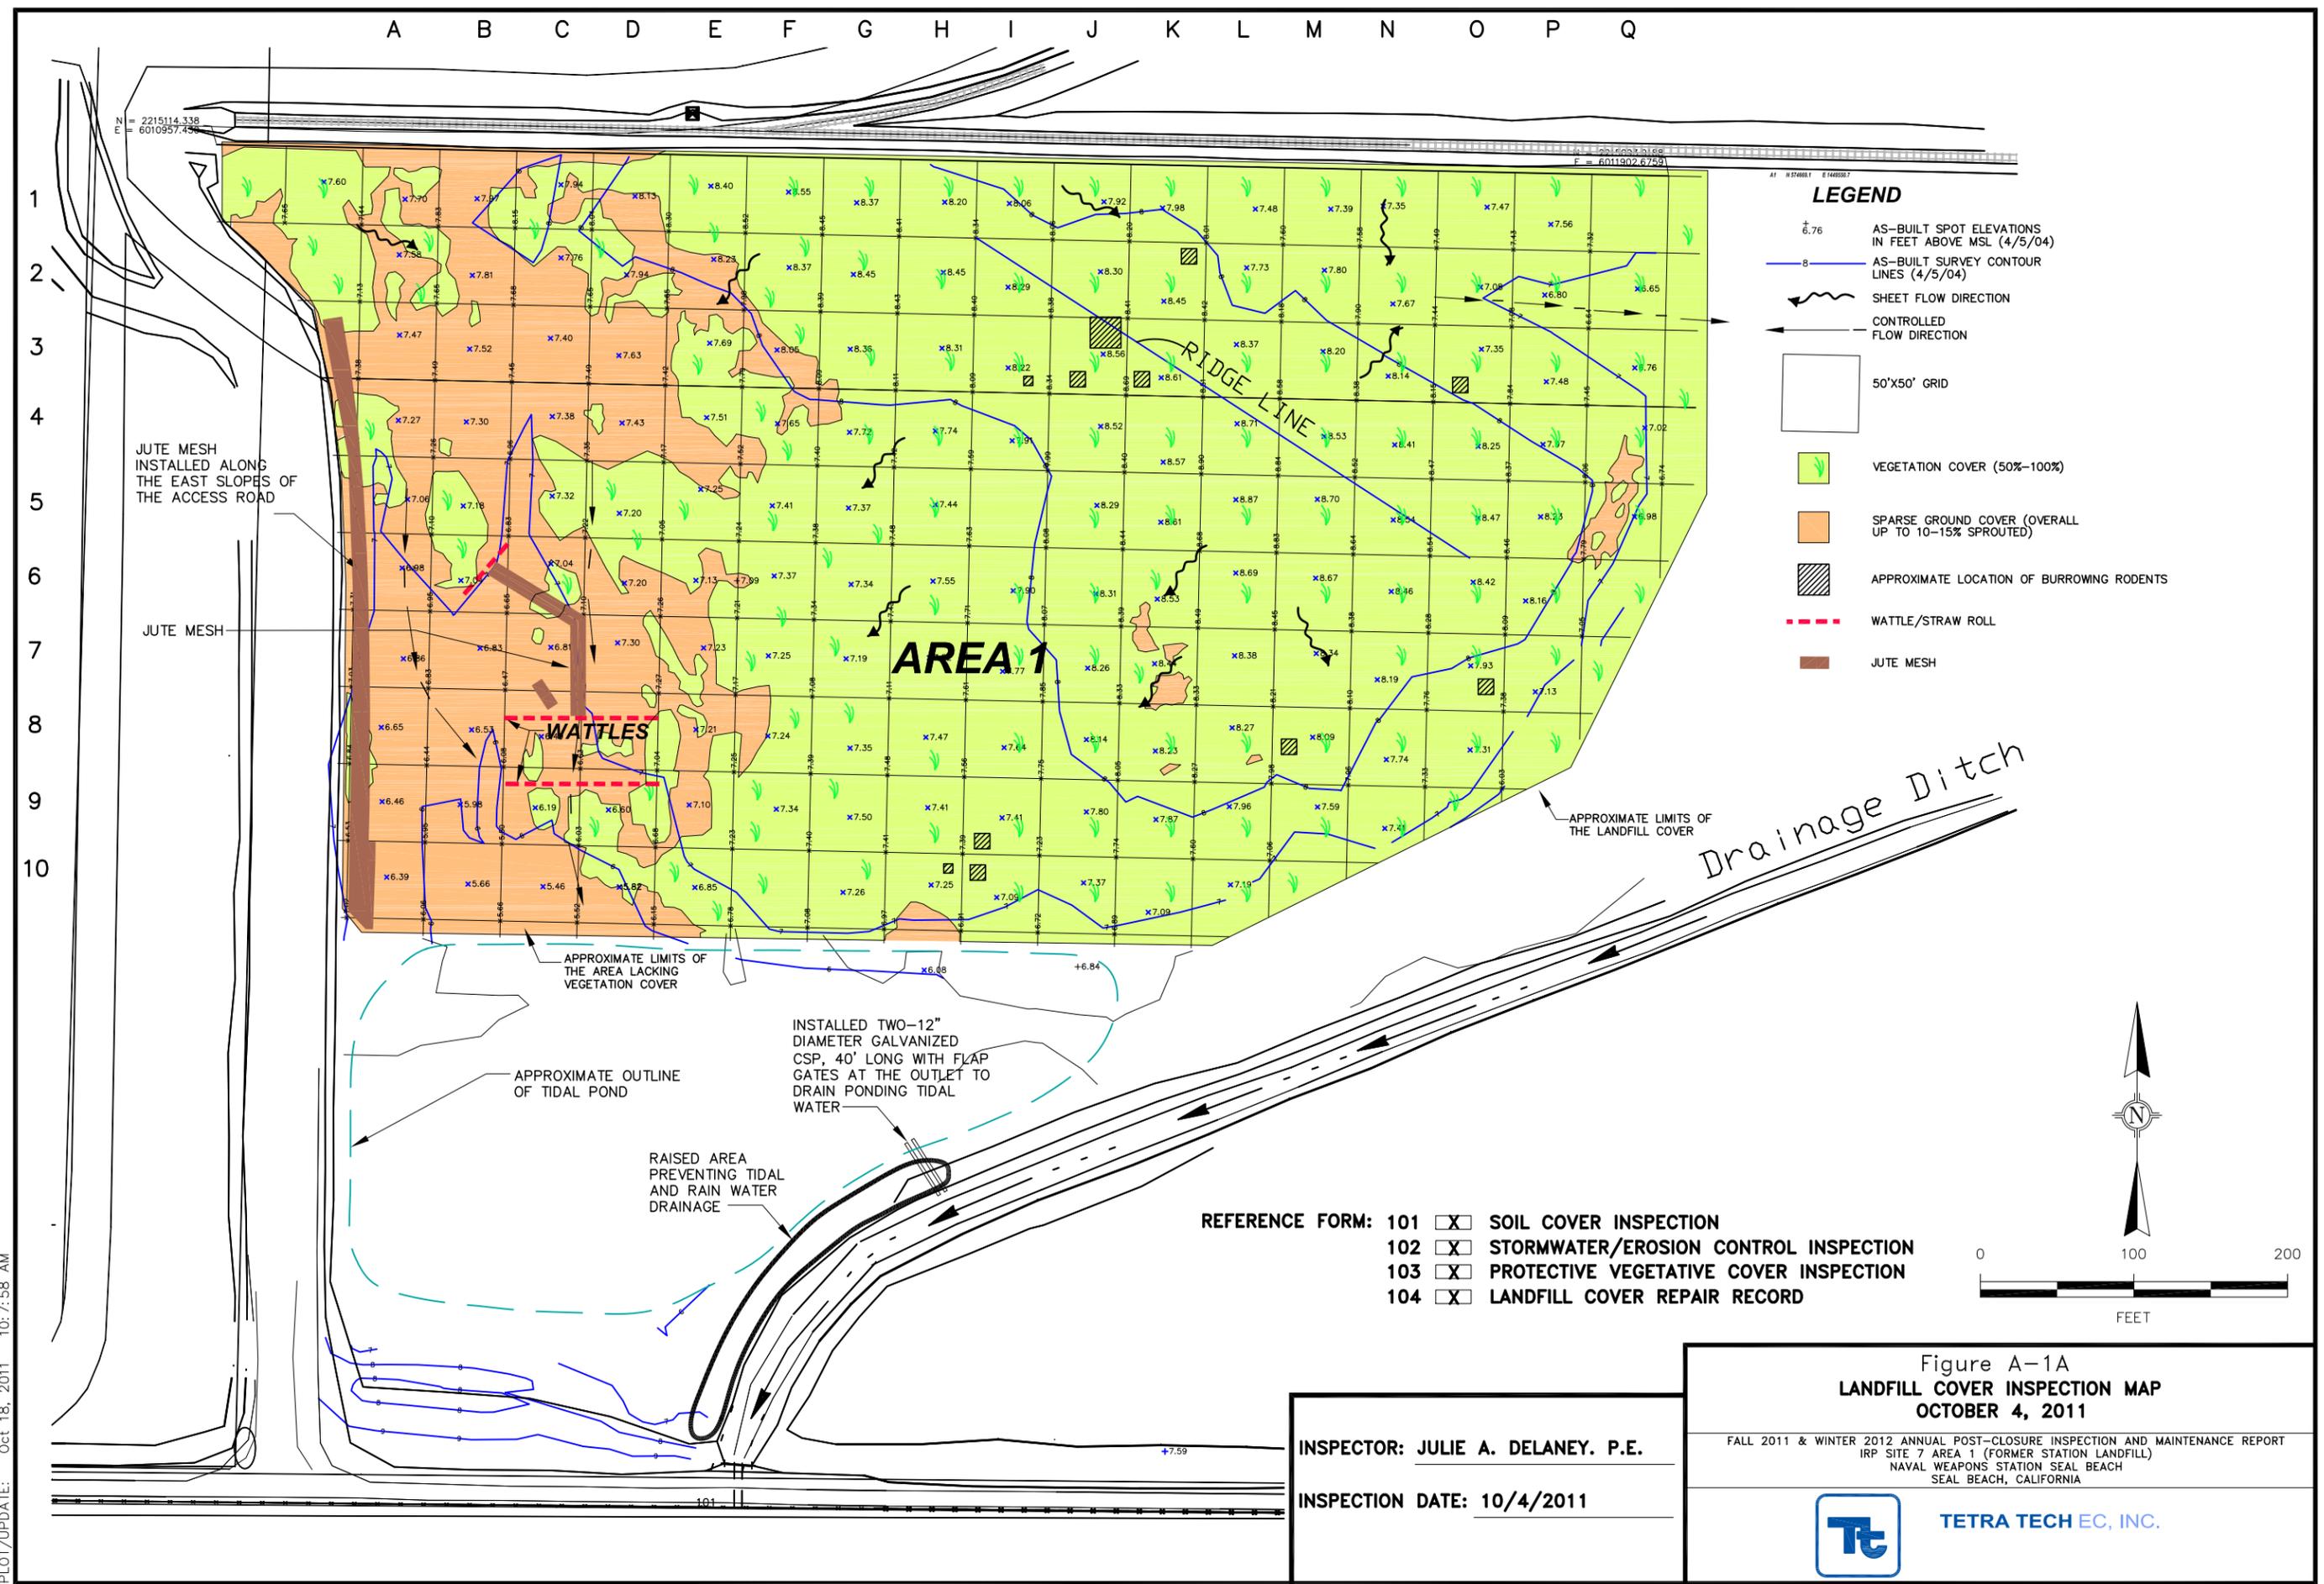
Figure A-1A  
**LANDFILL COVER INSPECTION MAP**  
**OCTOBER 4, 2011**

Evidence of burrowing rodents (probably gophers) was observed (See Figure A-1A). Ground holes and 2" to 3" loose soil mounding was observed in 11 areas in the eastern 2/3rds of the landfill cover. No trash exposure was observed.

**RECOMMENDATIONS:** Consider setting traps or installing four to six 8' to 10' high predatory bird perches in the vicinity of the burrowing rodents. Holes in disturbed areas should be filled and tamped when rodents are gone.

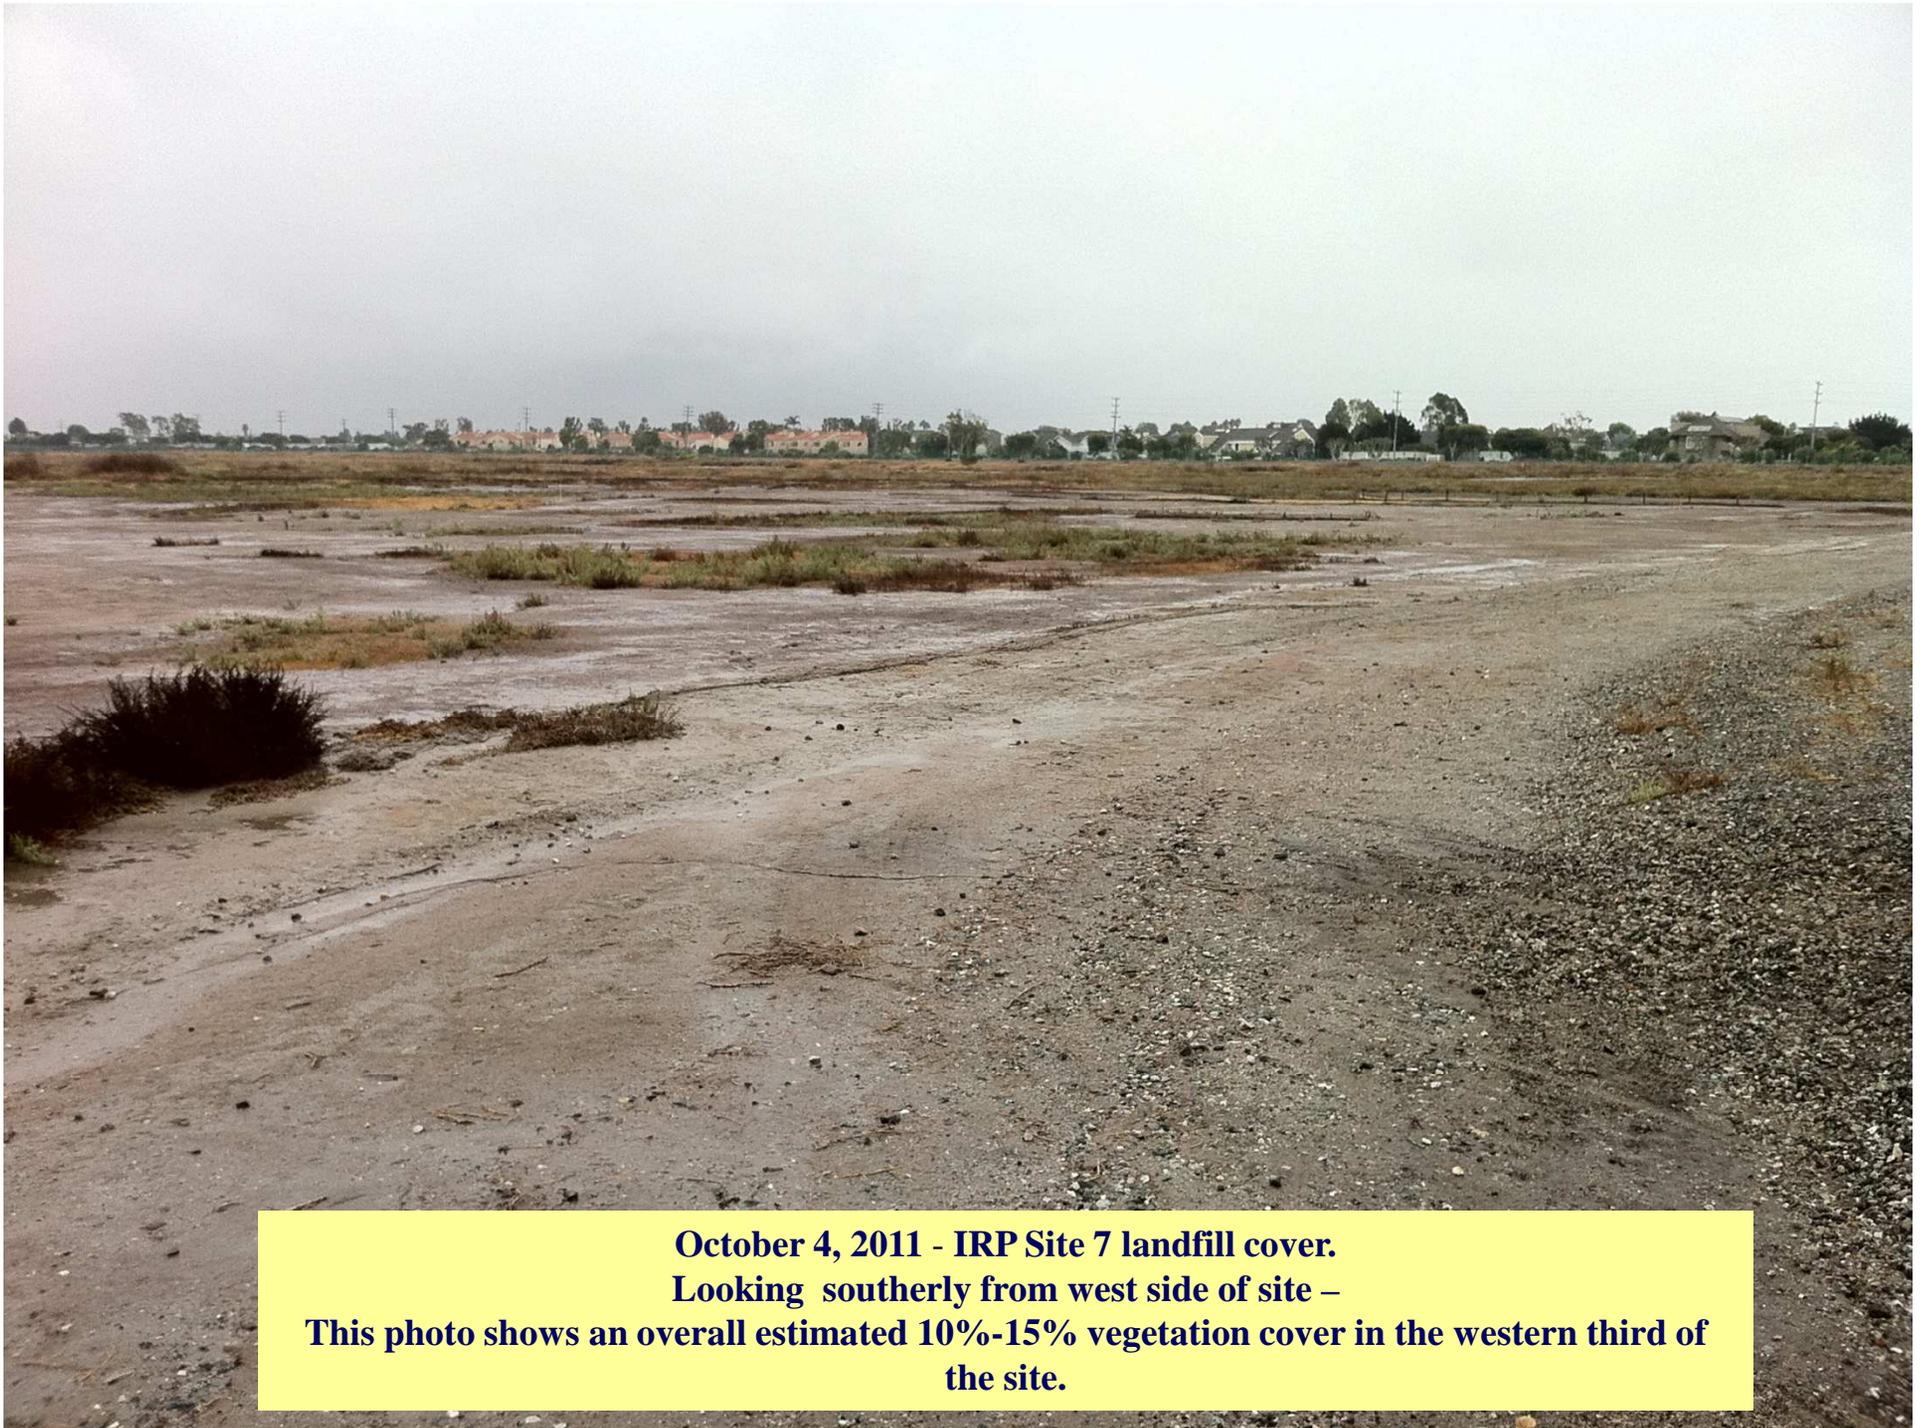
**October 4, 2011 - IRP Site 7 landfill cover.  
Looking southerly from west side of site –  
This photo shows an overall estimated 10%-15% vegetation cover in the western third of  
the site.**

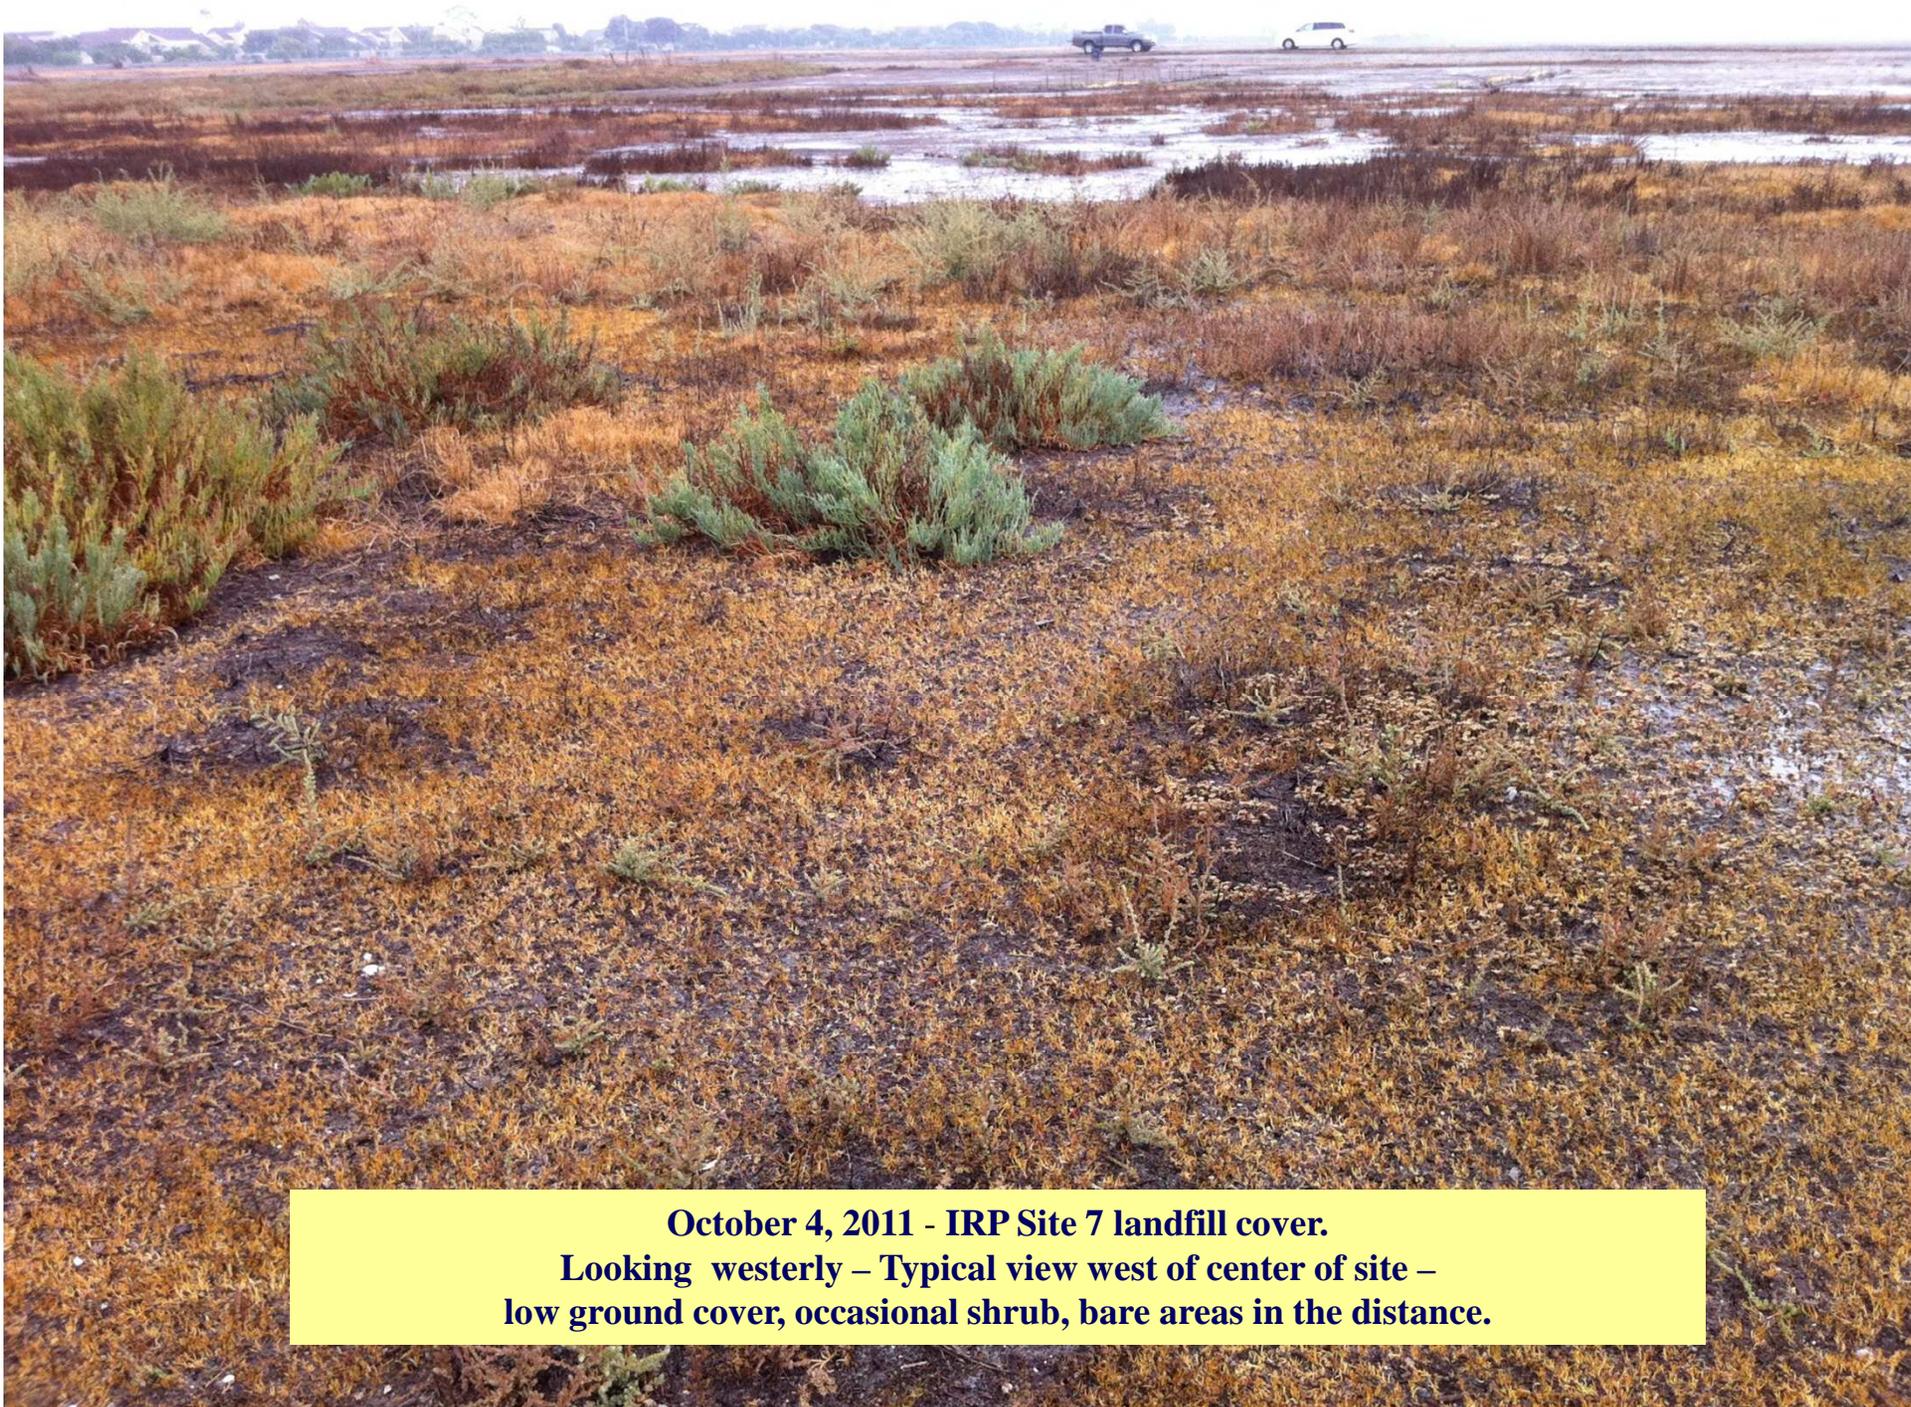
**October 4, 2011 - IRP Site 7 landfill cover.  
Looking westerly – Typical view west of center of site –  
low ground cover, occasional shrub, bare areas in the distance.**

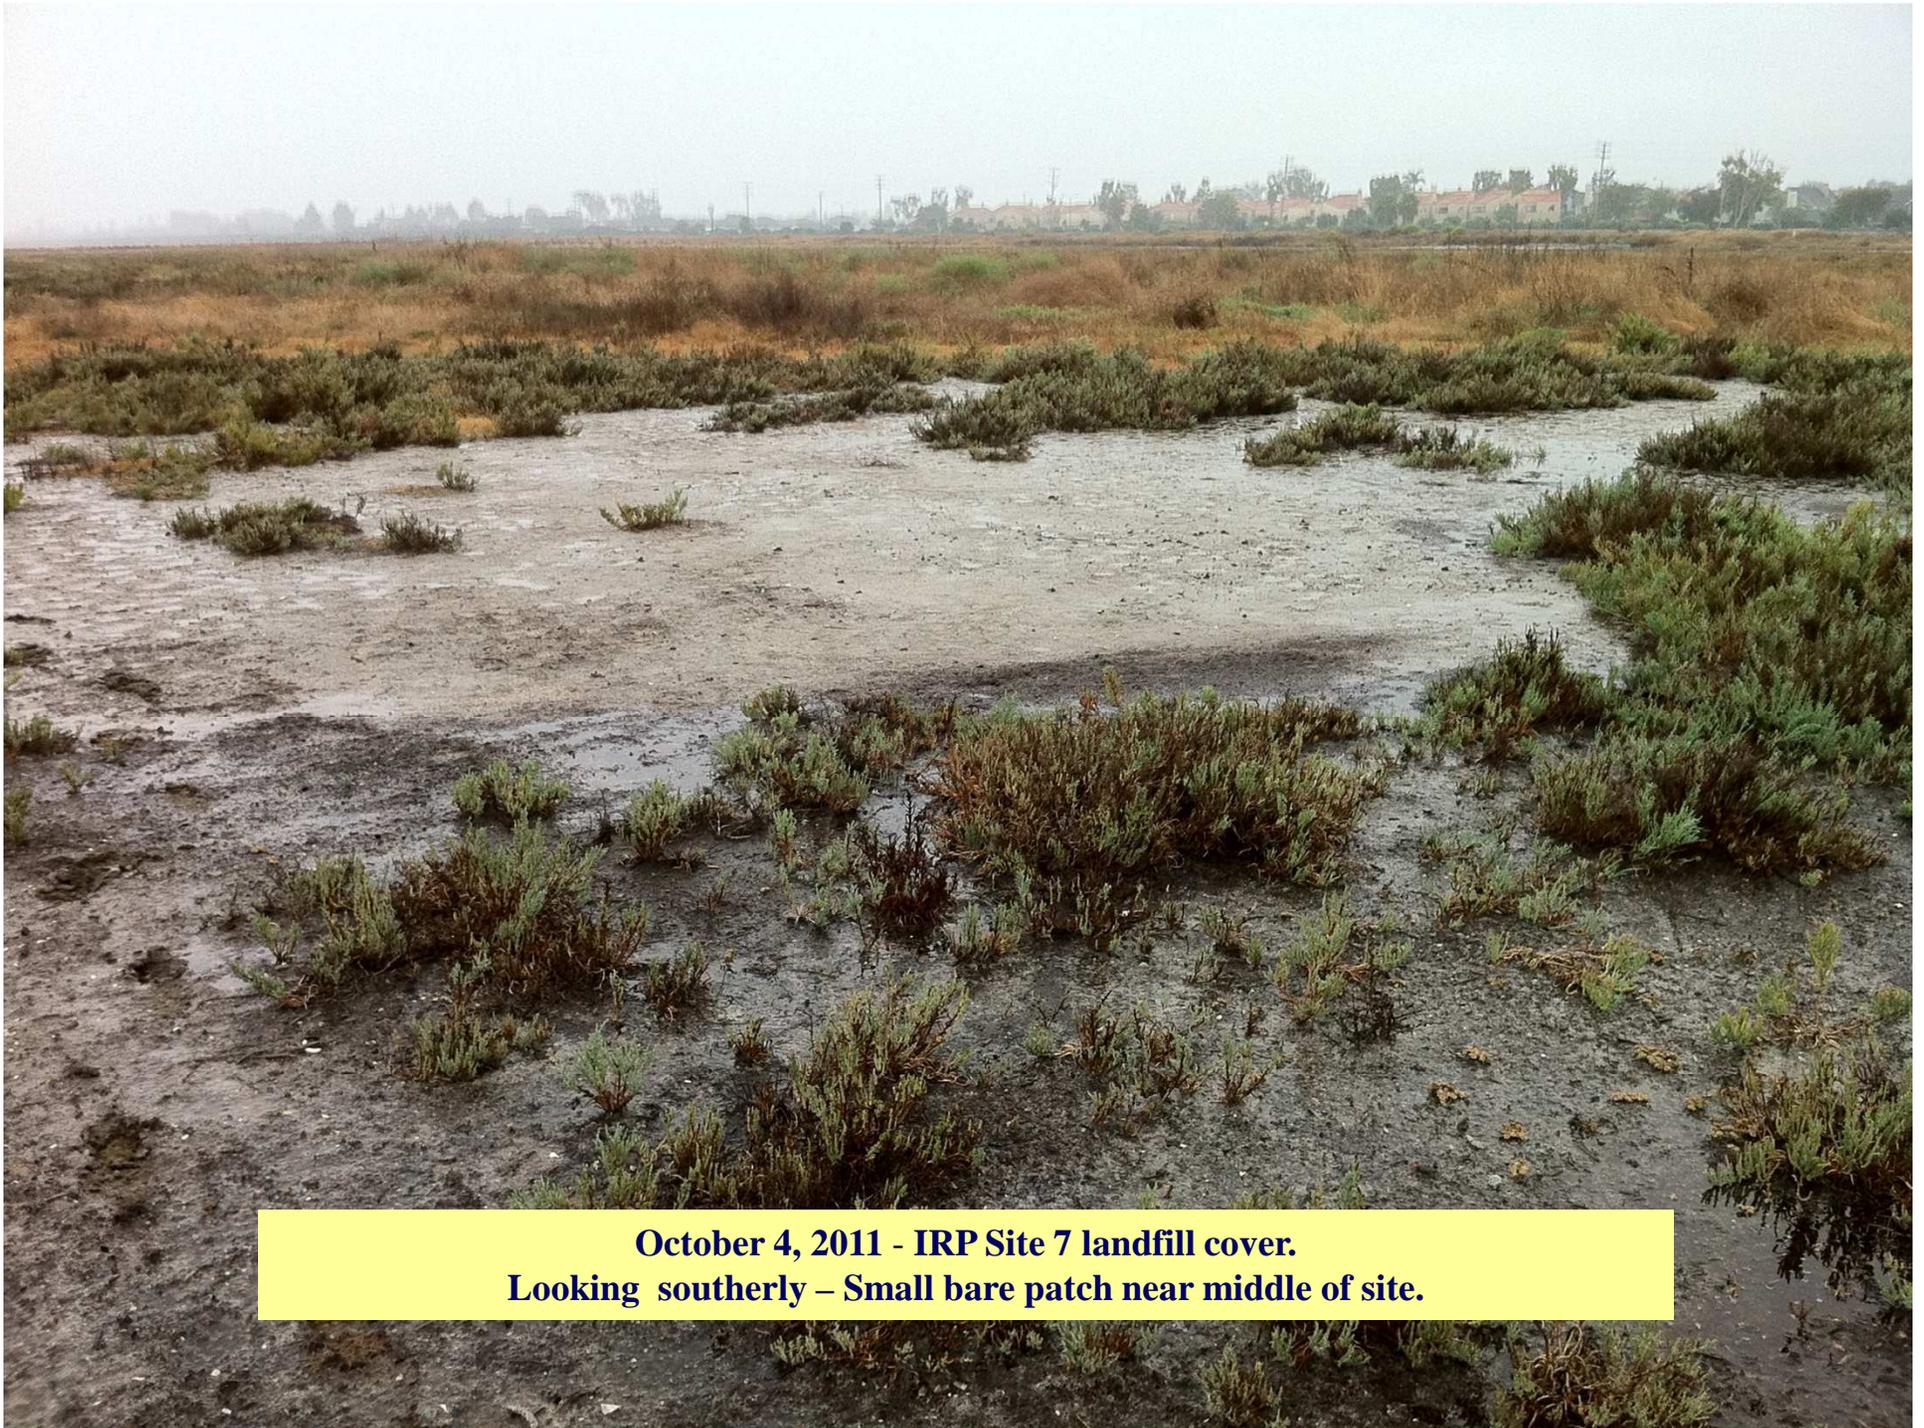
**October 4, 2011 - IRP Site 7 landfill cover.  
Looking southerly – Small bare patch near middle of site.**

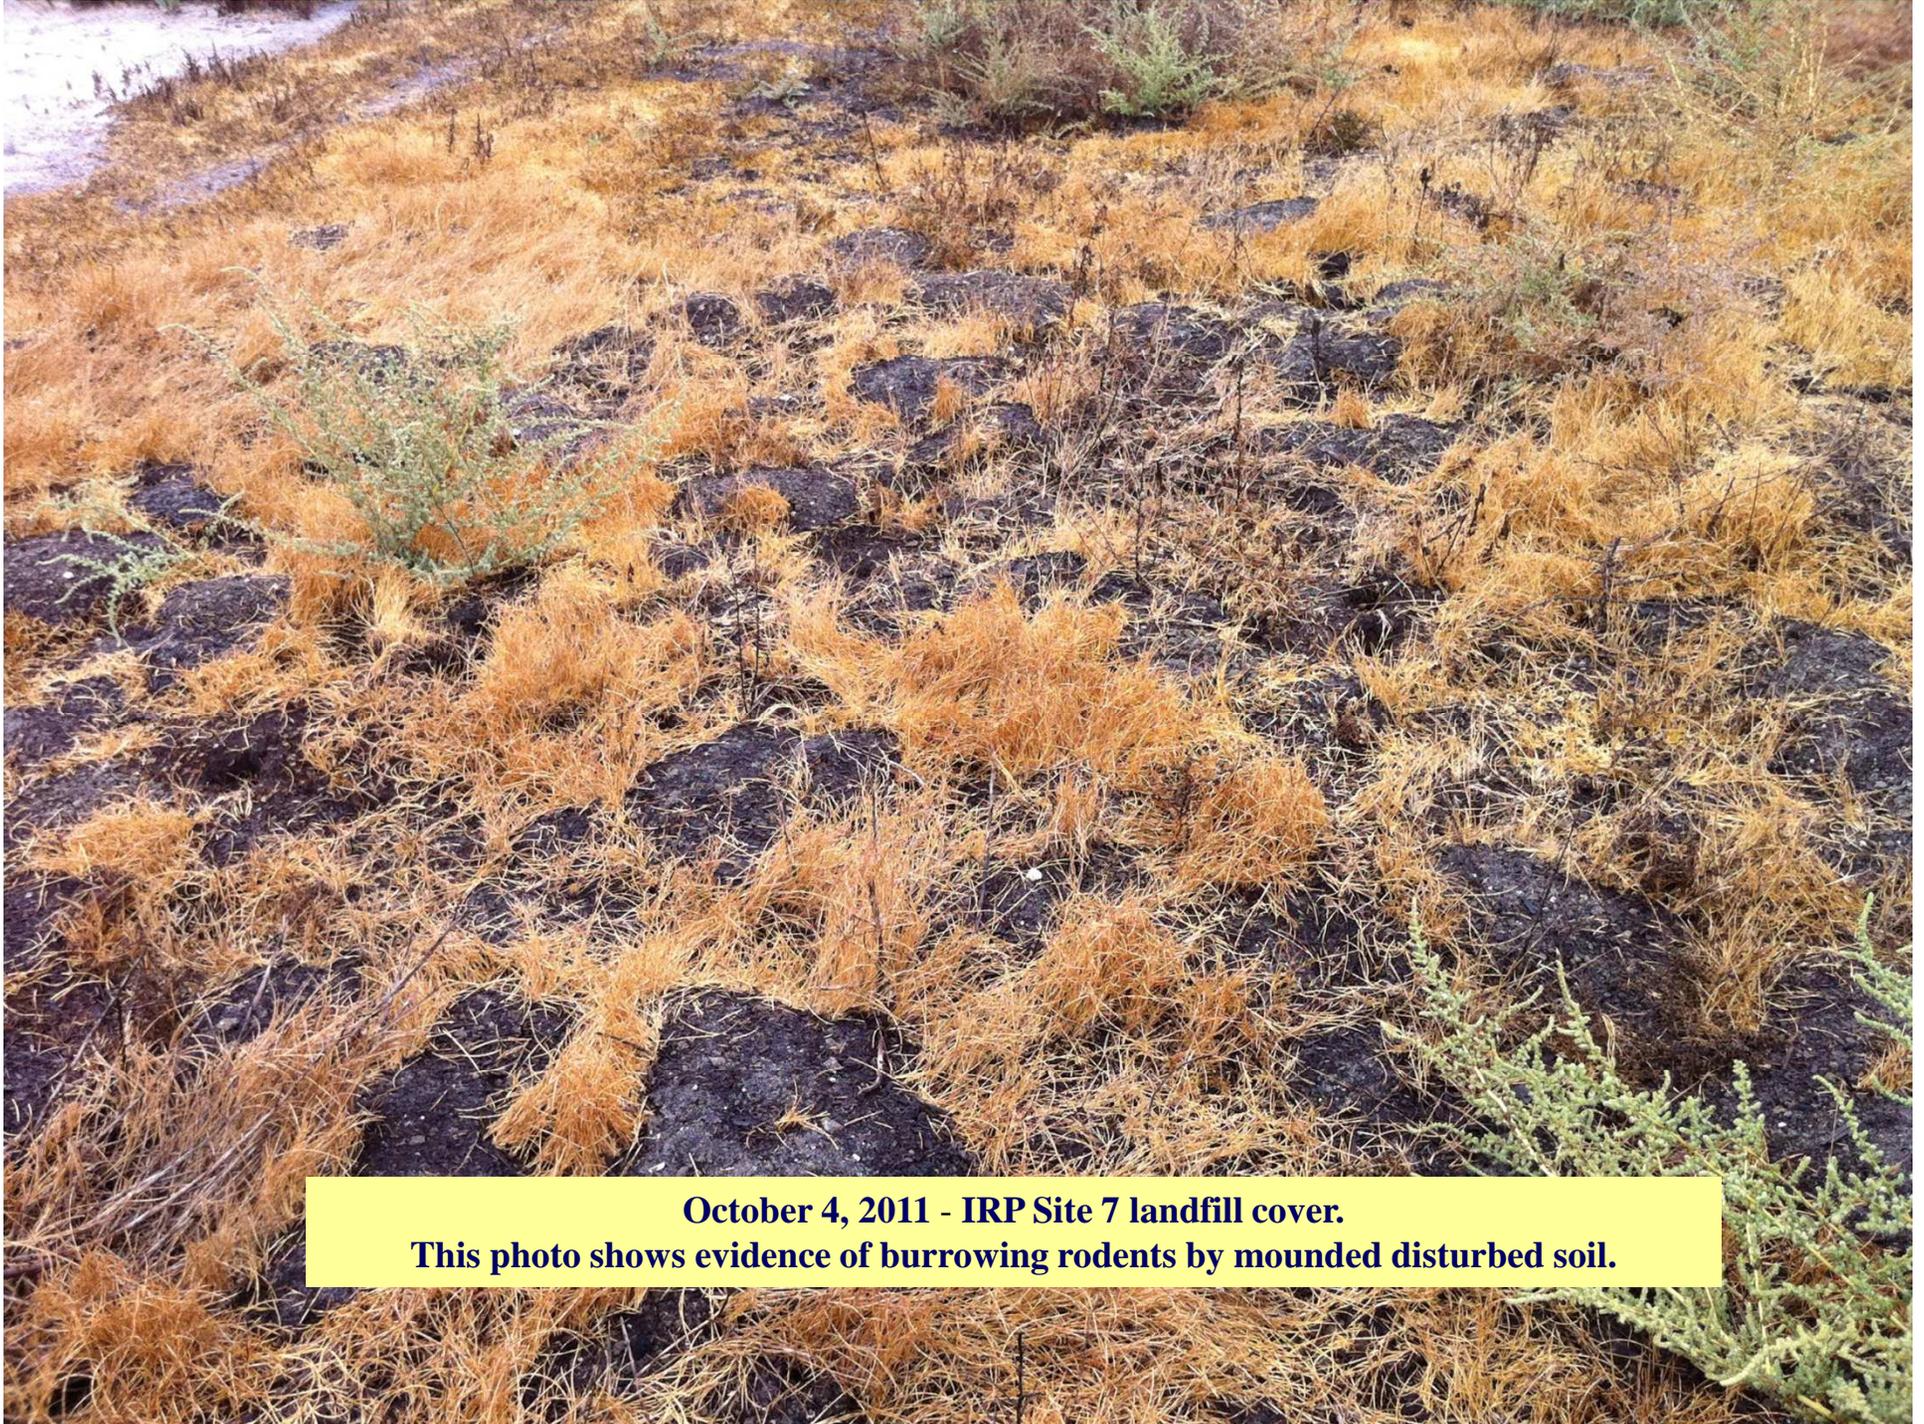
**October 4, 2011 - IRP Site 7 landfill cover.  
This photo shows evidence of burrowing rodents by mounded disturbed soil.**

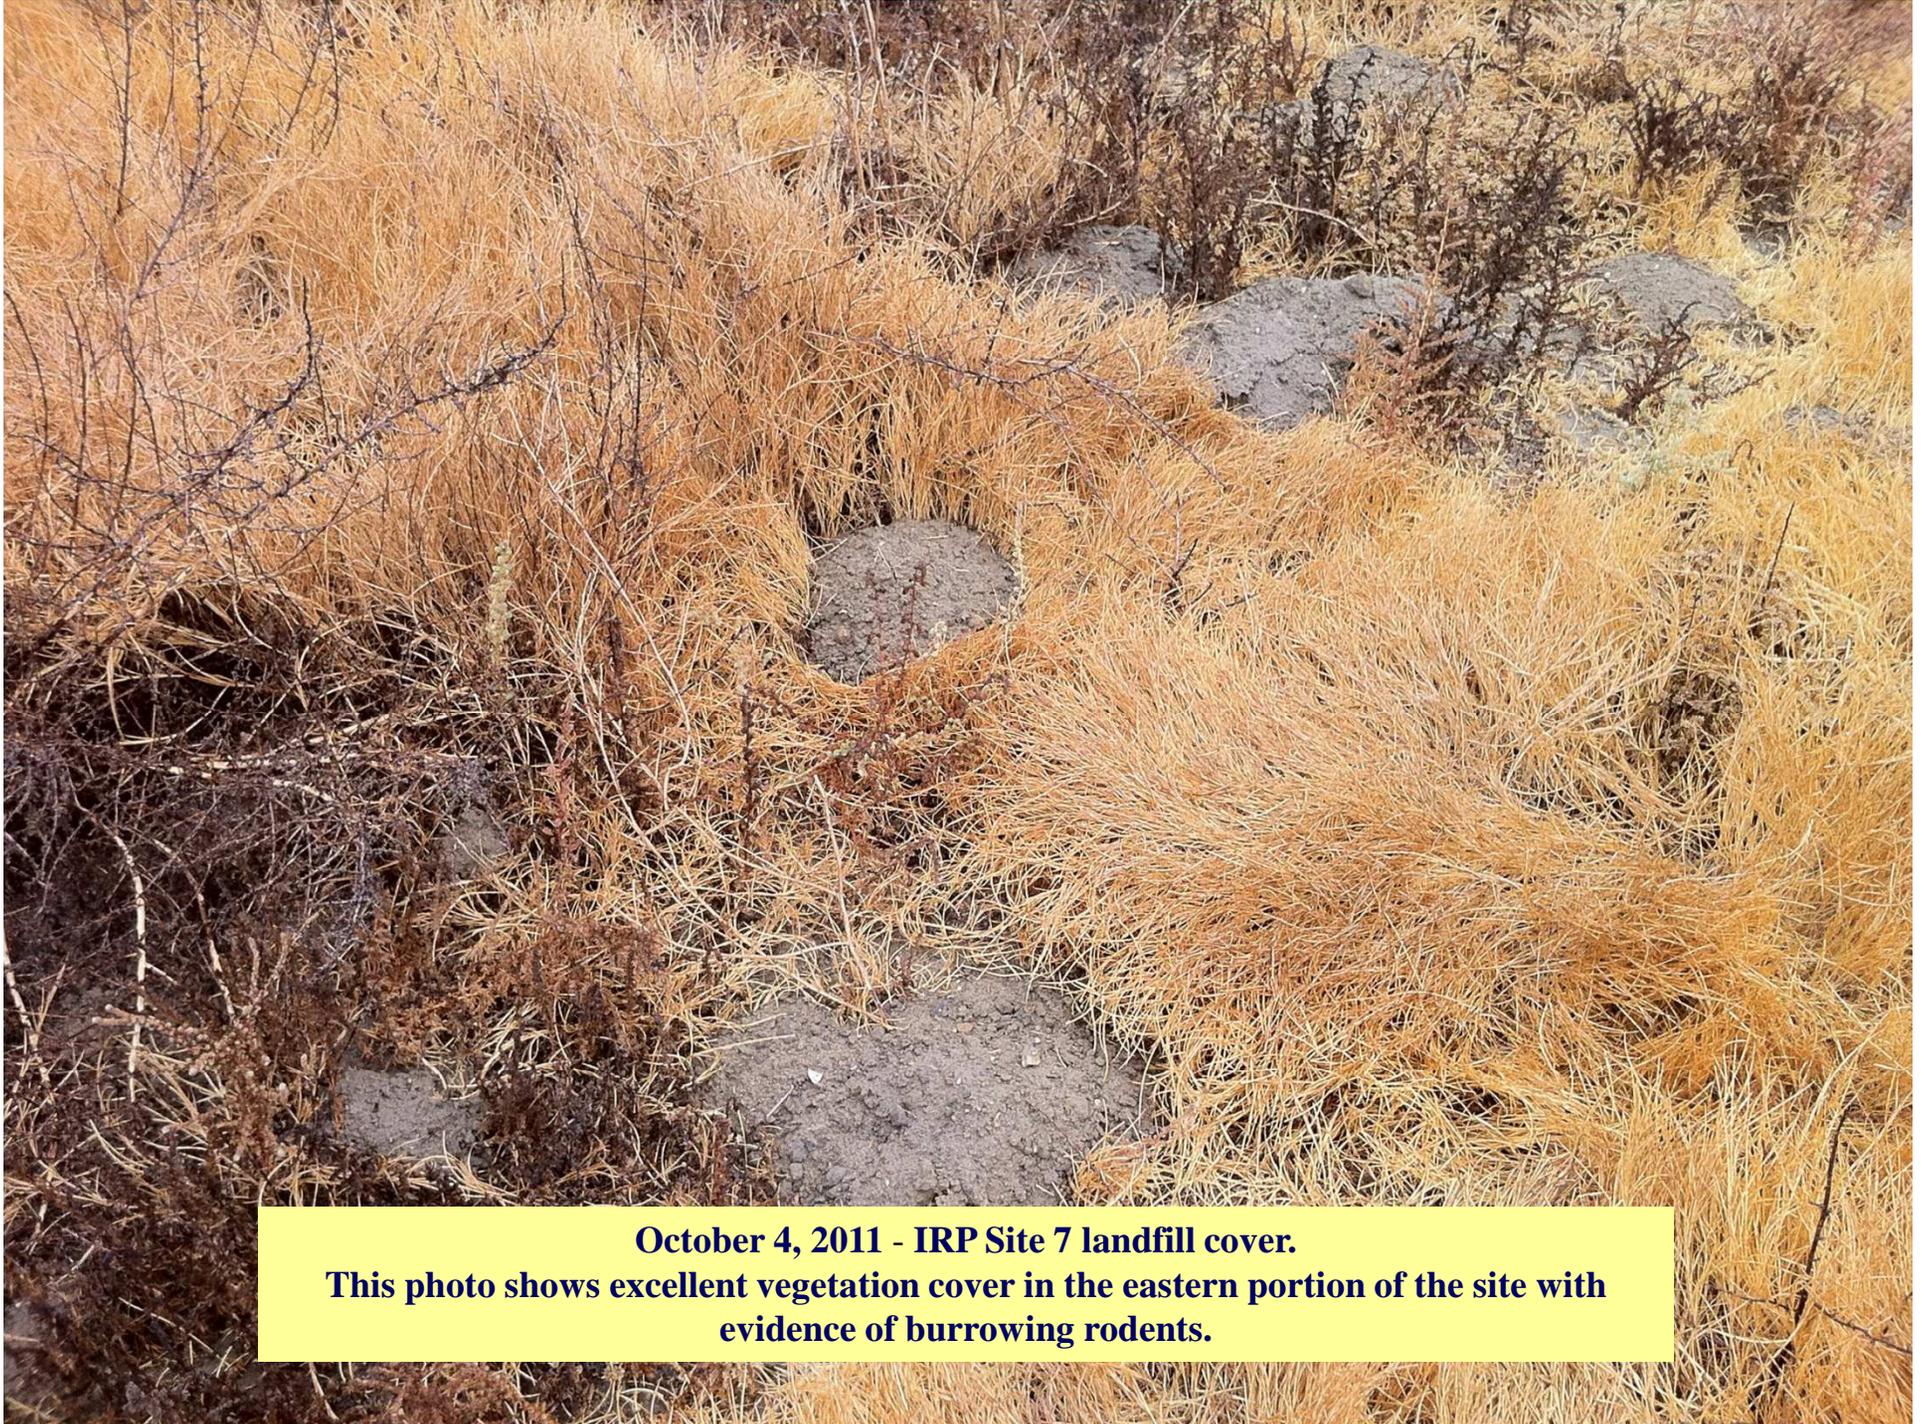
**October 4, 2011 - IRP Site 7 landfill cover.  
This photo shows excellent vegetation cover in the eastern portion of the site with  
evidence of burrowing rodents.**

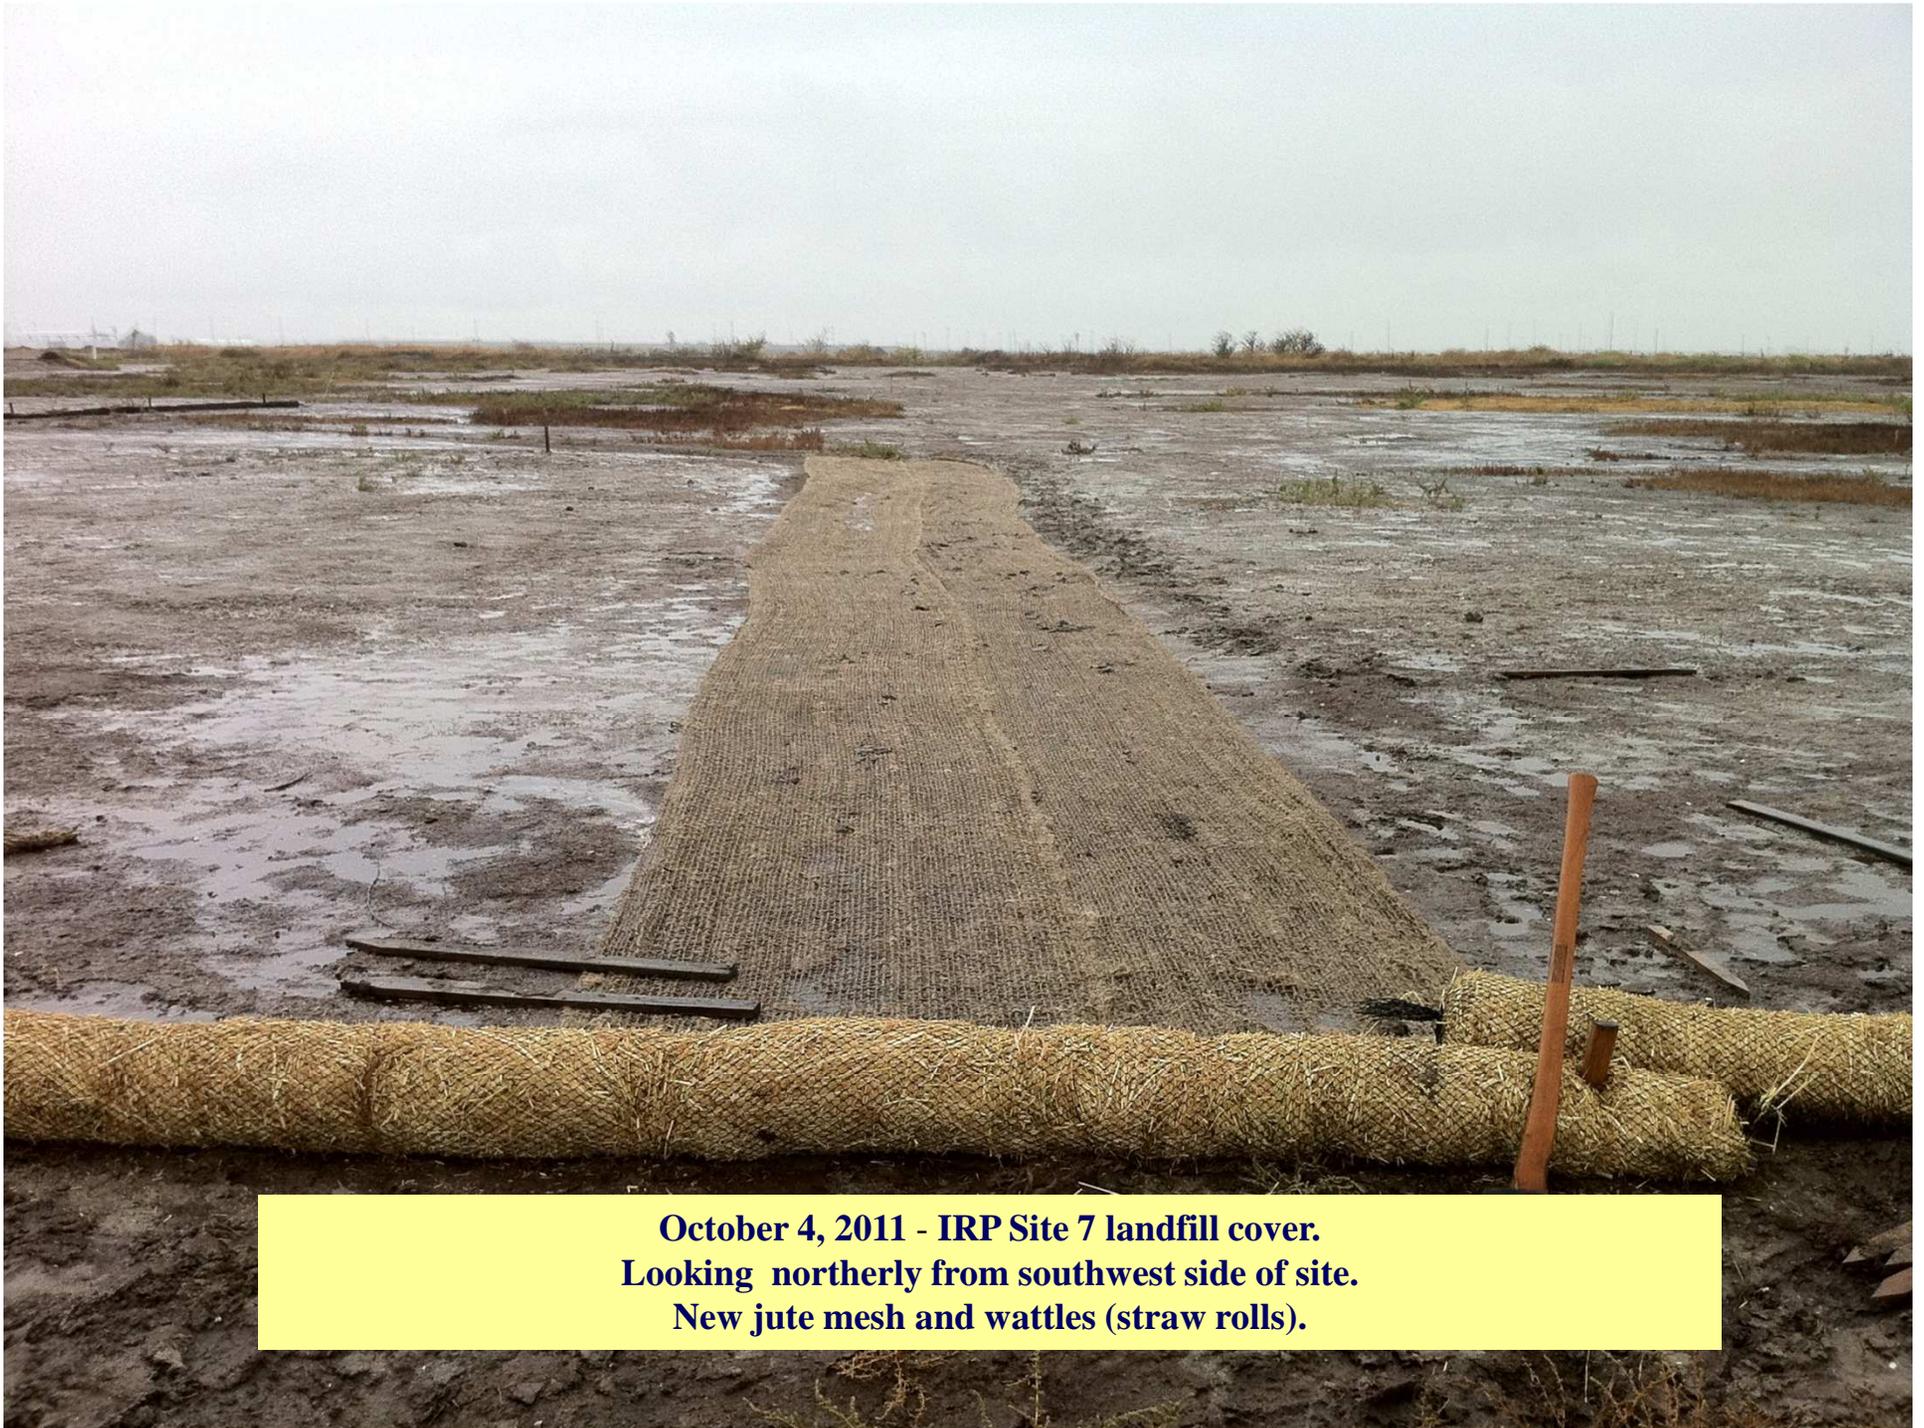
**October 4, 2011 - IRP Site 7 landfill cover.  
Looking northerly from southwest side of site.  
New jute mesh and wattles (straw rolls).**

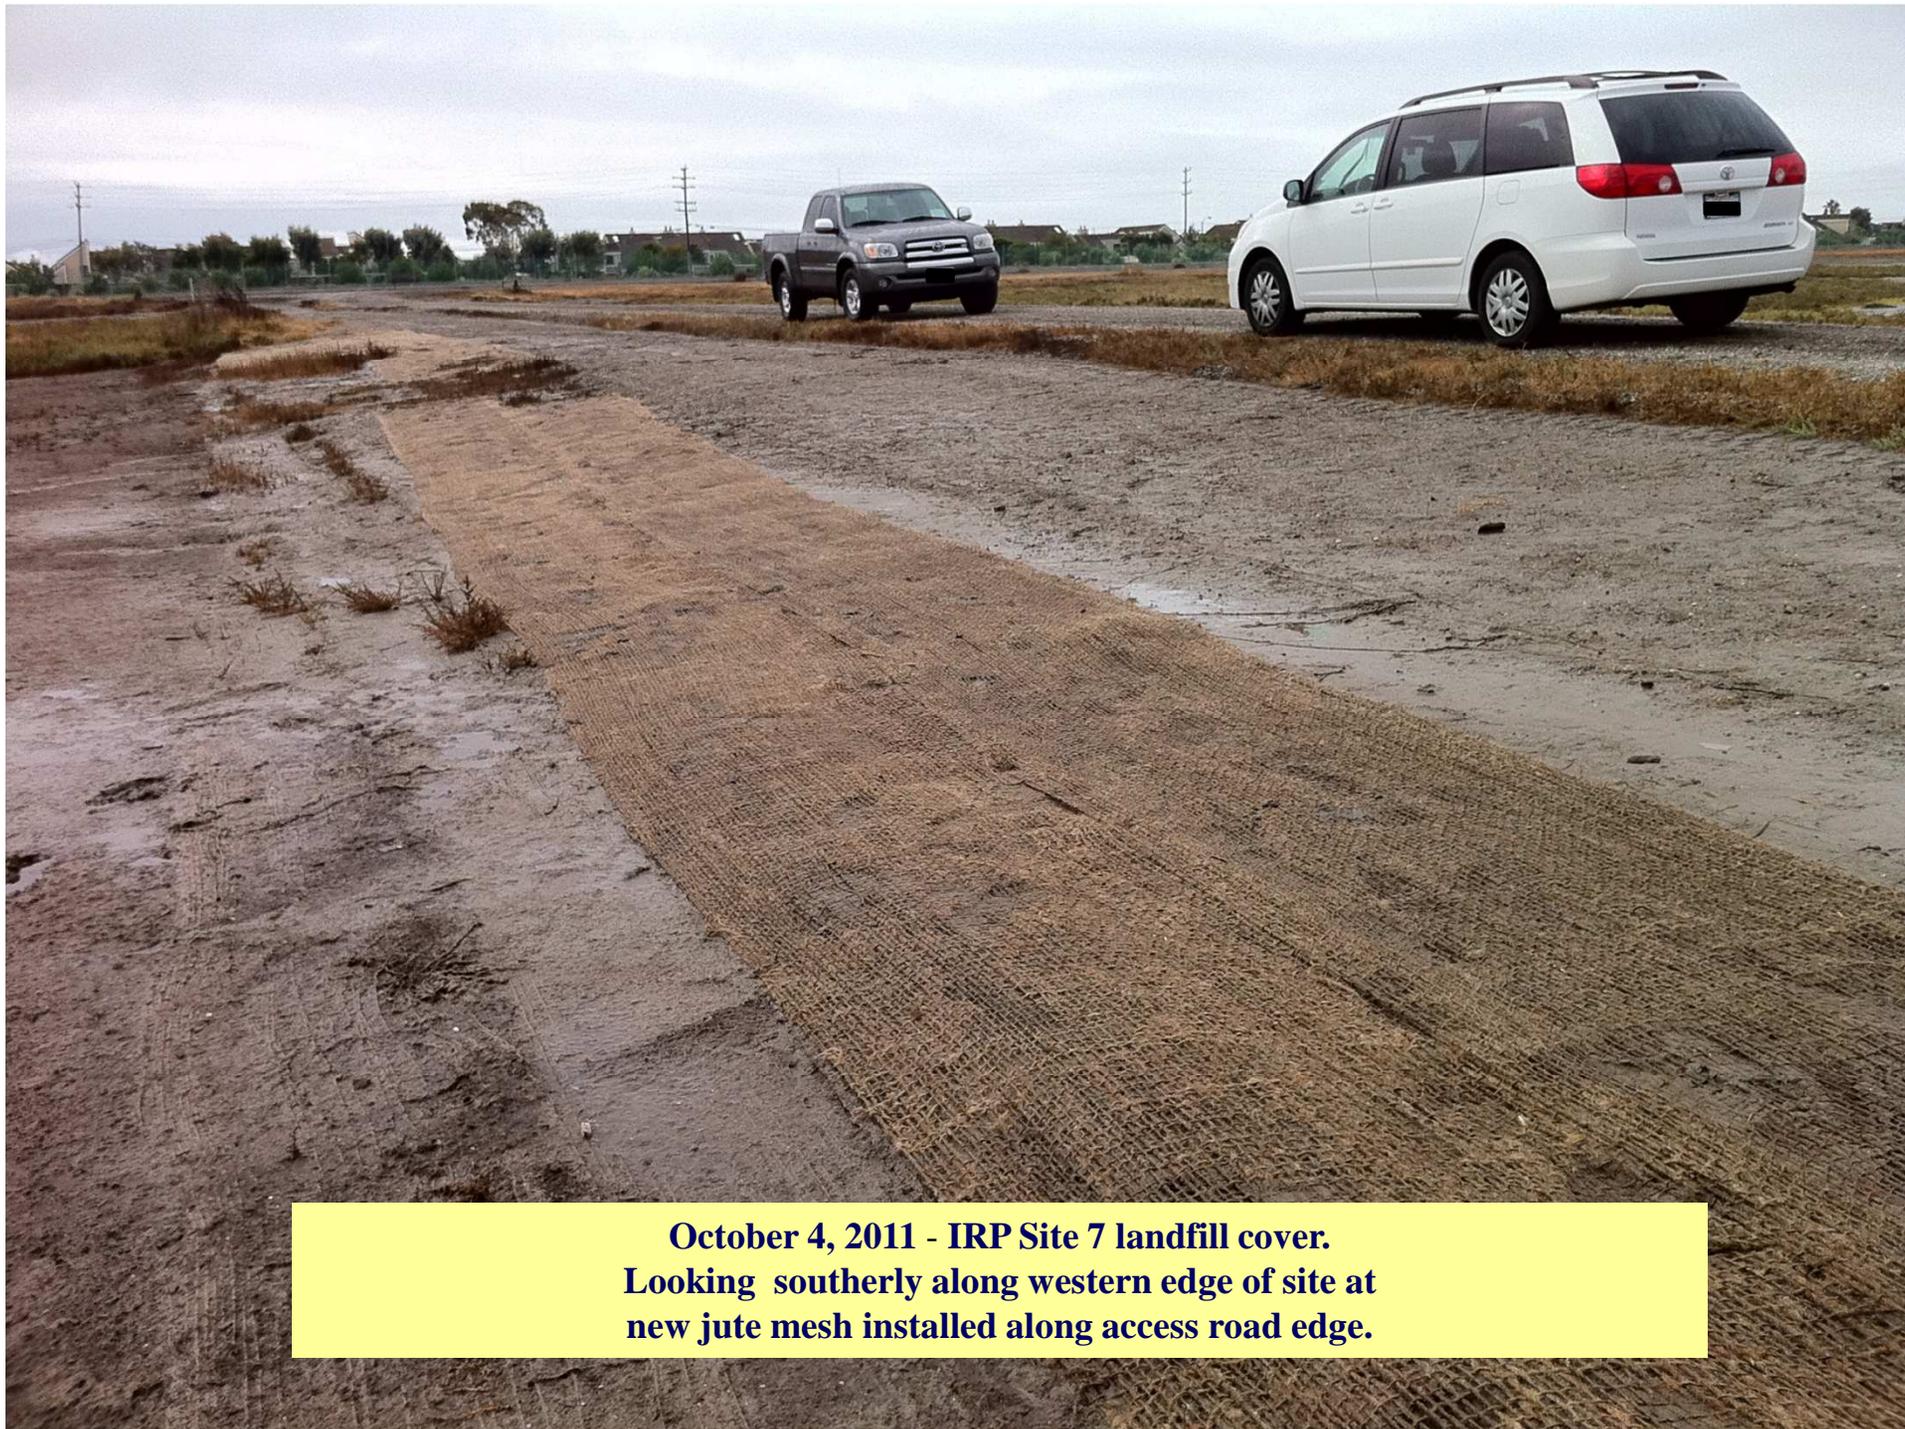
**October 4, 2011 - IRP Site 7 landfill cover.  
Looking southerly along western edge of site at  
new jute mesh installed along access road edge.**
