**FALL 2011 & WINTER 2012 ANNUAL POST-CLOSURE  
INSPECTION AND MAINTENANCE REPORT**

**August 8, 2012**

**INSTALLATION RESTORATION PROGRAM SITE 7 AREA 1  
(FORMER STATION LANDFILL)**

**NAVAL WEAPONS STATION SEAL BEACH  
SEAL BEACH, CALIFORNIA**

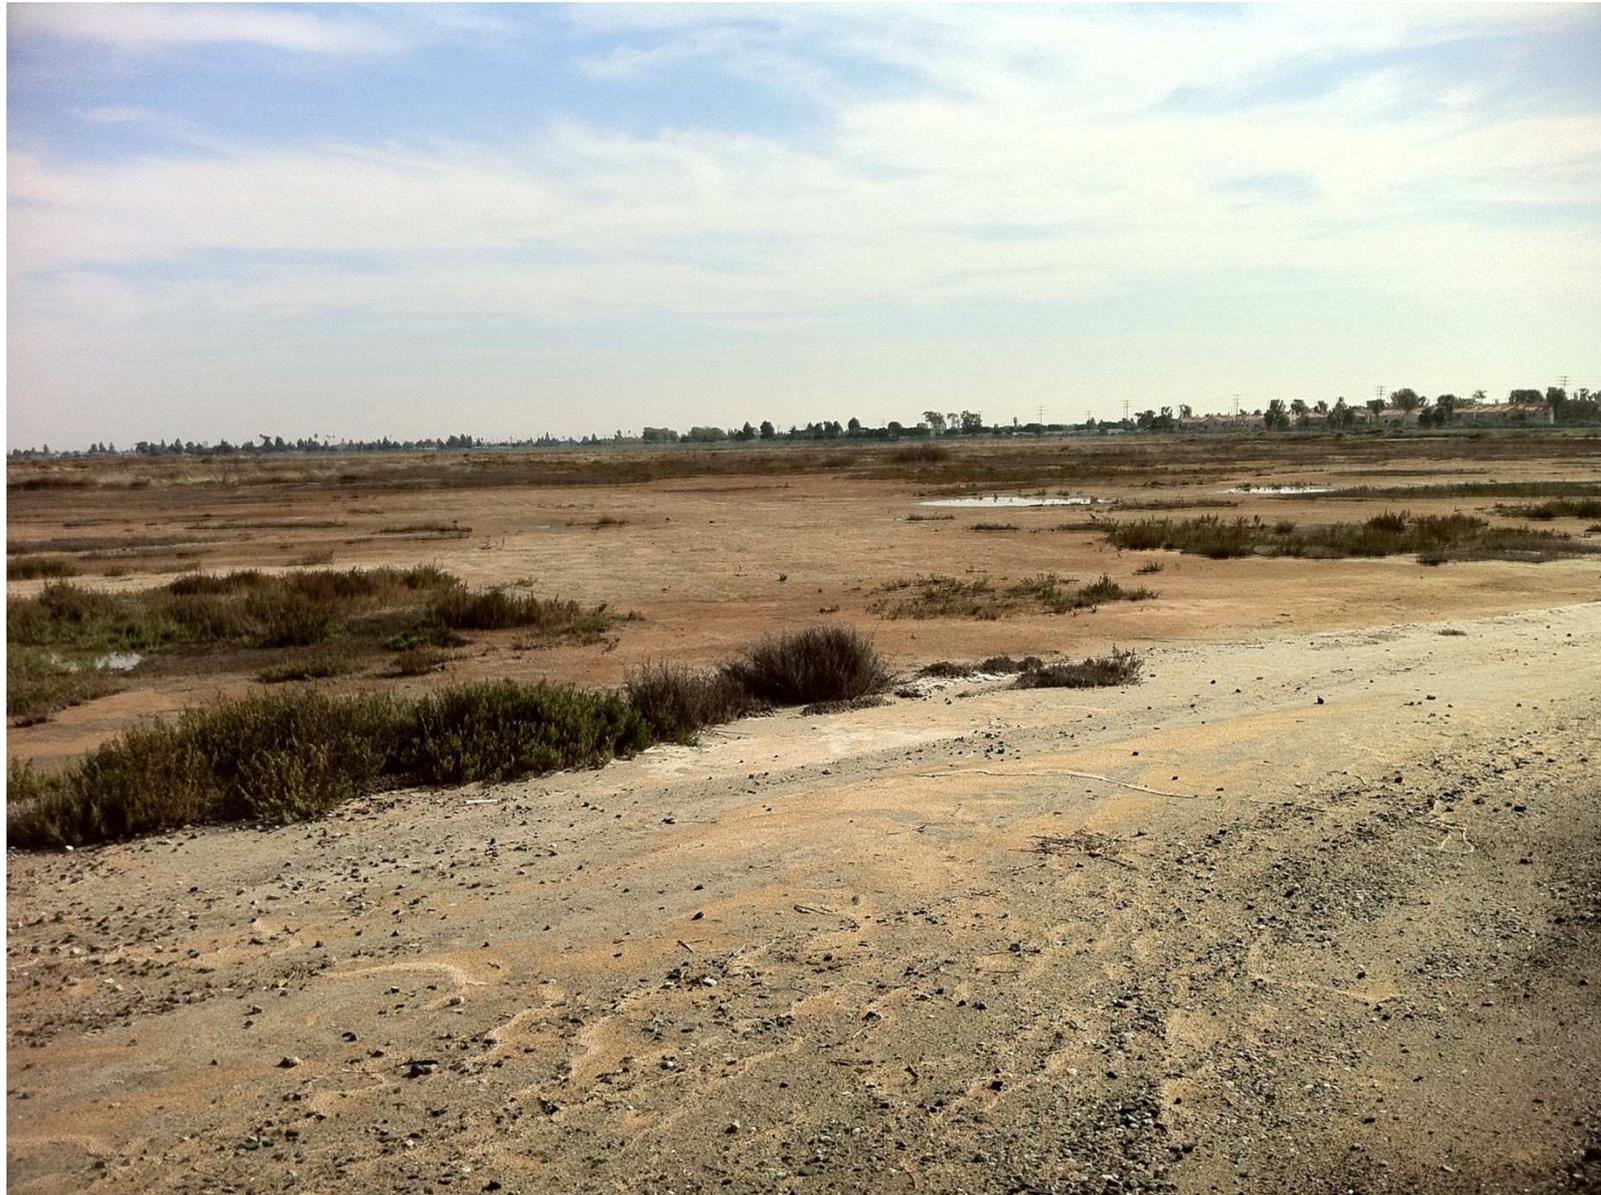
**November 23, 2011 - IRP Site 7 landfill cover.  
Looking southeast from west side of site. This photo shows small areas of ponding.**

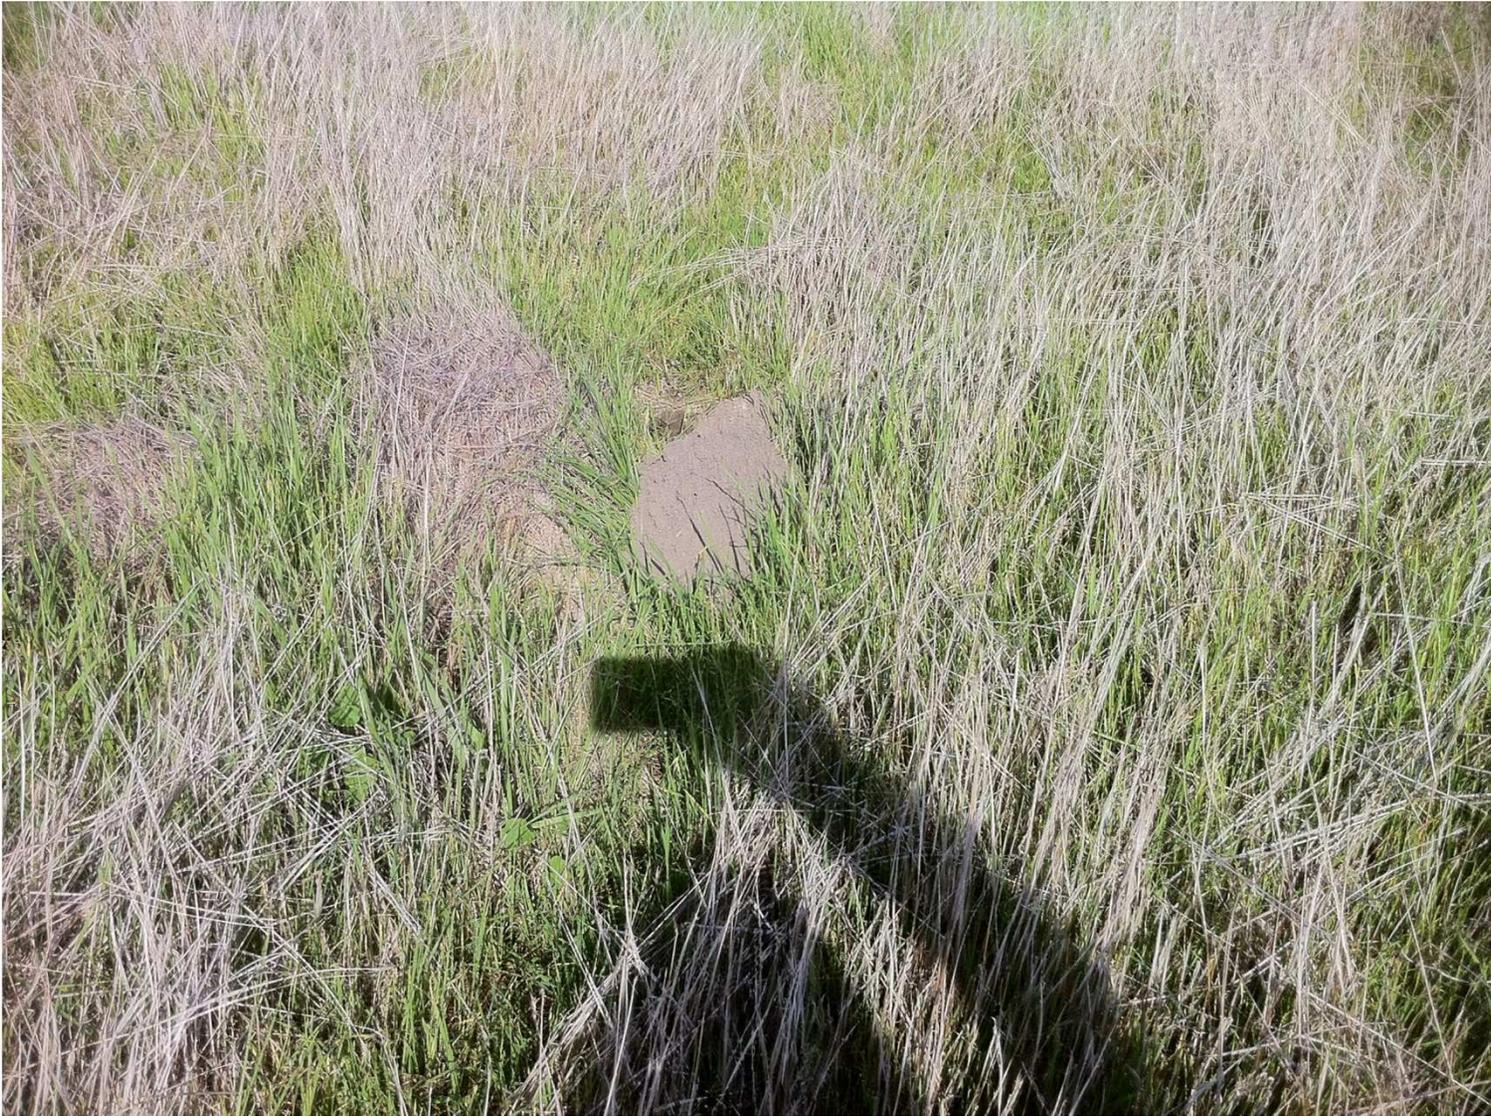
**November 23, 2011 - IRP Site 7 landfill cover.  
This photo shows evidence of burrowing rodents.**

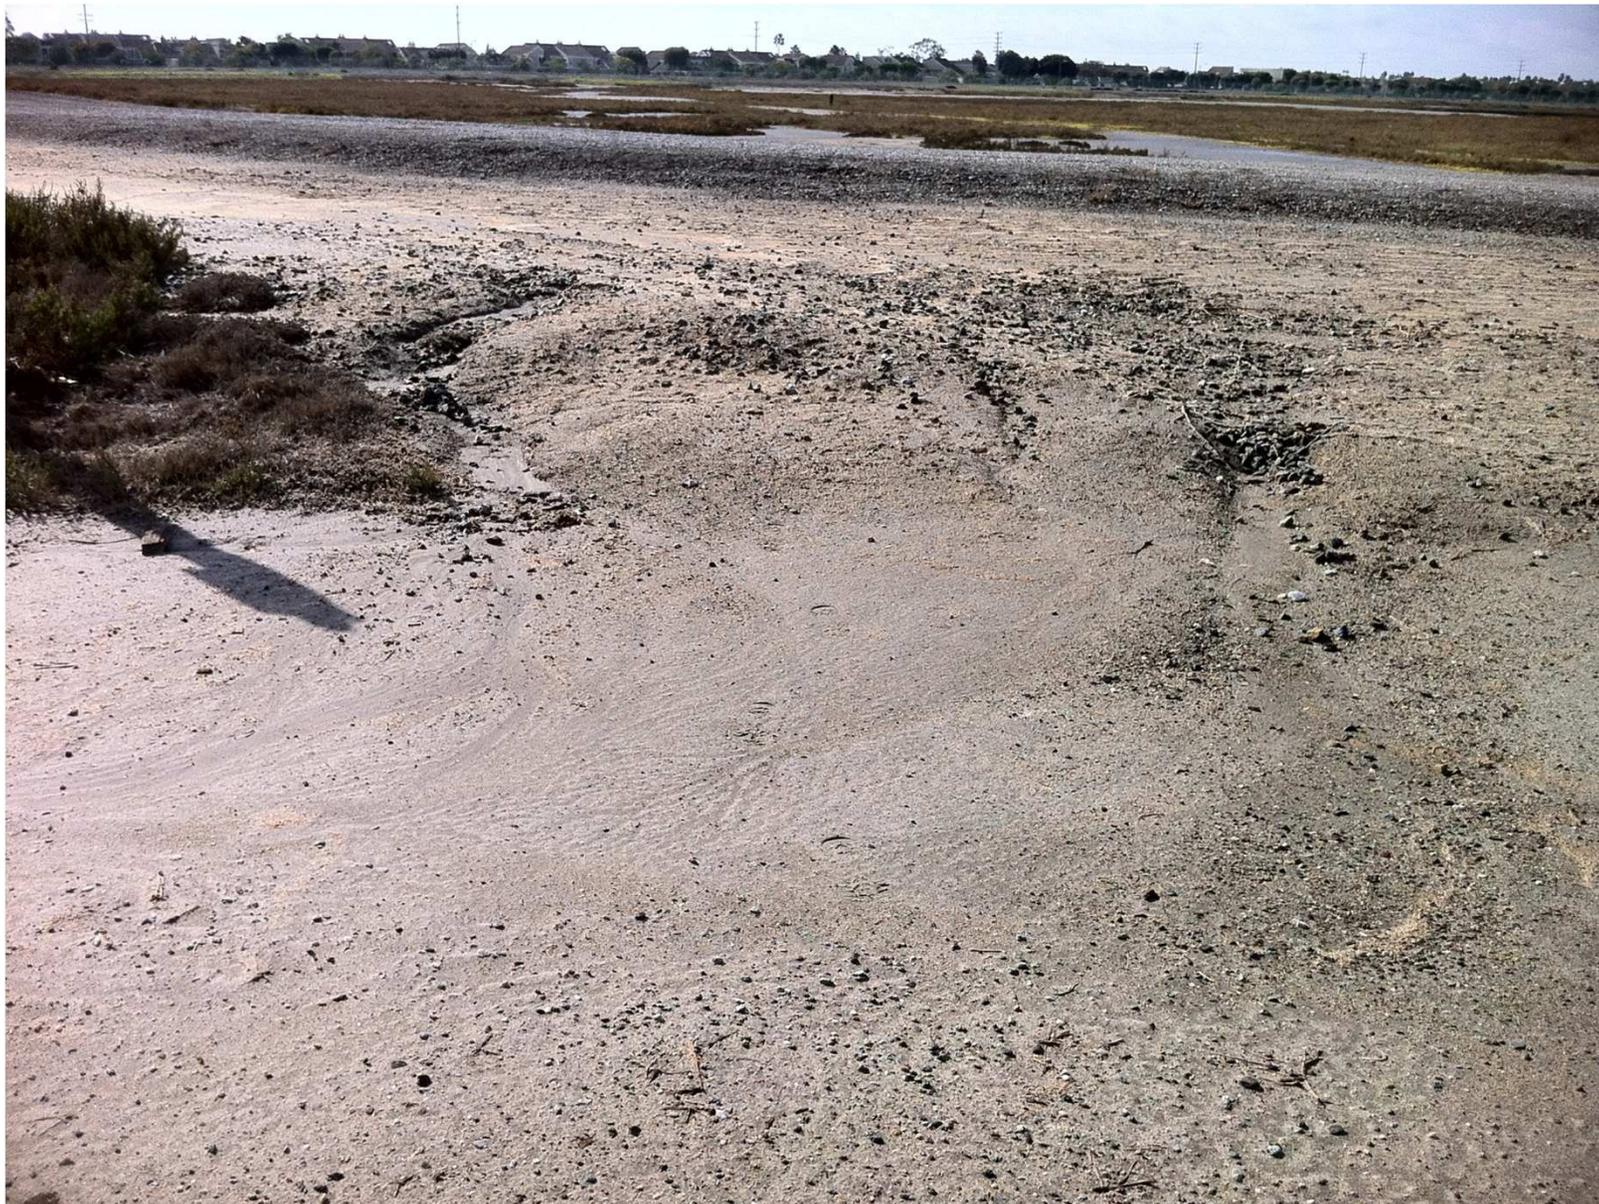
**November 23, 2011 - IRP Site 7 landfill cover.  
Looking Westerly at Northwest edge of site. This photo shows two short flow-lines  
along side of road.**

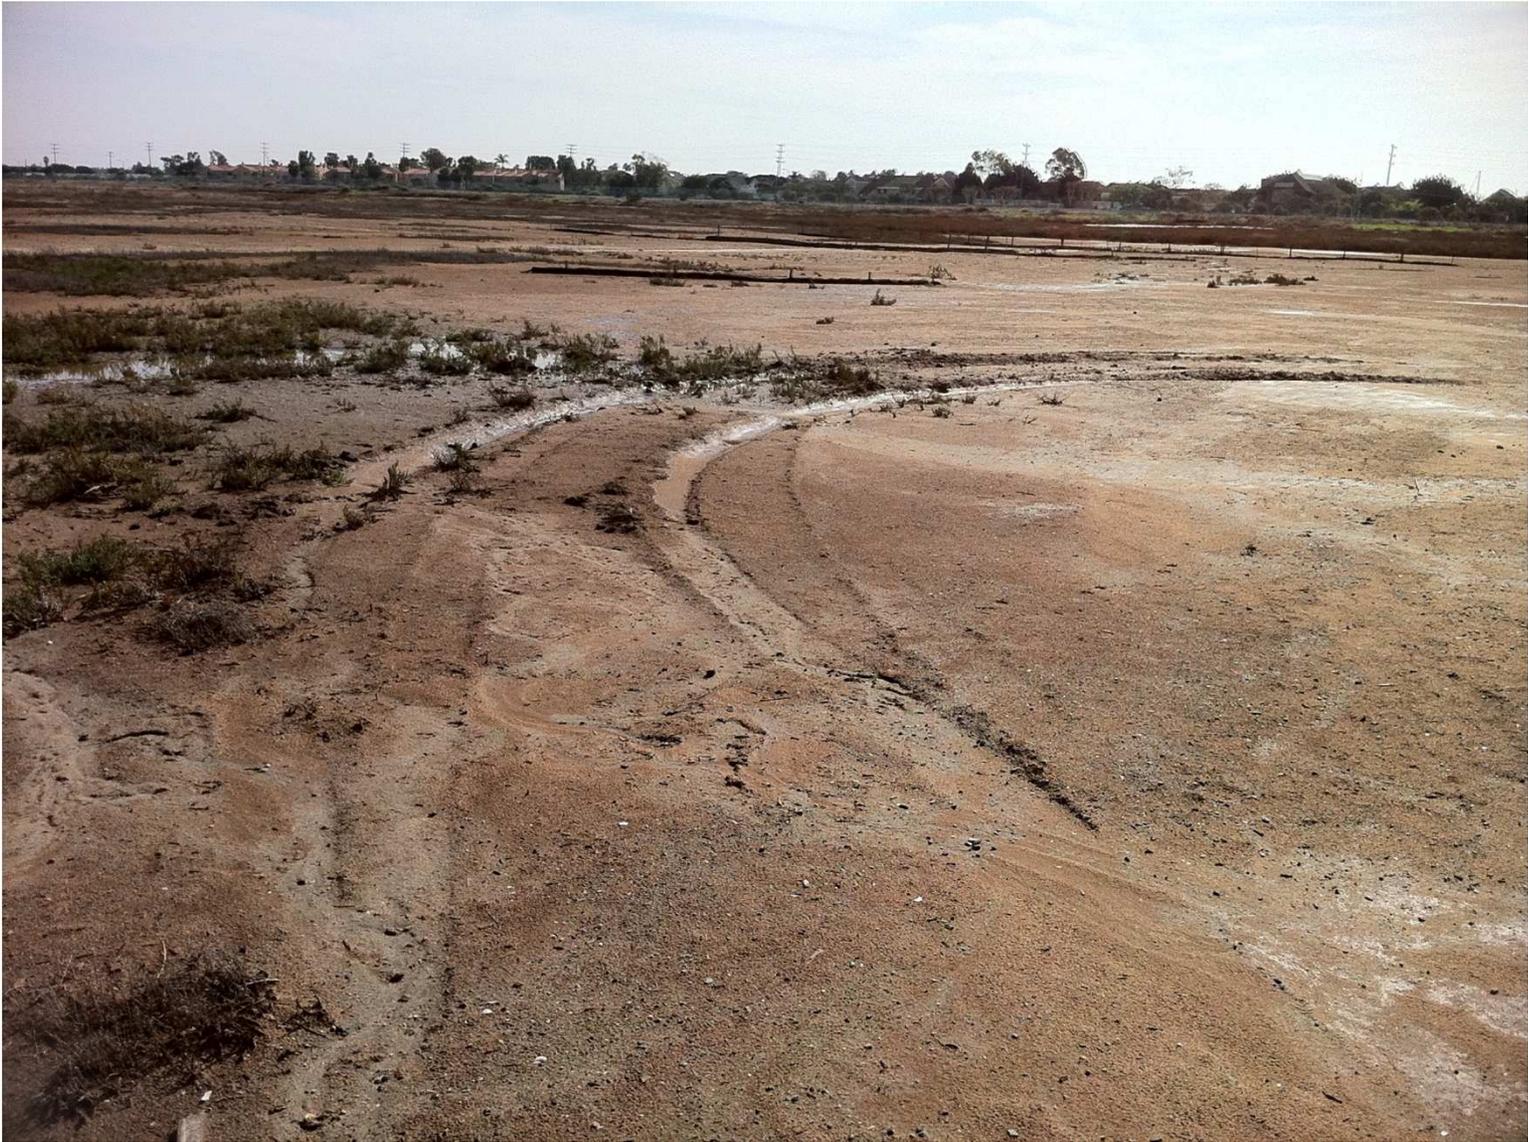
**November 23, 2011 - IRP Site 7 landfill cover.  
Looking southerly from west side of site.  
This photo shows tire tracks on western edge of landfill cover.**

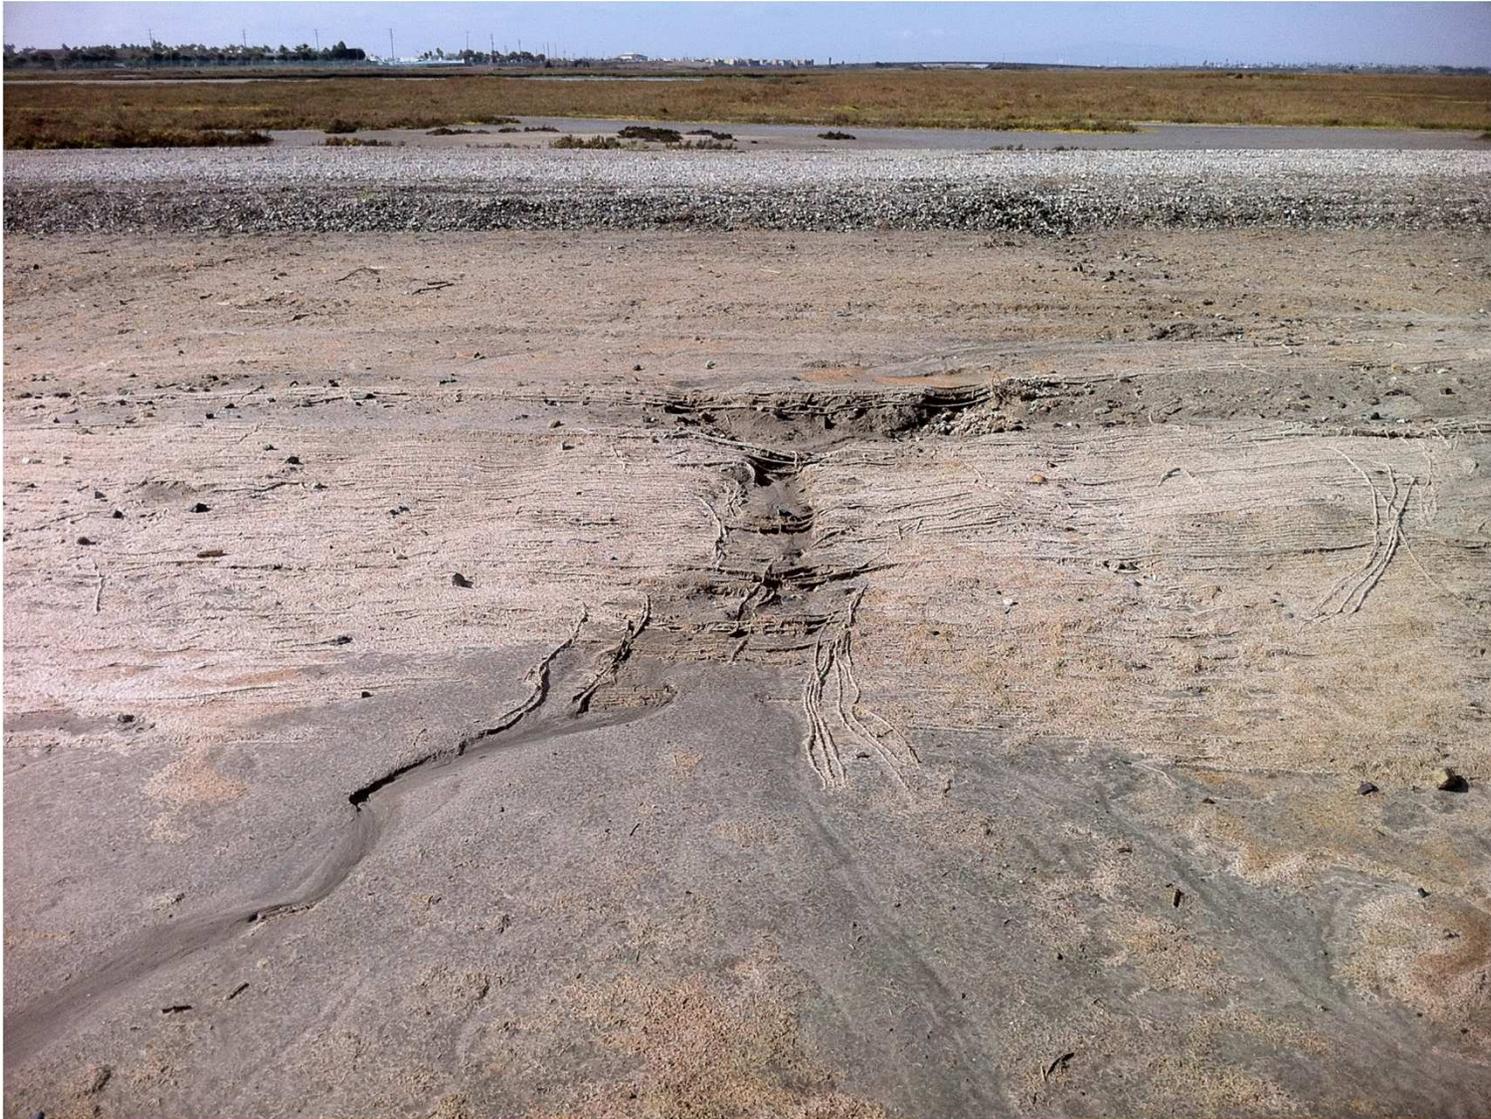
**November 23, 2011 - IRP Site 7 landfill cover.  
Looking west along western edge of site. This photo shows a short flow-line along side  
of road.**

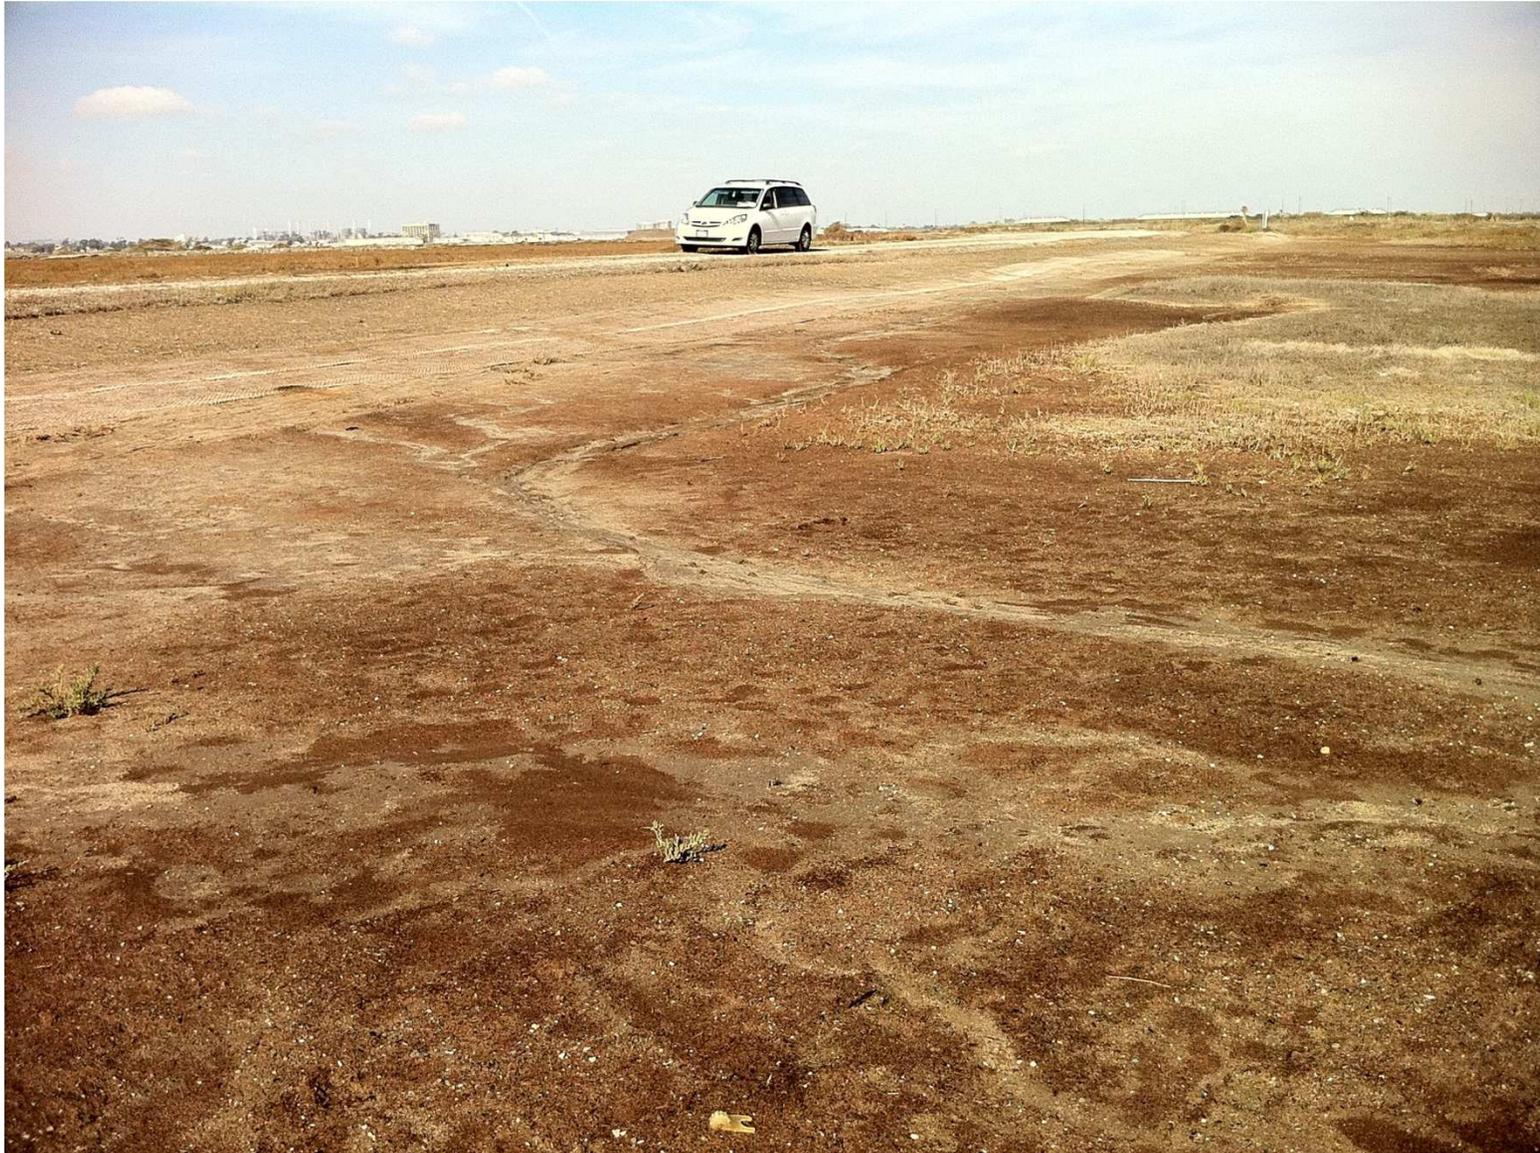
**November 23, 2011 - IRP Site 7 landfill cover.  
Looking northerly along western edge of site. This photo shows flow-line near road.**

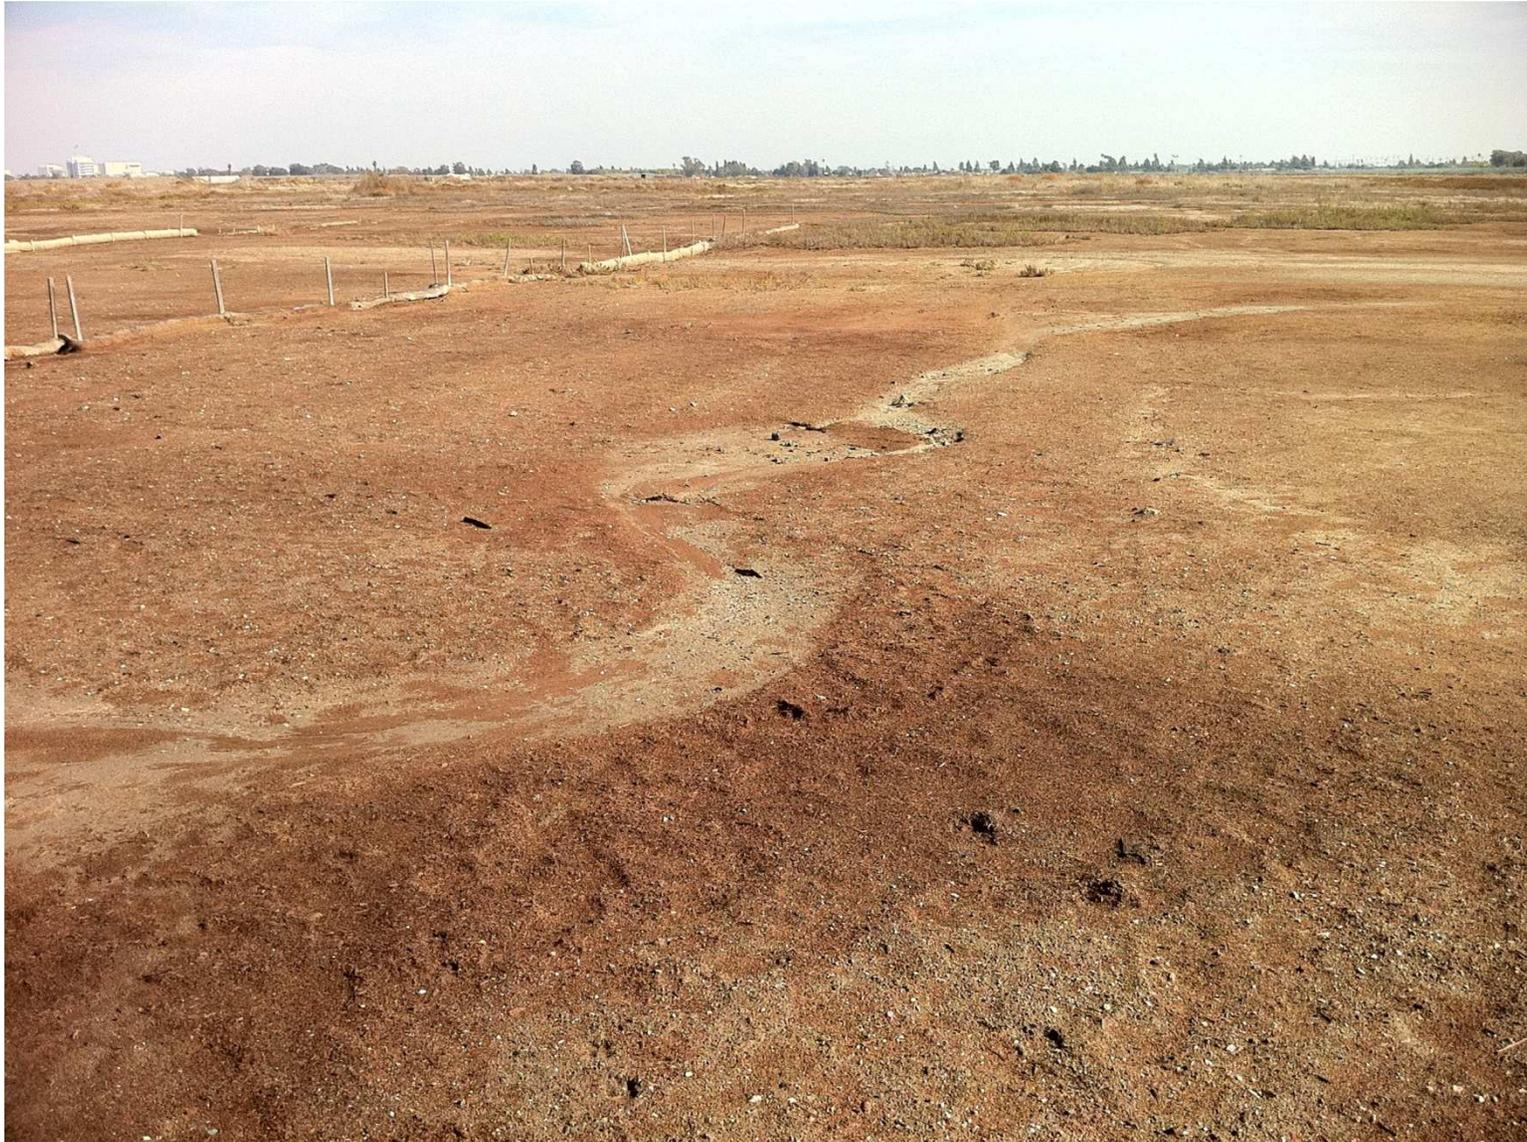
**November 23, 2011 - IRP Site 7 landfill cover.  
Looking easterly from southwestern edge of site. This photo shows flow-line near  
southwest edge of site.**

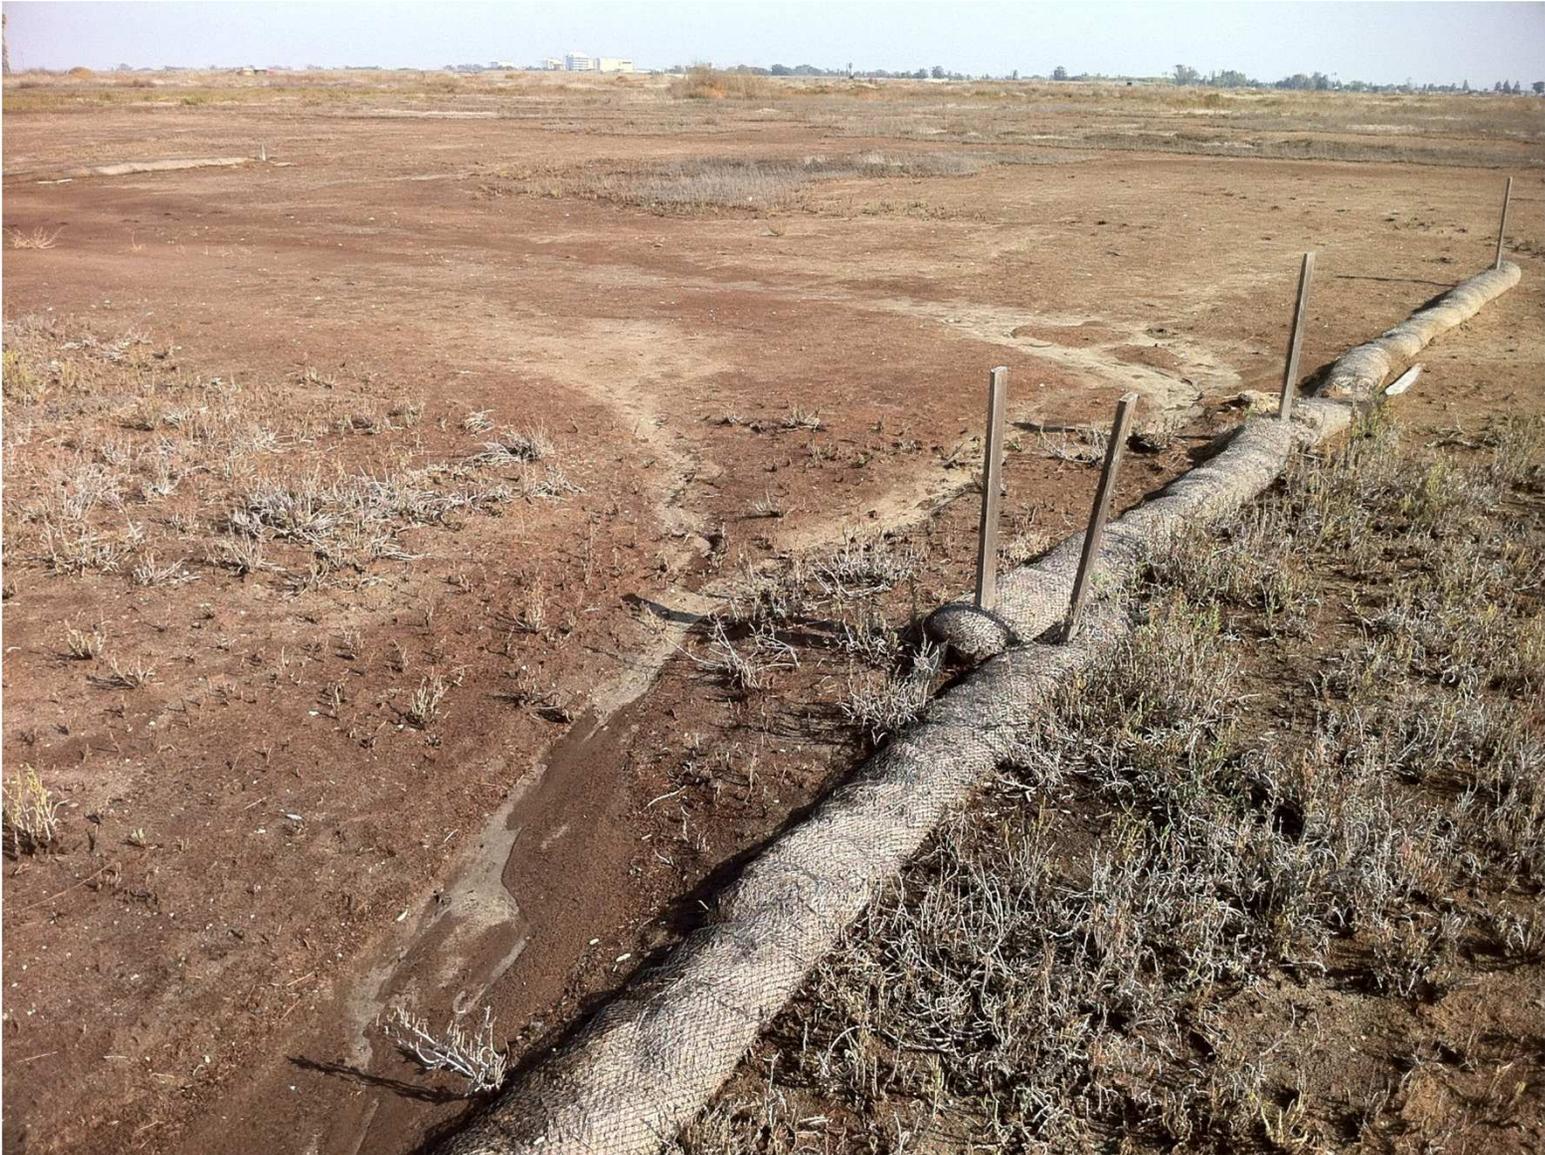
**November 23, 2011 - IRP Site 7 landfill cover.  
Looking easterly along southern wattle showing shallow flow-lines.**

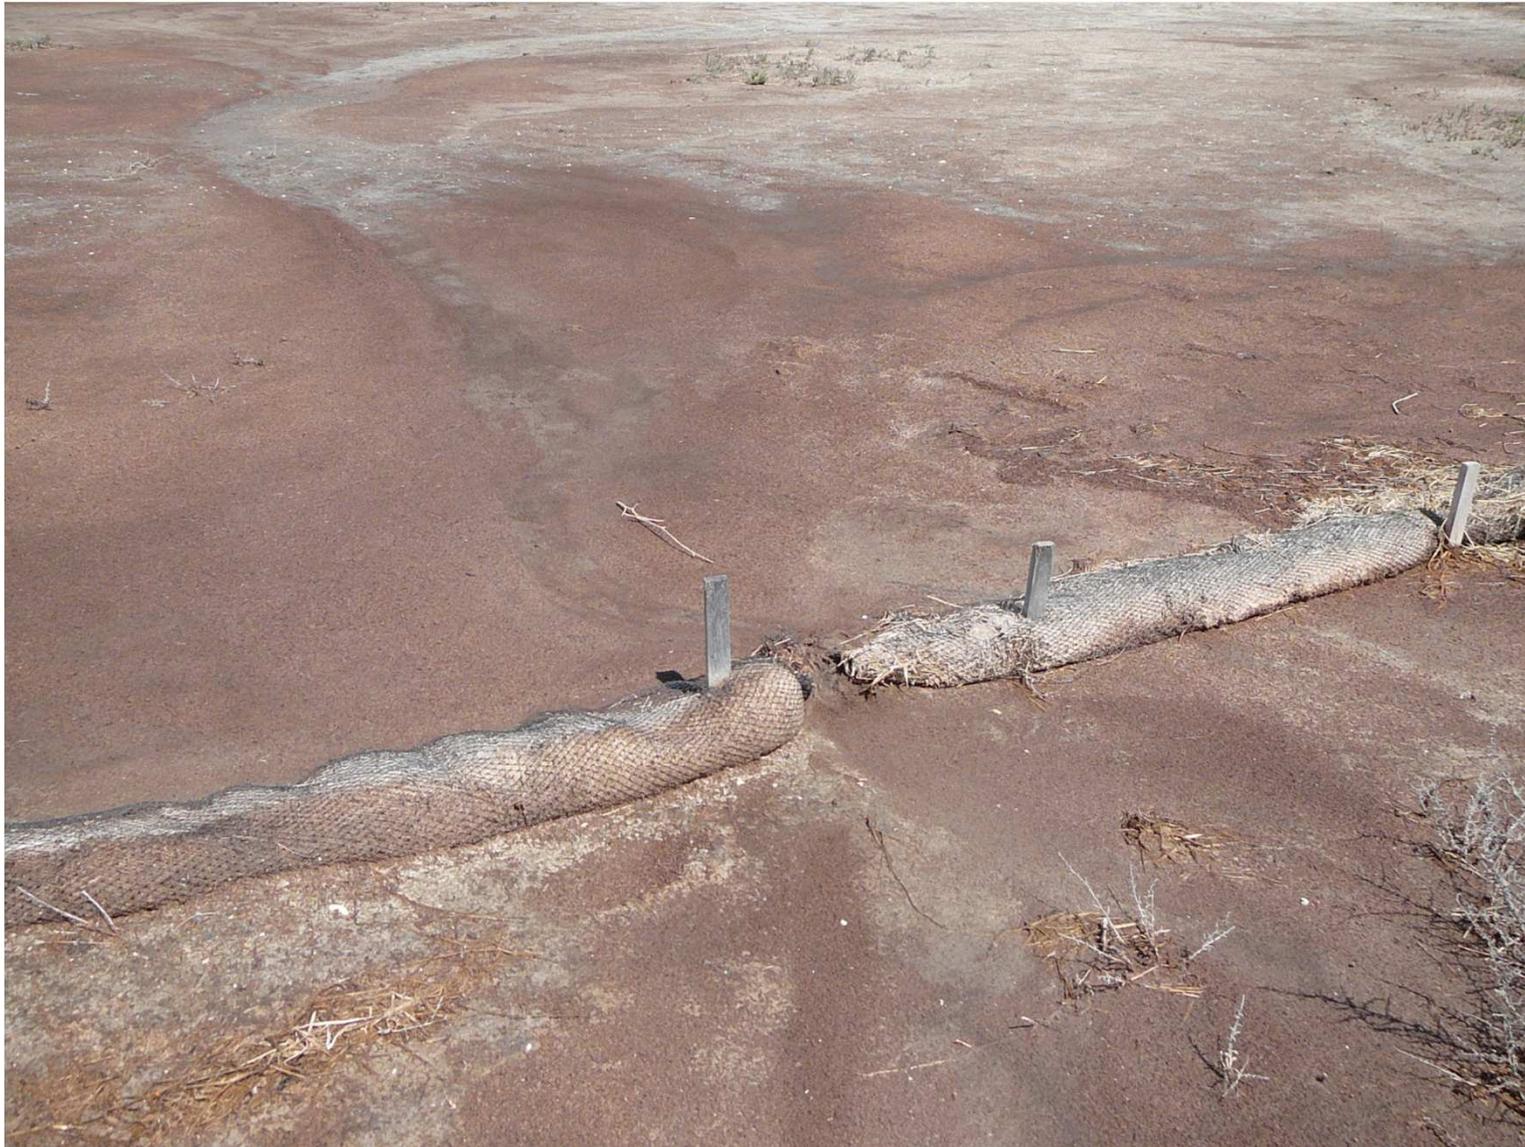
**March 19, 2012 - IRP Site 7 landfill cover.  
Looking north at 8" gap in northernmost straw wattle (repaired 3-28-2012).  
(See Figure A-1C for location).**

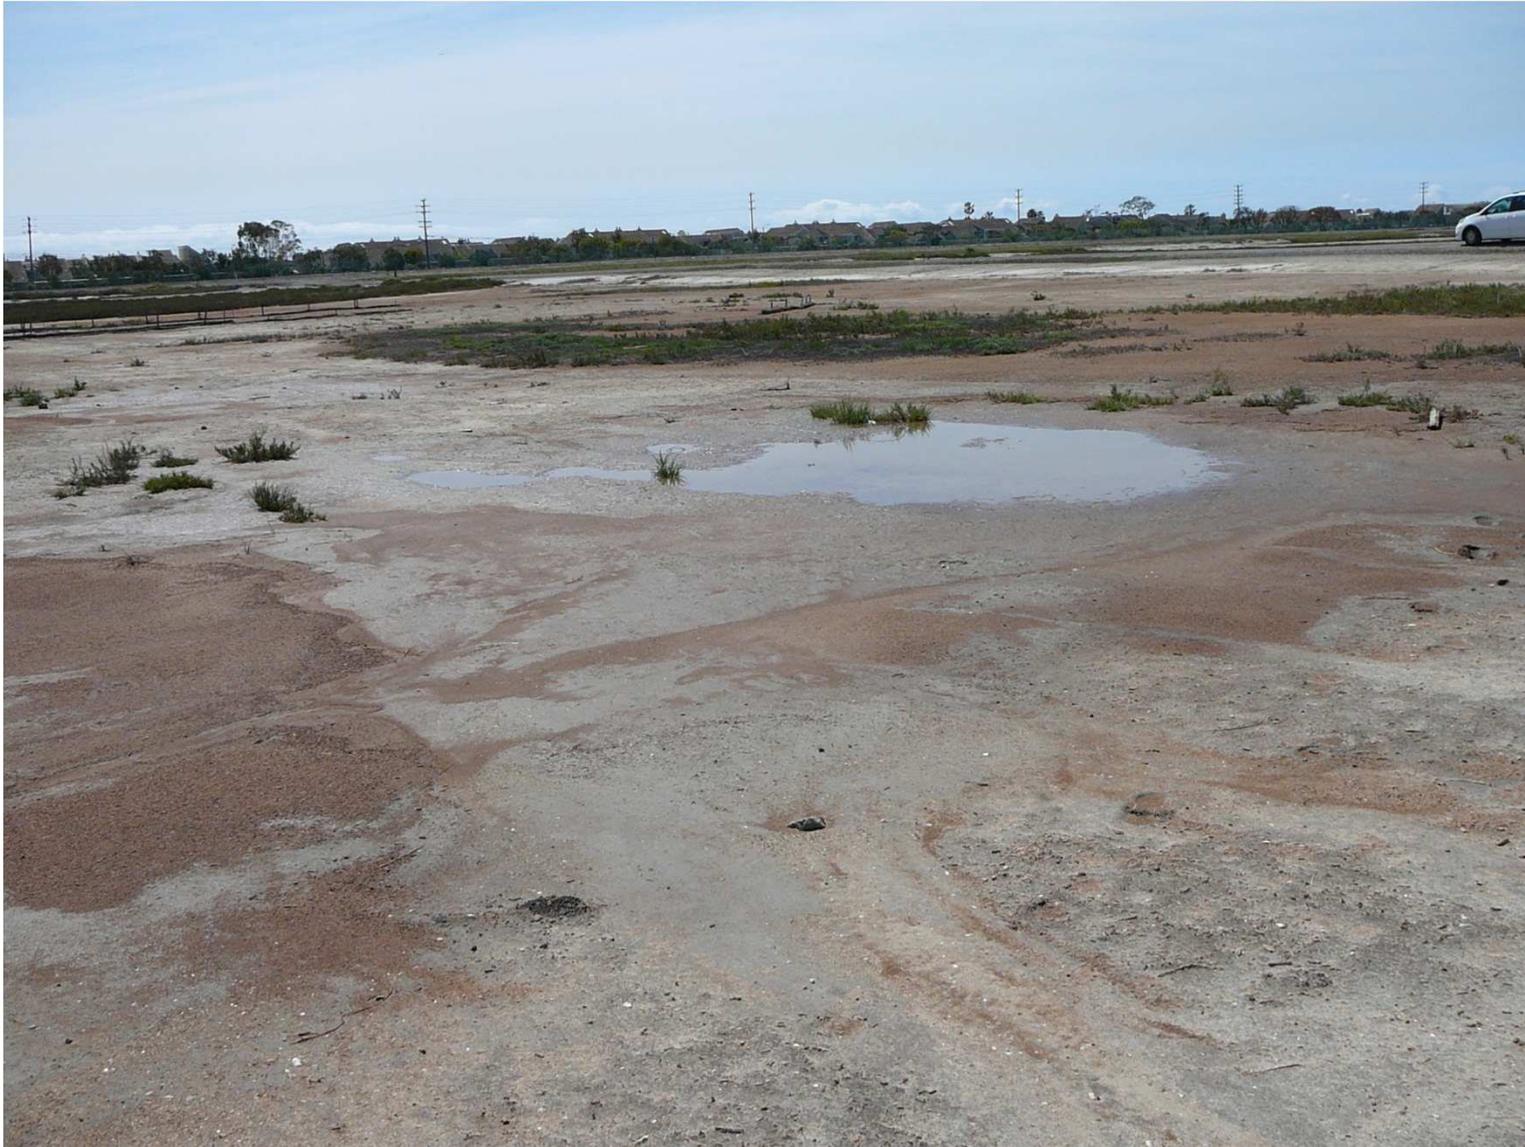
**March 19, 2012 - IRP Site 7 landfill cover.  
Looking southwest at small area of ponding (See Figure A-1C for location).**

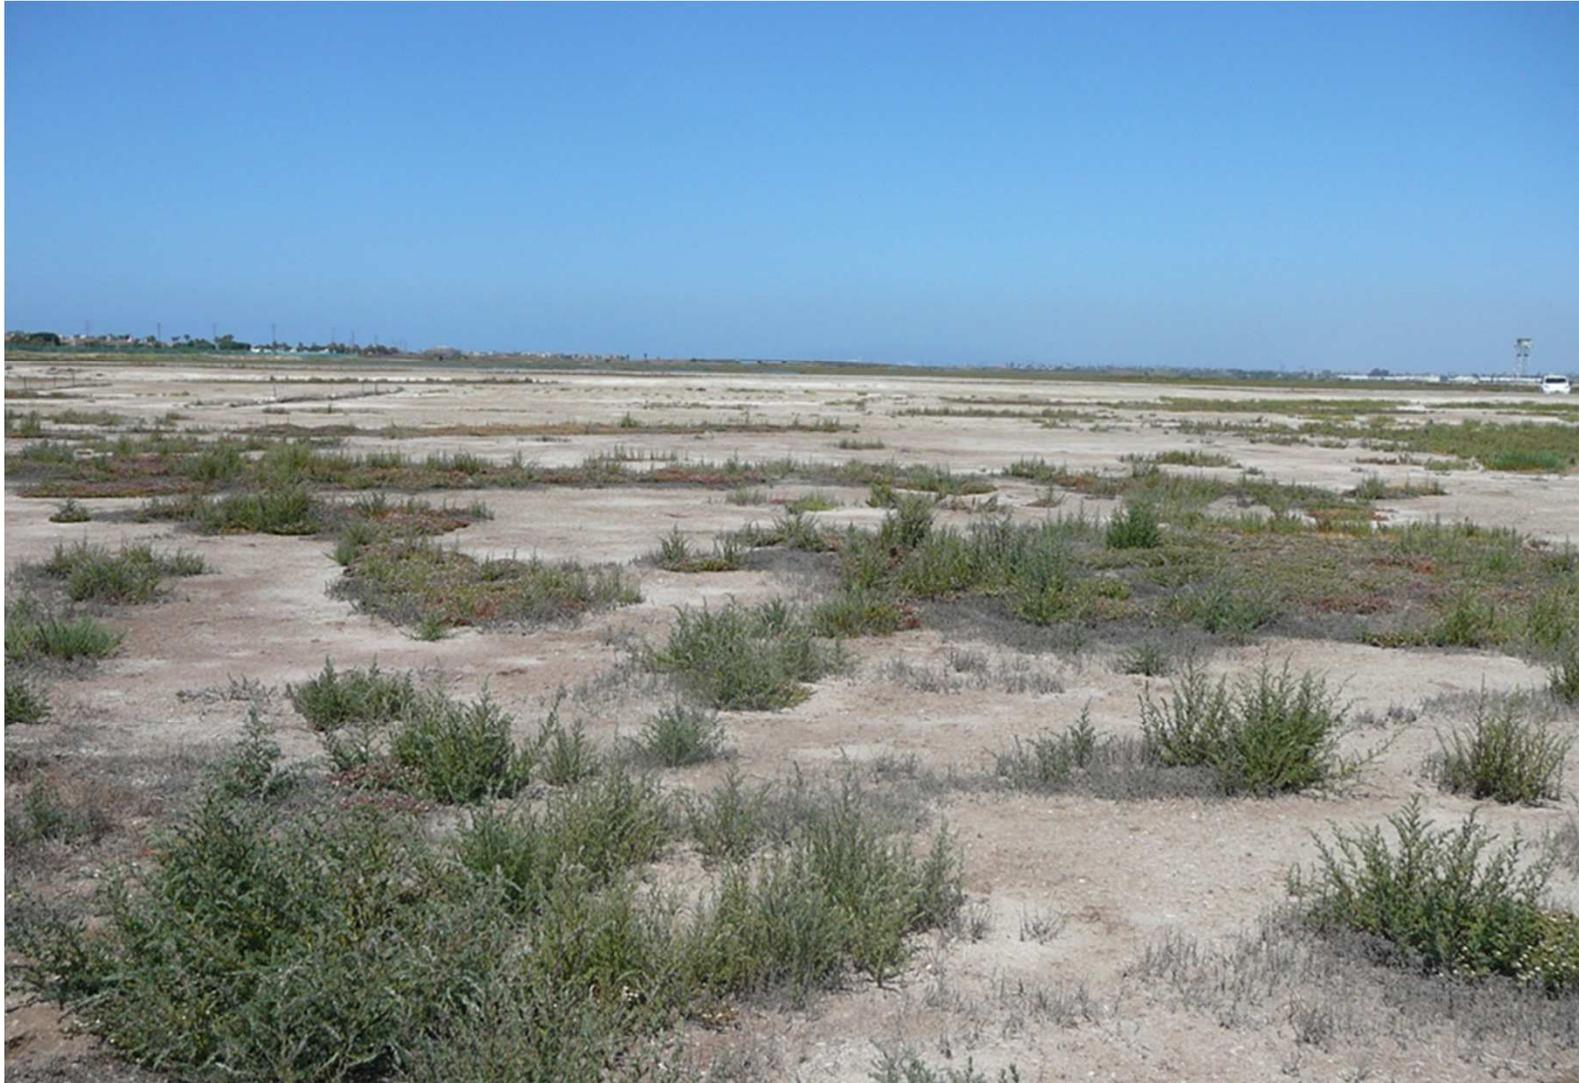
**June 6, 2012 - IRP Site 7 landfill cover.  
Looking west across the poorly vegetated area along the northwestern edge of the site.**

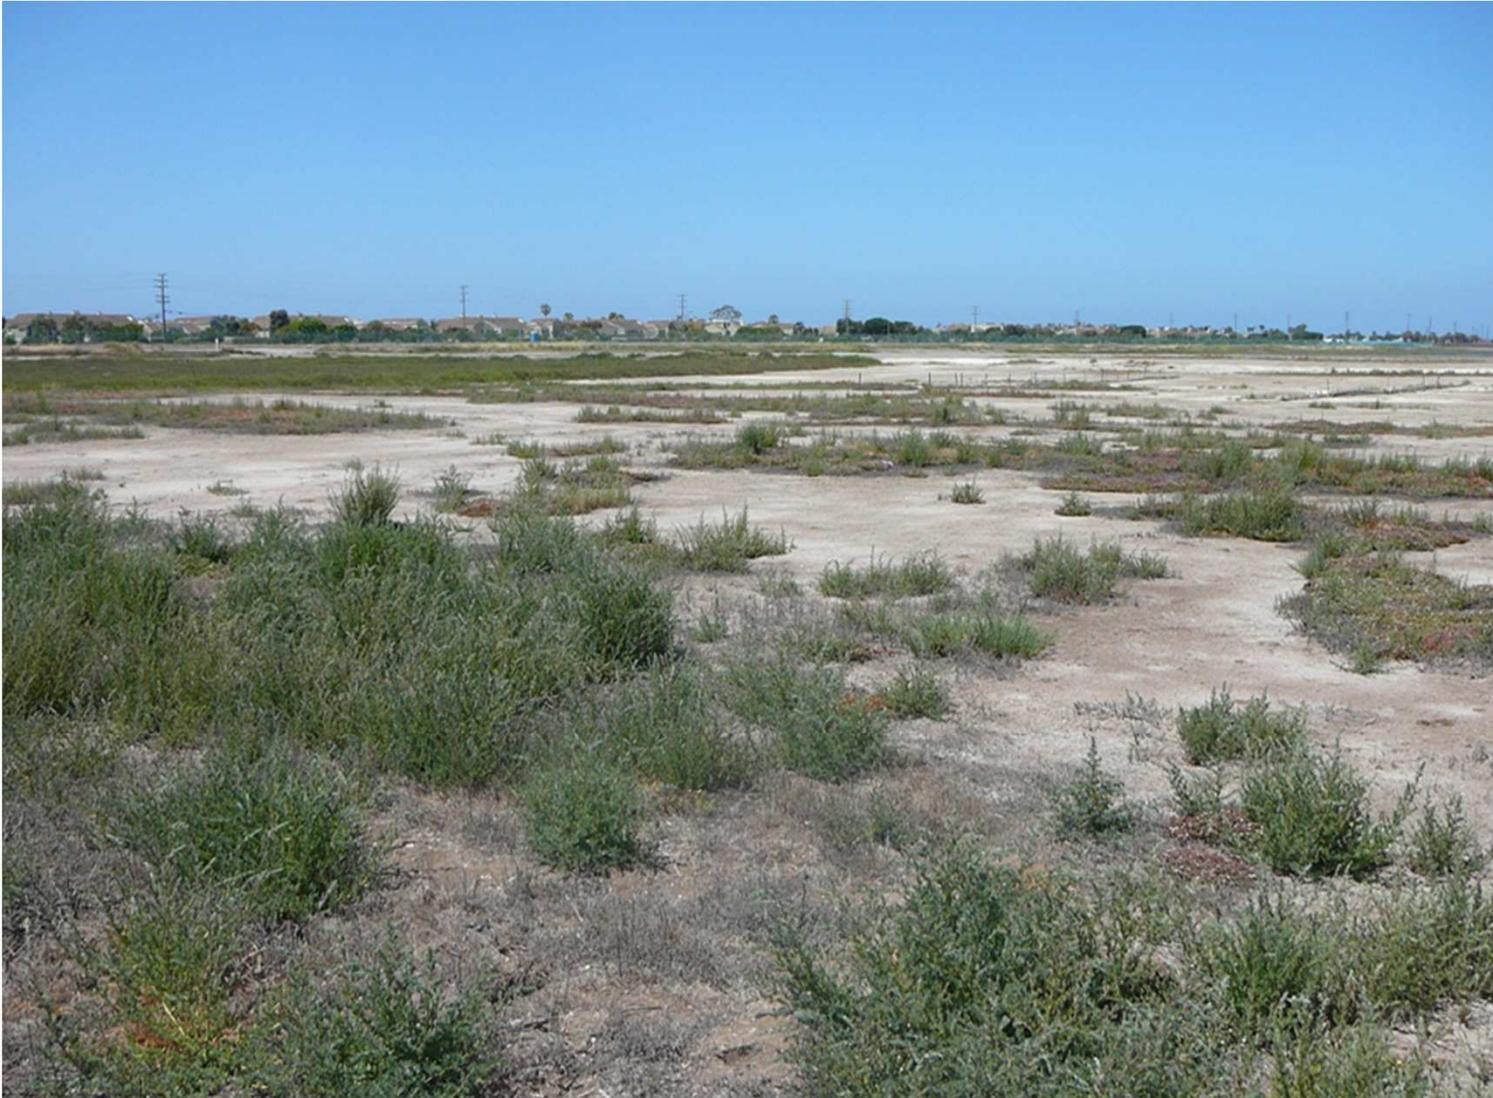
**June 6, 2012 - IRP Site 7 landfill cover.  
Looking southwest across the poorly vegetated area along the southwestern edge of the site.**

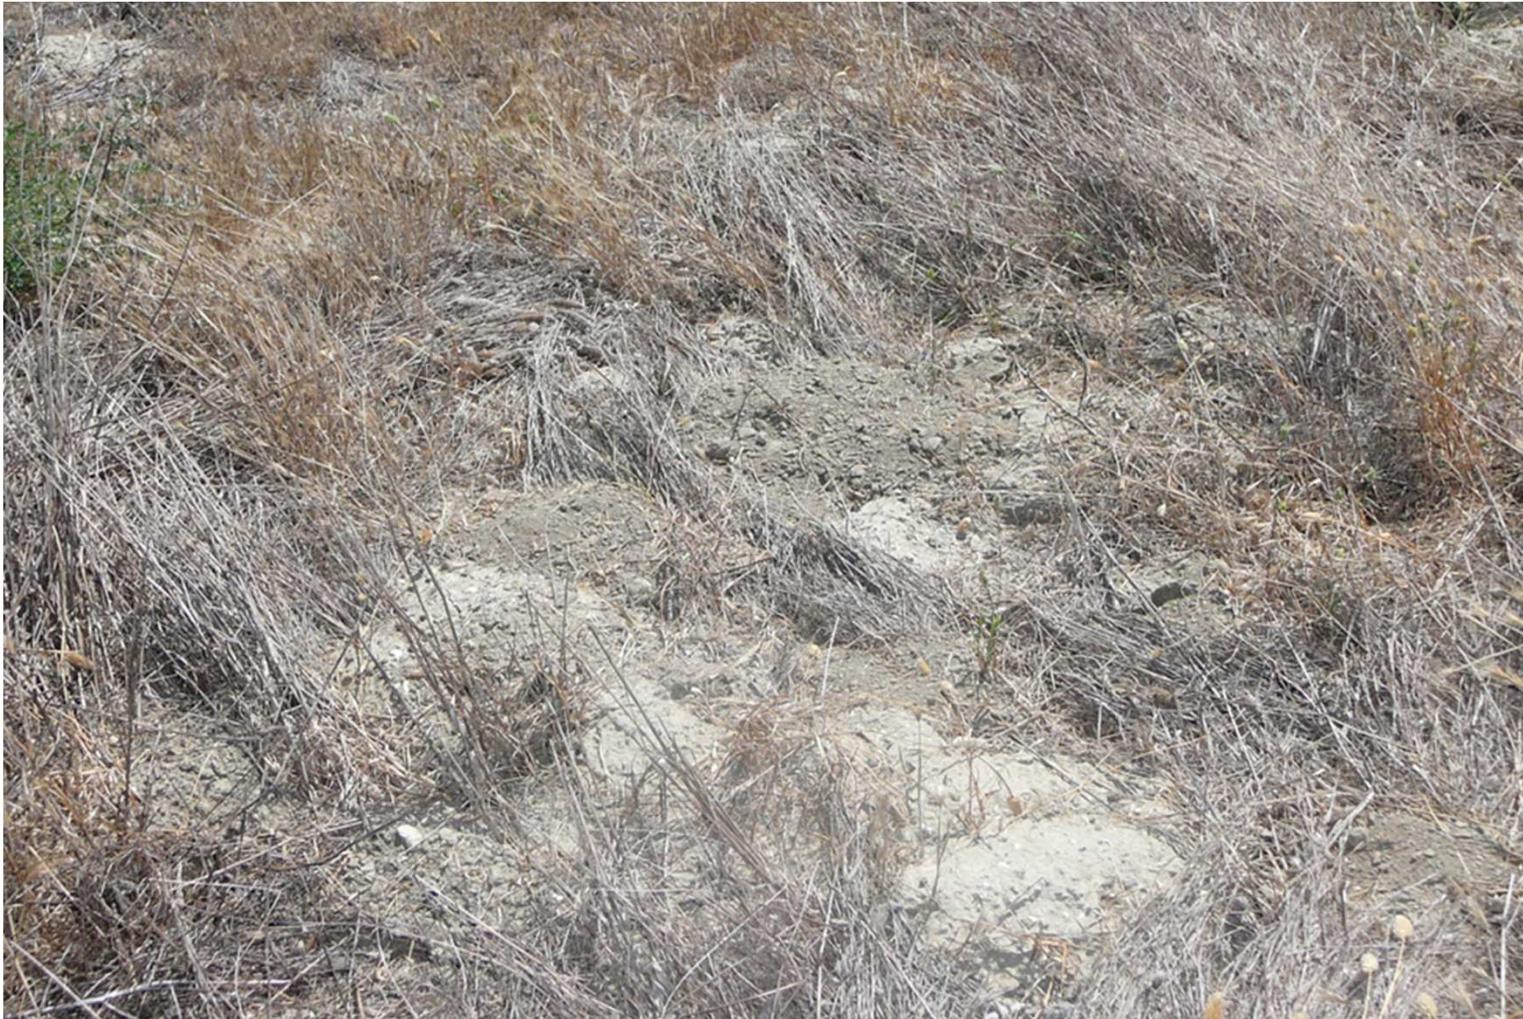
**June 6, 2012 - IRP Site 7 landfill cover.  
This photo shows typical evidence of burrowing rodents.**
