**FALL 2011 & WINTER 2012 ANNUAL POST-CLOSURE  
INSPECTION AND MAINTENANCE REPORT**

**August 8, 2012**

**INSTALLATION RESTORATION PROGRAM SITE 7 AREA 1  
(FORMER STATION LANDFILL)**

**NAVAL WEAPONS STATION SEAL BEACH  
SEAL BEACH, CALIFORNIA**

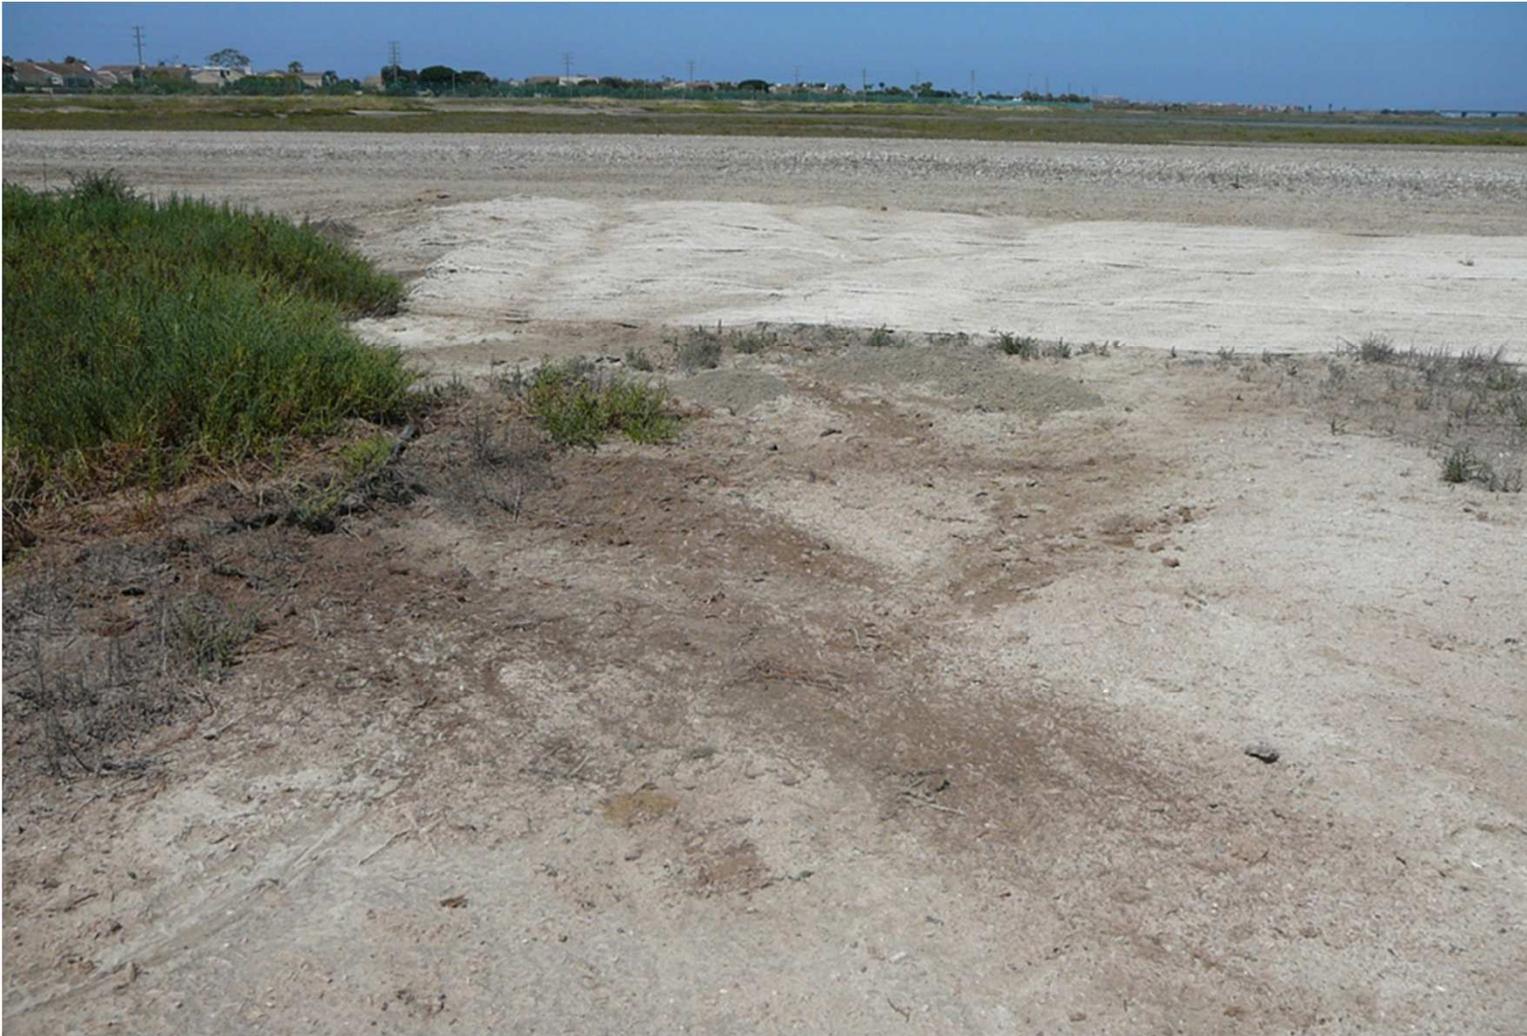
**June 6, 2012 - IRP Site 7 landfill cover.  
Evidence of burrowing rodents along the access road at the southwest corner of the site.**
