**FALL 2014 AND WINTER 2015
ANNUAL POST-CLOSURE INSPECTION AND MAINTENANCE REPORT**

**INSTALLATION RESTORATION PROGRAM SITE 7 AREA 1
(FORMER STATION LANDFILL)
NAVAL WEAPONS STATION SEAL BEACH, SEAL BEACH, CALIFORNIA**

November 2015

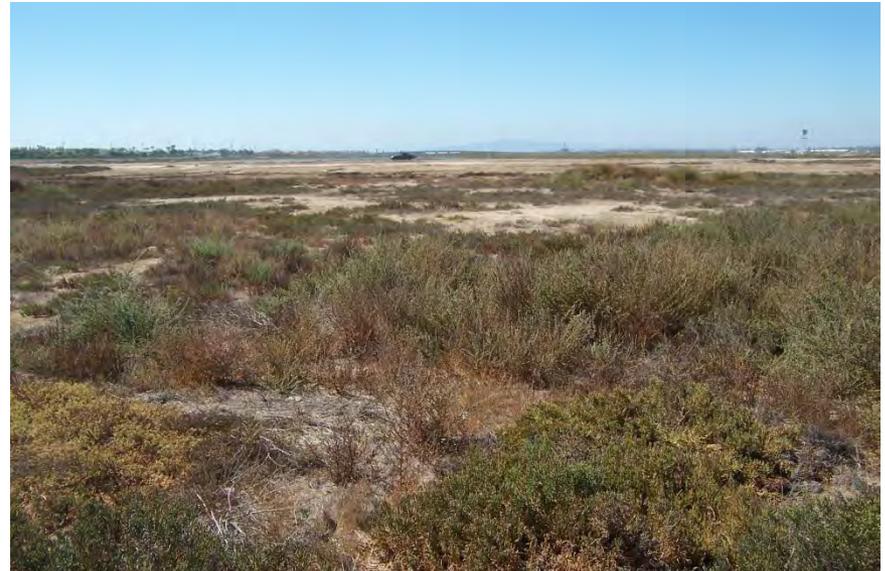
Photo 4: September 30, 2014 Pre-Rain Season Inspection

Compared with Post-Rain Season Inspection. Looking east, from the northern portion of the west edge of the landfill. Jute mesh in the northern portion of the western 1/3rd of the landfill is visible on the right side of the photo beyond the vegetated patch. Photo shows vegetation conditions in the western portion of the landfill after a dry year.

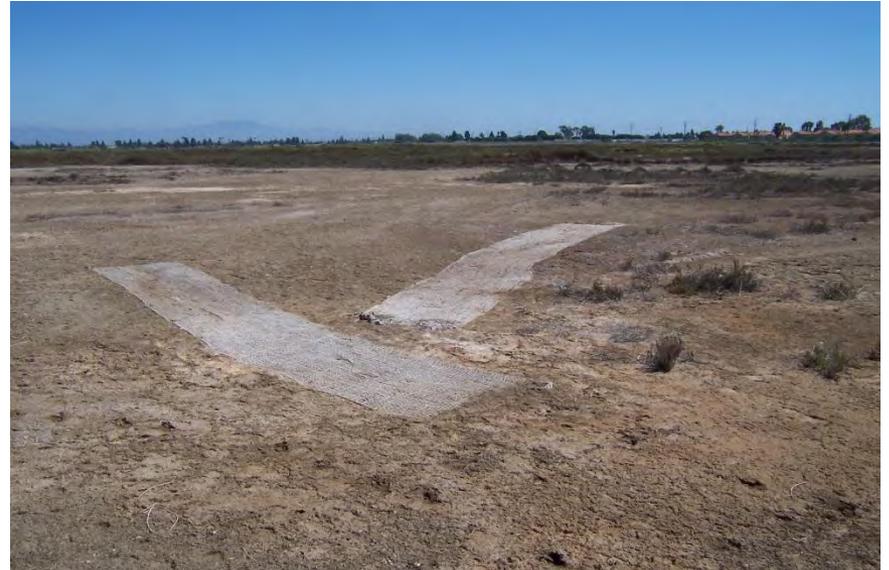
Photo 6: September 30, 2014 Pre-Rain Season Inspection

Compared with Post-Rain Season Inspection. Looking south from northwestern corner of landfill cover, adjacent to access road. Photo shows areas of vegetation cover and condition of access road.

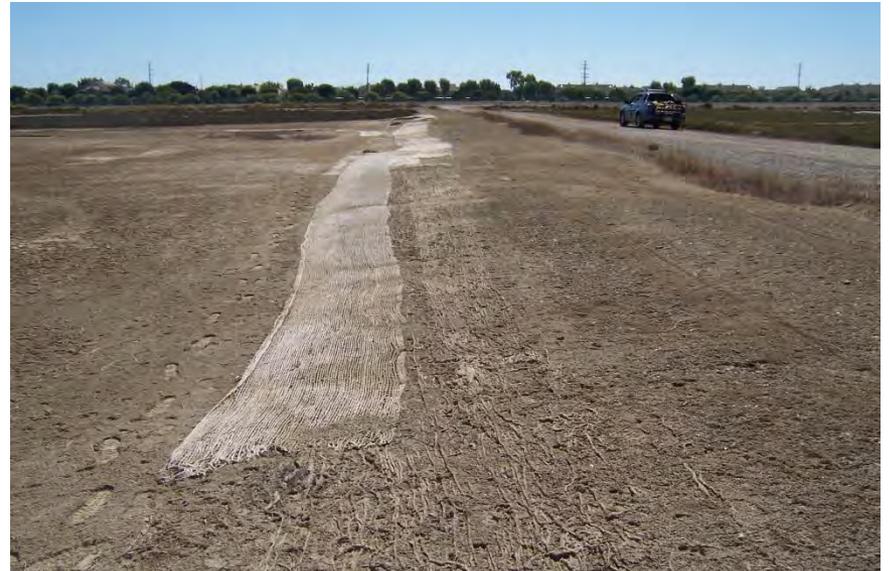
Photo 8: September 30, 2014 Pre-Rain Season Inspection

Compared with Post-Rain Season Inspection. Looking south along southern portion of west edge of landfill cover. Photo shows condition of jute mesh and access road.

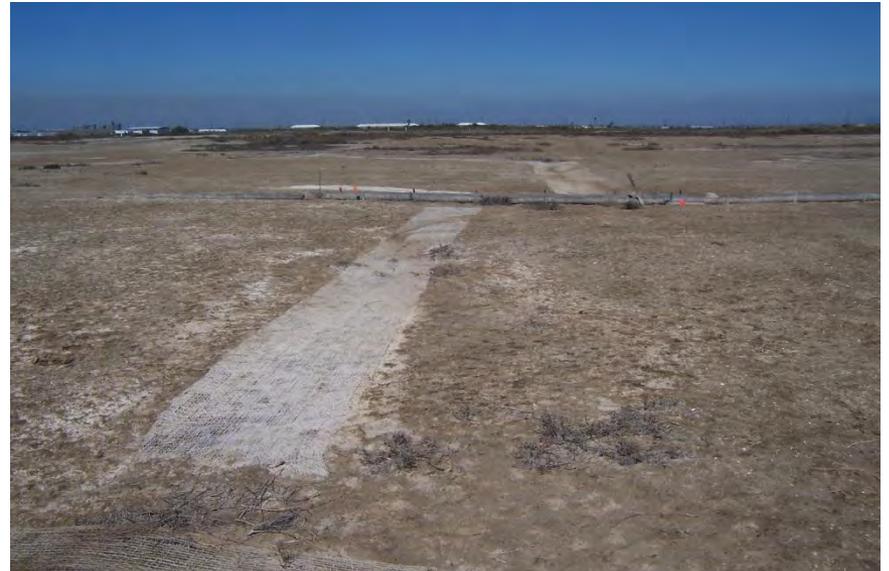
Photo 11: September 30, 2014 Pre-Rain Season Inspection

Compared with Post-Rain Season Inspection. Looking north, past the central straw wattle, in the direction of the west section of jute mesh. Photo shows the condition of the wattle, jute mesh, and the sheet flow drainage patterns.

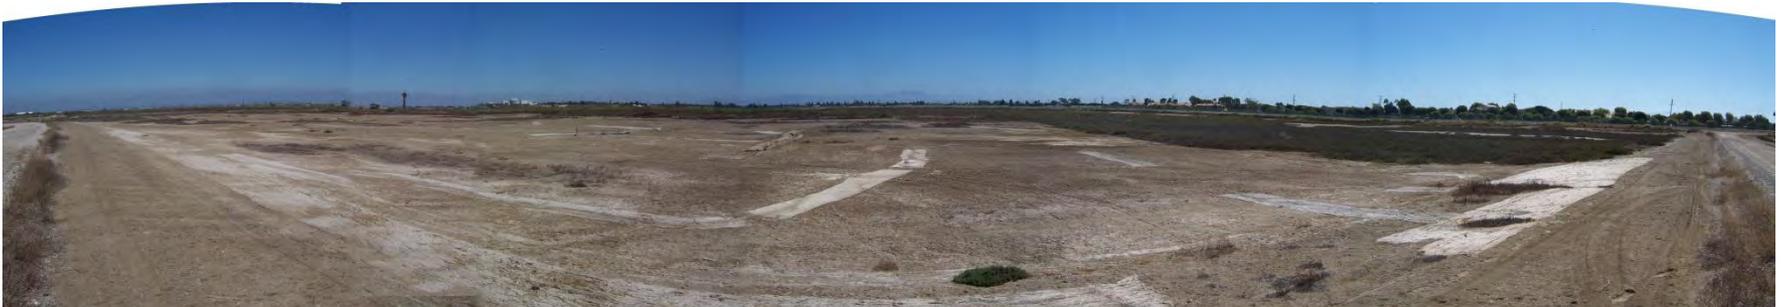
Photo 14: September 30, 2014 Pre-Rain Season Inspection

Compared with Post-Rain Season Inspection. Looking northeast from south portion of west edge of landfill cover. Photo shows condition of jute mesh.

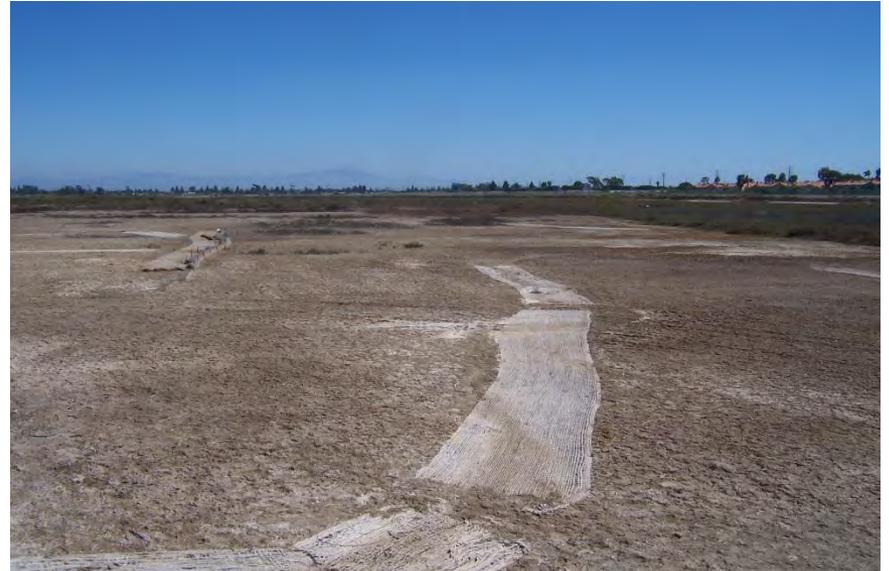
Photo 16: September 30, 2014 Pre-Rain Season Inspection

Compared with Post-Rain Season Inspection. Looking southeast, along the southern edge of the landfill cover.
July 2014 photo shows damp soils in the distance in the area adjacent to the tidal pond.
No damp soils were observed in this area during the September 2014 Inspection.

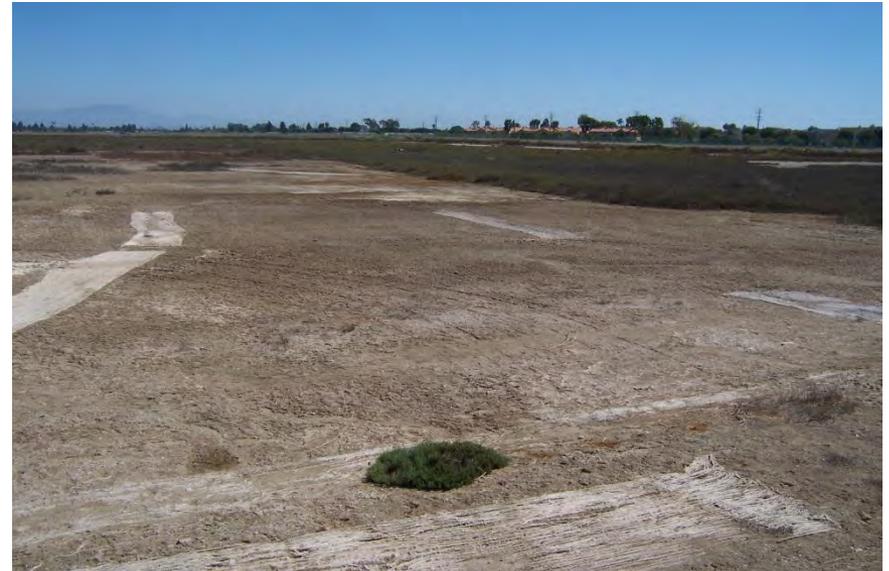
Photo 17: September 30, 2014 Pre-Rain Season Inspection

Compared with Post-Rain Season Inspection. Looking northeast, from the southwest corner of the landfill. Photo shows jute mesh, wattles, and vegetation conditions in the western portion of the landfill after a dry winter.

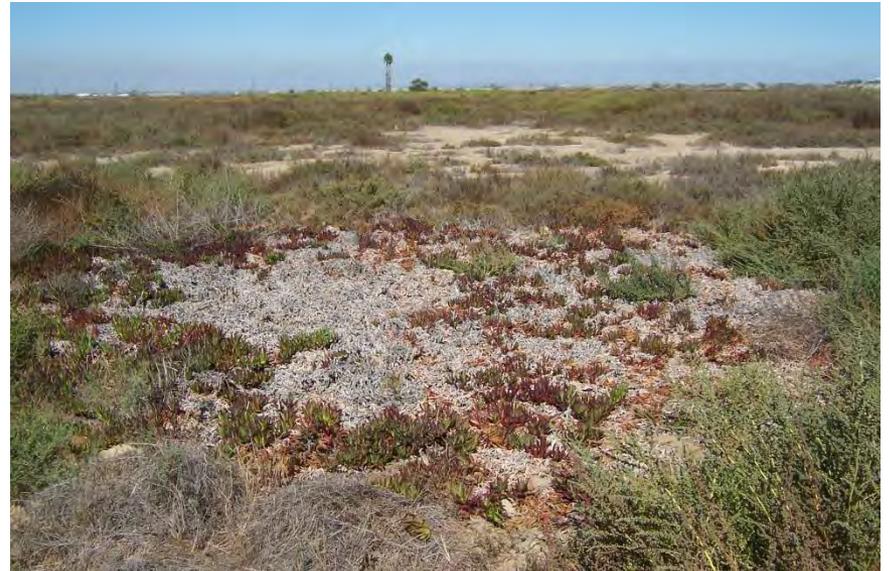
Photo 19: September 30, 2014 Pre-Rain Season Inspection
Fresh burrows observed in central portion of western 1/3rd of landfill.

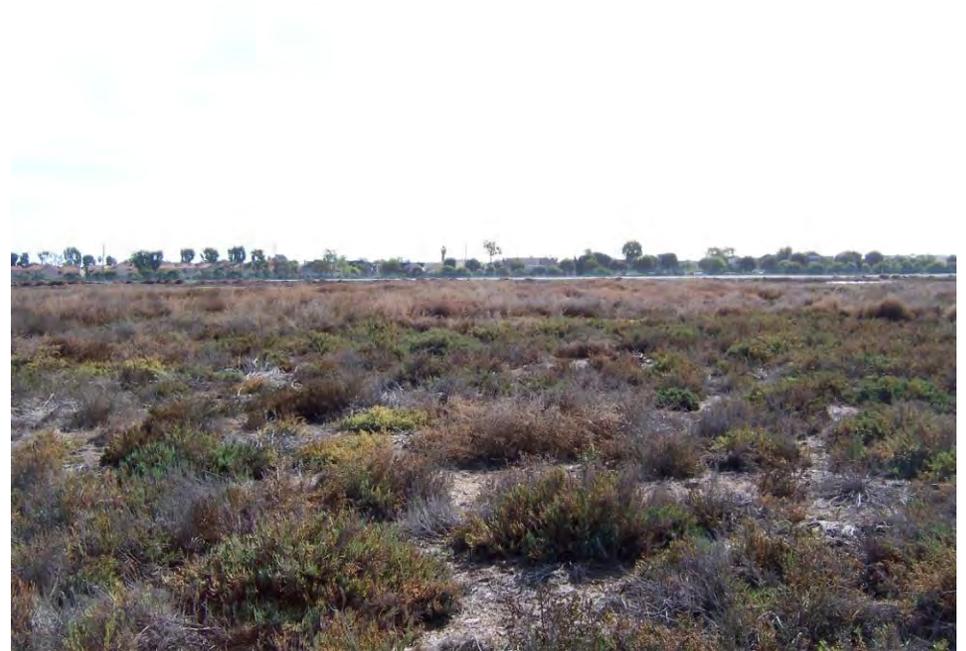
Photo 2: December 4, 2014 Post-Rain Inspection

Compared with Pre-Rain Season Inspection. Looking south from central portion of the landfill cover.
Small bare patch near middle of site. No ponding.

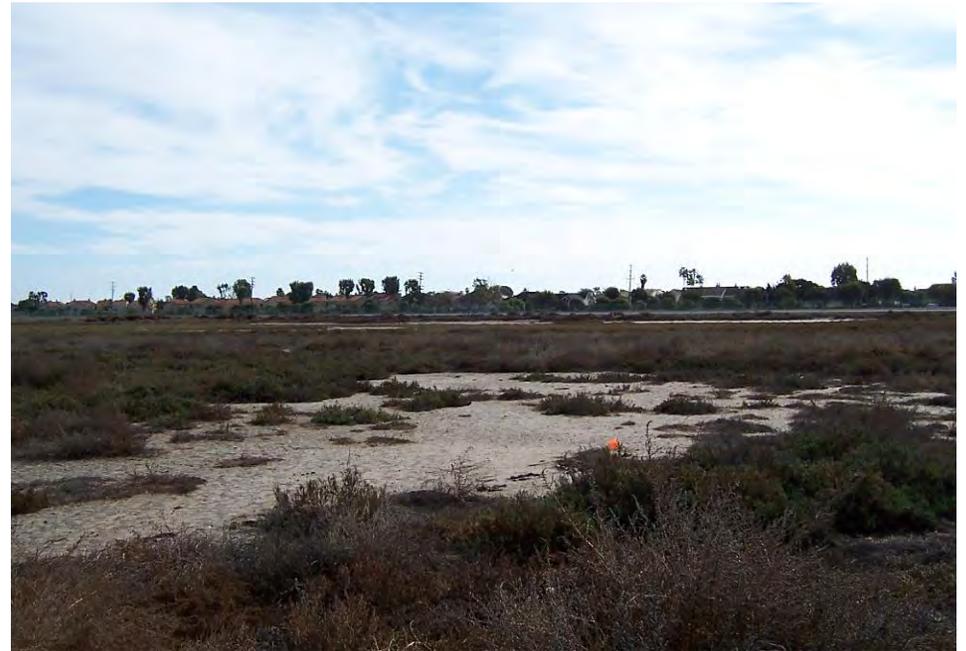
Photo 3: December 4, 2014 Post-Rain Inspection

Compared with Pre-Rain Season Inspection. Looking west from central portion of the landfill.
Typical view west of center of site – low groundcover, occasional shrub, bare areas in the western 1/3rd of the landfill in the distance. No ponding.

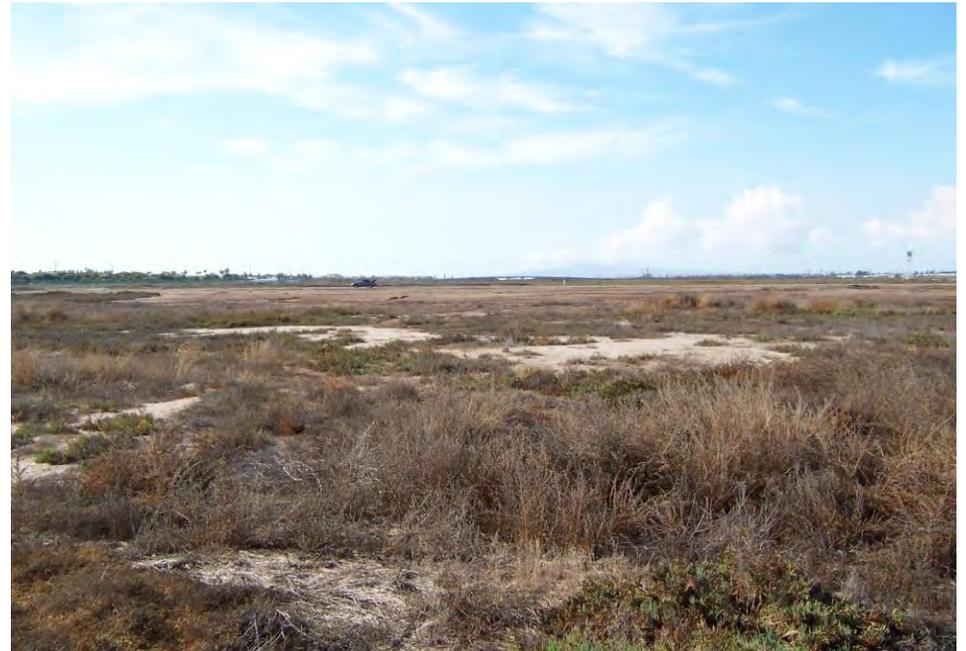
Photo 4: December 4, 2014 Post-Rain Inspection

Compared with Pre-Rain Season Inspection. Looking east, from the northern portion of the west edge of the landfill. Three small ponds, including pond at location of jute mesh in the northern portion of the western 1/3rd of the landfill on the right side of the photo beyond the vegetated patch.

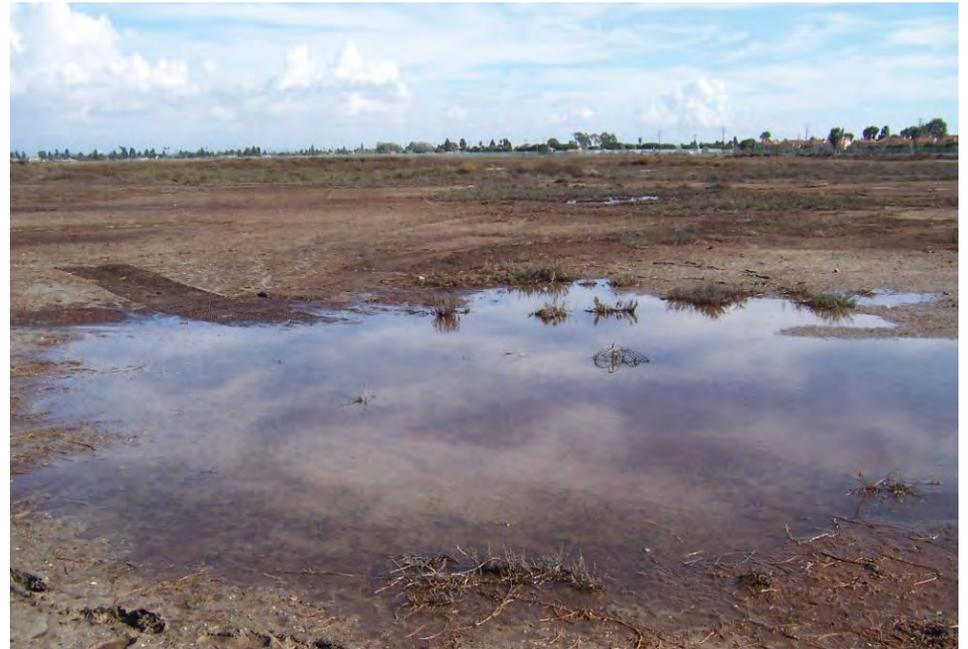
Photo 6: December 4, 2014 Post-Rain Inspection

Compared with Pre-Rain Season Inspection. Looking south from northwestern corner of landfill cover, adjacent to access road. Photo shows areas of vegetation cover and condition of access road.

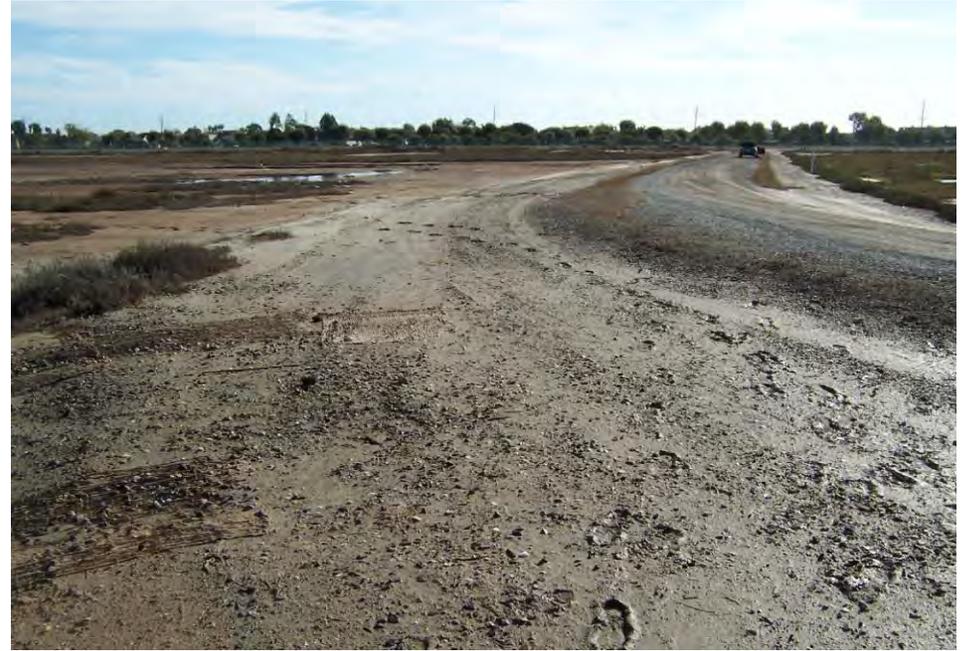
Photo 7: December 4, 2014 Post-Rain Inspection

Compared with Pre-Rain Season Inspection. Looking south along central portion of west edge of landfill at a 100 foot section of jute mesh installed on the slope parallel to the access road. No new erosion or flow lines were present.

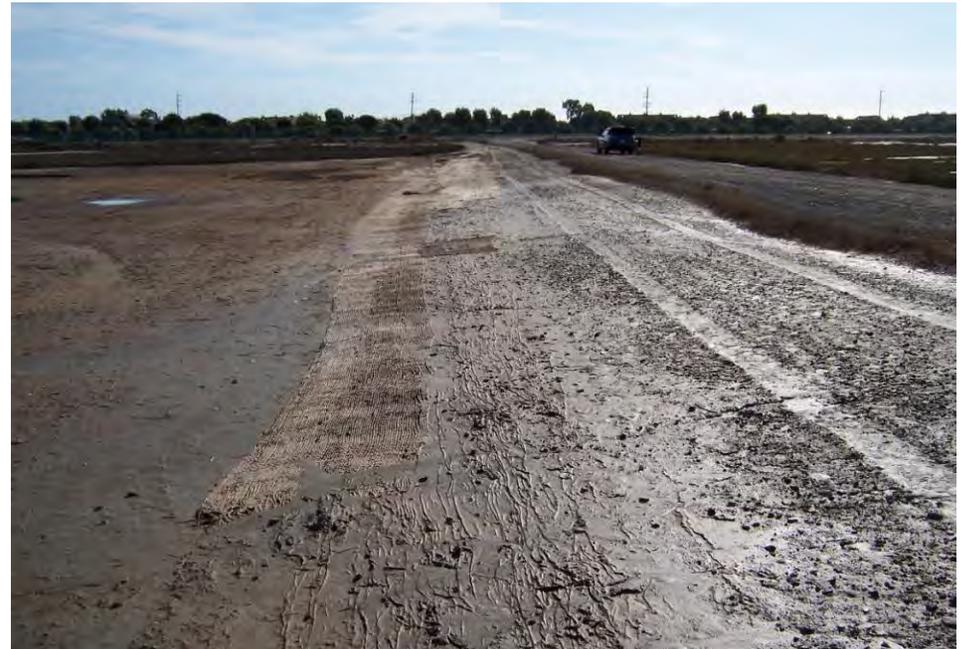
Photo 8: December 4, 2014 Post-Rain Inspection

Compared with Pre-Rain Season Inspection. Looking south along southern portion of west edge of landfill cover. Photo shows condition of jute mesh and access road. No new erosion or flow lines were present.

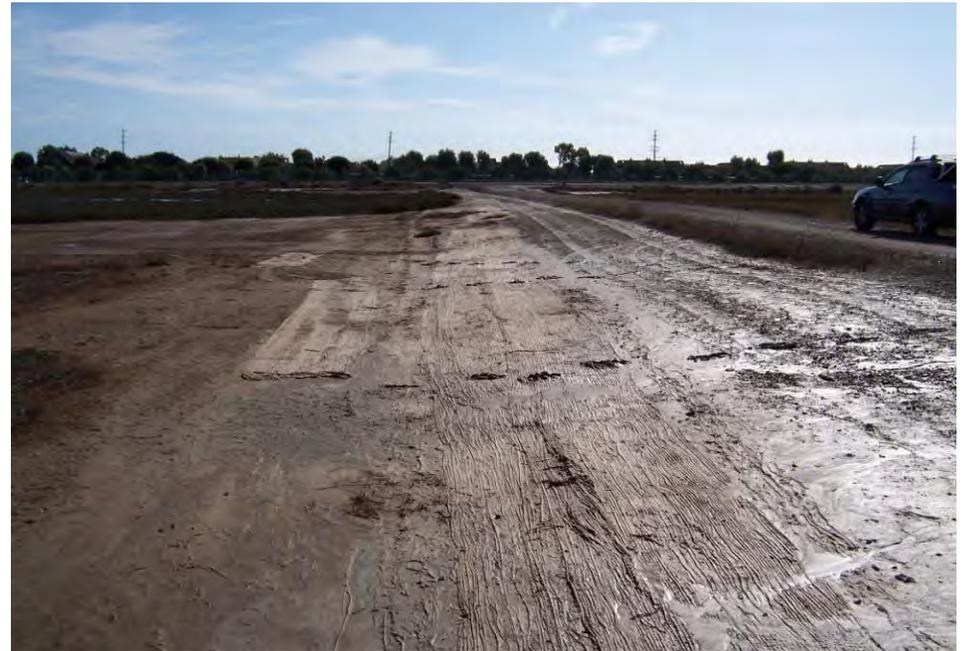
Photo 9: December 4, 2014 Post-Rain Inspection

Compared with Pre-Rain Season Inspection. Looking east from the south portion of west edge of landfill cover. Photo shows central and southern wattles and jute mesh, small ponds in distance.

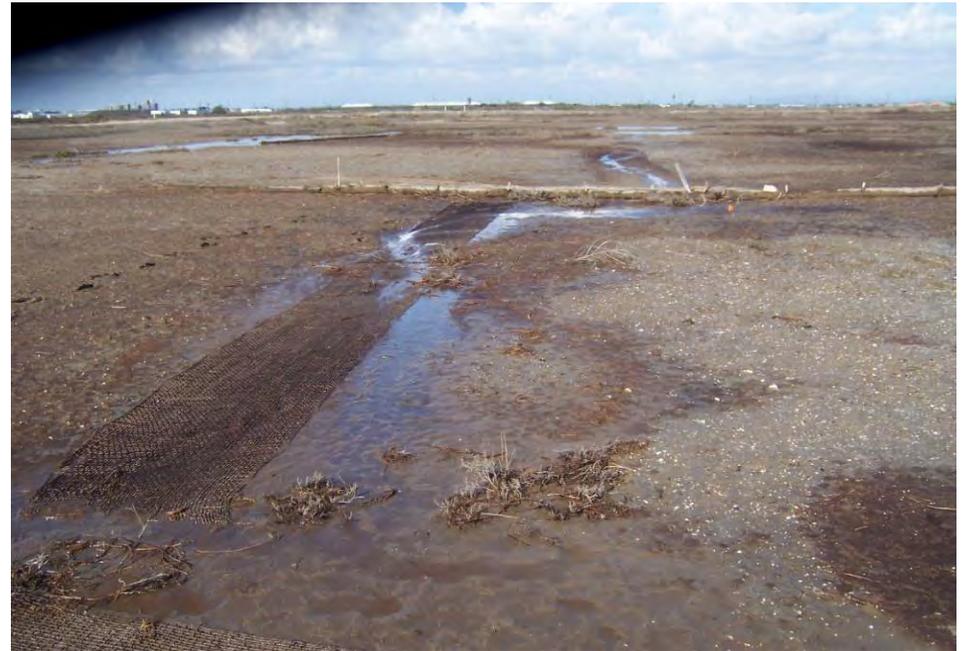
Photo 11: December 4, 2014 Post-Rain Inspection

Compared with Pre-Rain Season Inspection. Looking north, past the central straw wattle, in the direction of the west section of jute mesh. Photo shows the drainage and ponding.

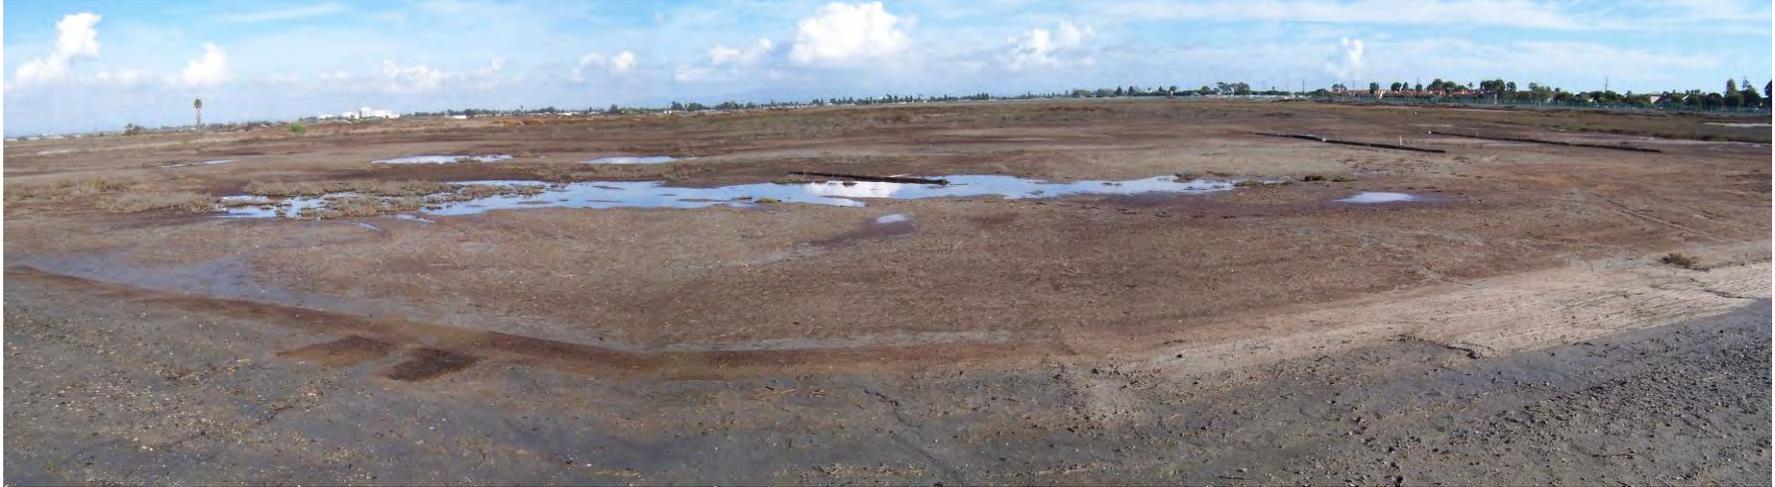
Photo looking east at the largest pond, located on the central western margin of the landfill. Pond drains to the east at the location of the wattle in the center of the photo, then drains south along jute mesh and through wattles on the right side of the photo, then on to the tidal pond to the south.

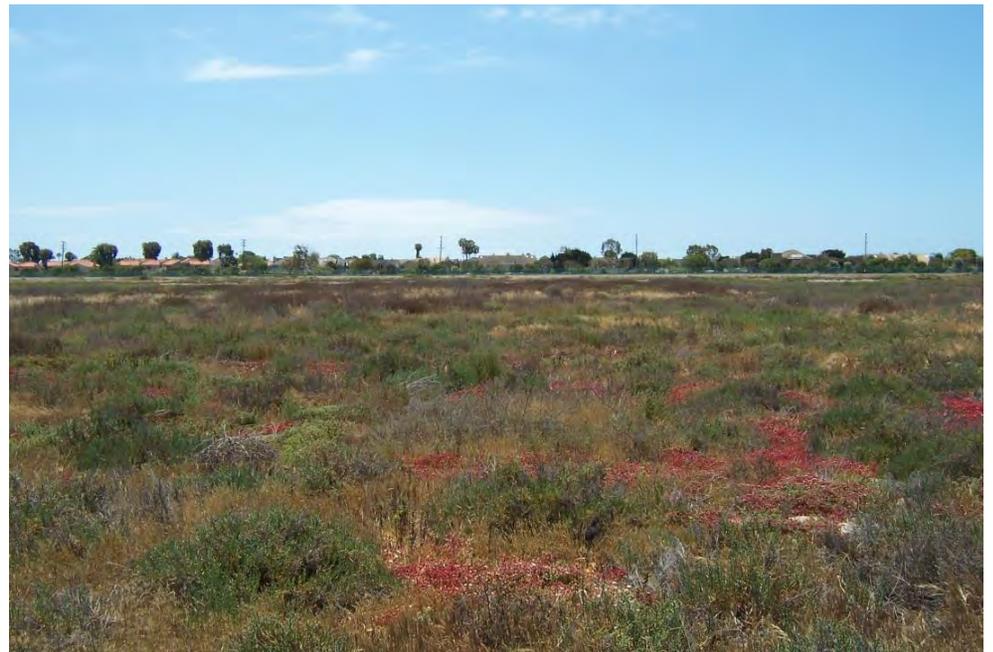
Photo 2: May 20, 2015 Post-Rain Inspection

Compared with Post-Rain Inspection Dec 2014. Looking south from central portion of the landfill cover.
Small bare patch near middle of site. No ponding.

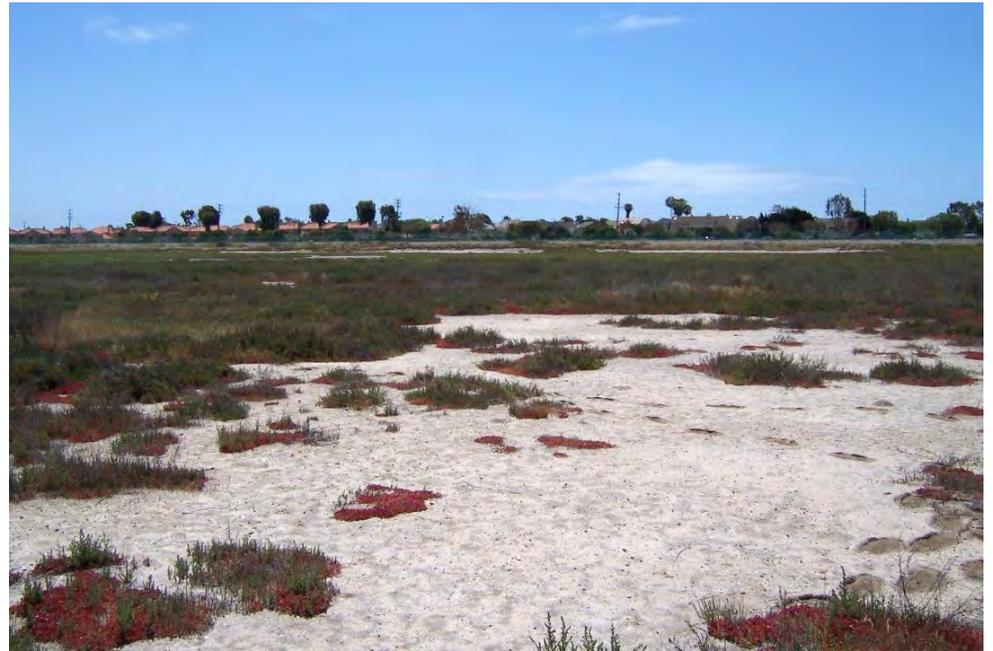
Photo 3: May 20, 2015 Post-Rain Inspection

Compared with Post-Rain Inspection Dec 2014. Looking west from central portion of the landfill. Typical view west of center of site – low groundcover, occasional shrub, bare areas in the western 1/3rd of the landfill in the distance. No ponding.

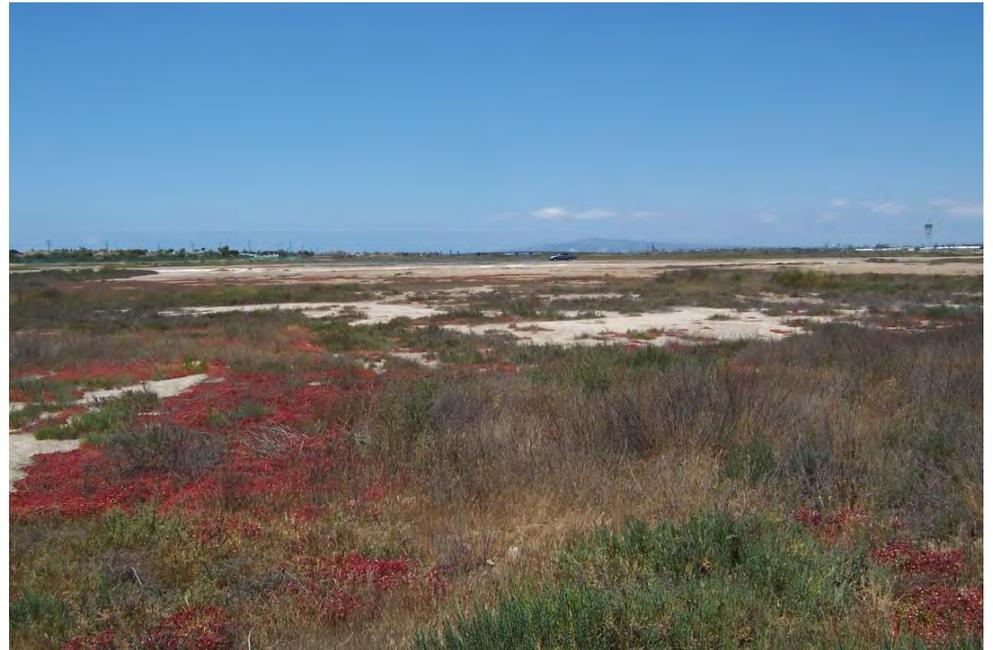
Photo 4: May 20, 2015 Post-Rain Inspection

Compared with Post-Rain Inspection Dec 2014. Looking east, from the northern portion of the west edge of the landfill. No ponding.

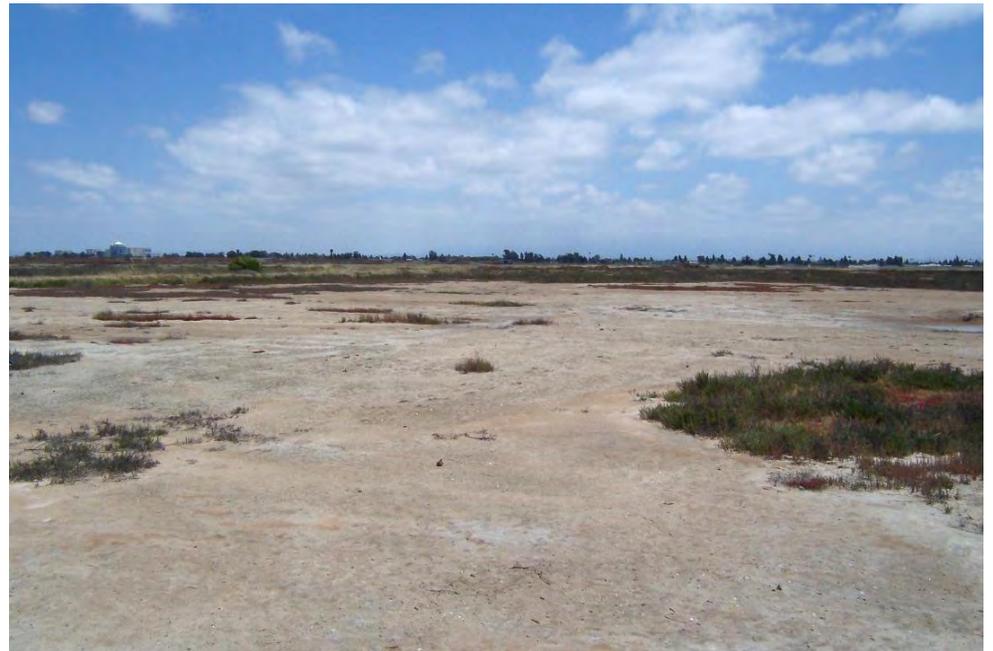
Photo 5: May 20, 2015 Post-Rain Inspection

Compared with Post-Rain Inspection Dec 2014. Looking southeast at two 25 foot sections of jute mesh installed in the north portion of the western 1/3rd of the landfill. No ponding.

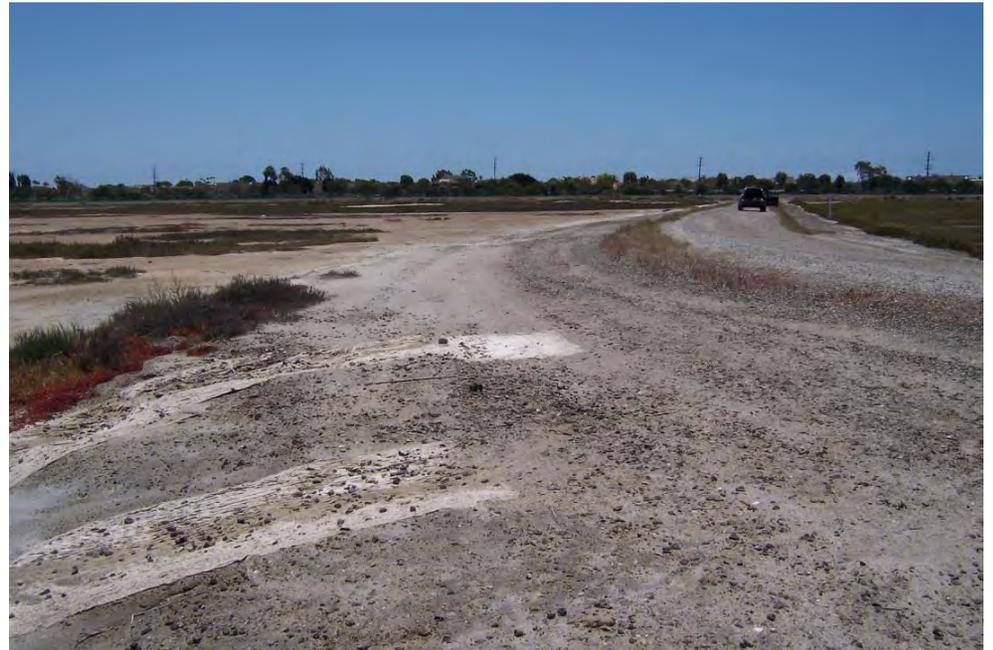
Photo 7: May 20, 2015 Post-Rain Inspection

Compared with Post-Rain Inspection Dec 2014. Looking south along central portion of west edge of landfill at a 100 foot section of jute mesh installed on the slope parallel to the access road. No new erosion or flow lines were present.

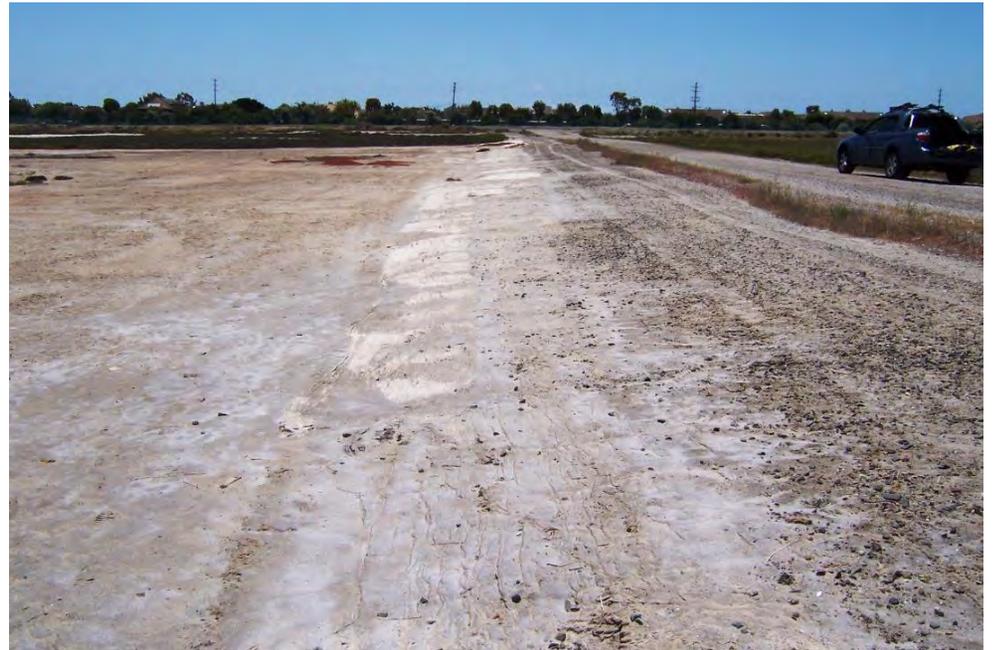
Photo 8: May 20, 2015 Post-Rain Inspection

Compared with Post-Rain Inspection Dec 2014. Looking south along southern portion of west edge of landfill cover. Photo shows condition of jute mesh and access road. No new erosion or flow lines were present.

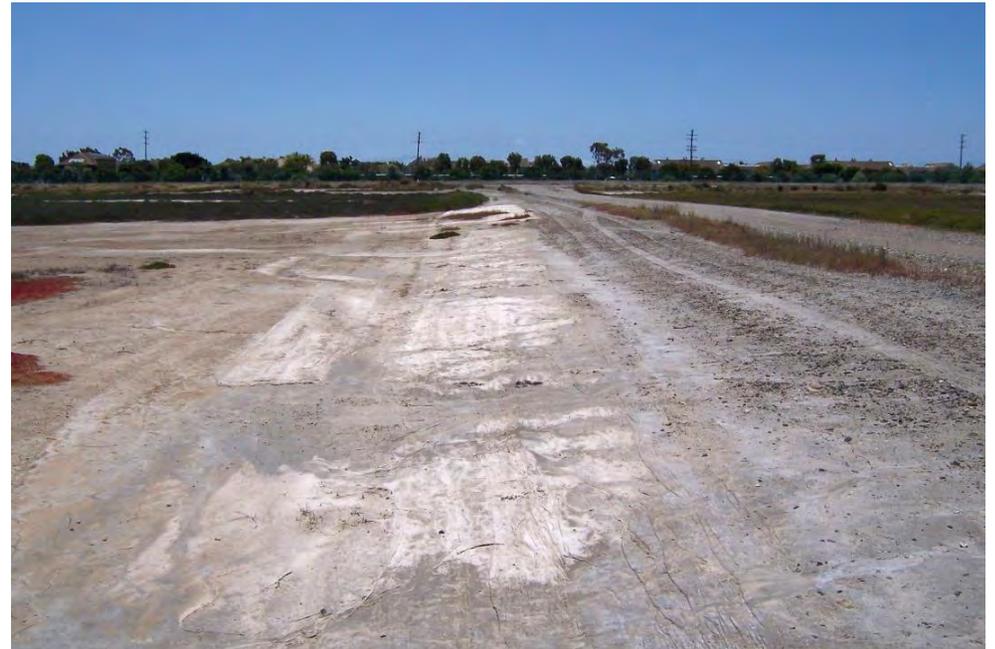
Photo 9: May 20, 2015 Post-Rain Inspection

Compared with Post-Rain Inspection Dec 2014. Looking east from the south portion of west edge of landfill cover. Photo shows central and southern wattles and jute mesh. No ponding.

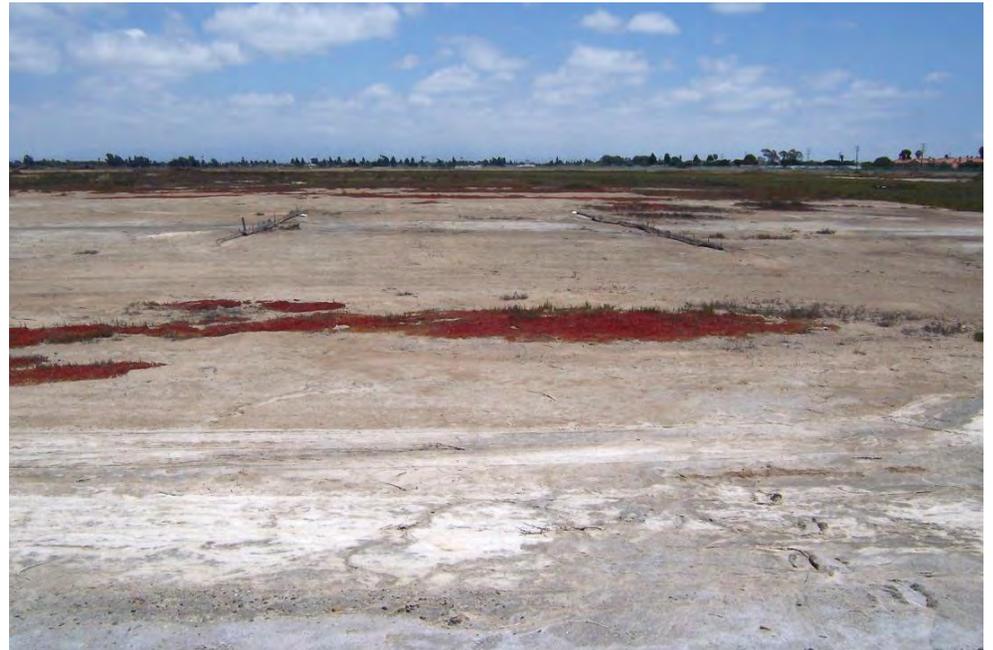
Photo 10: May 20, 2015 Post-Rain Inspection

Compared with Post-Rain Inspection Dec 2014. Looking northwest at 30 foot section of jute mesh installed between central and southern sections of wattles. No ponding.

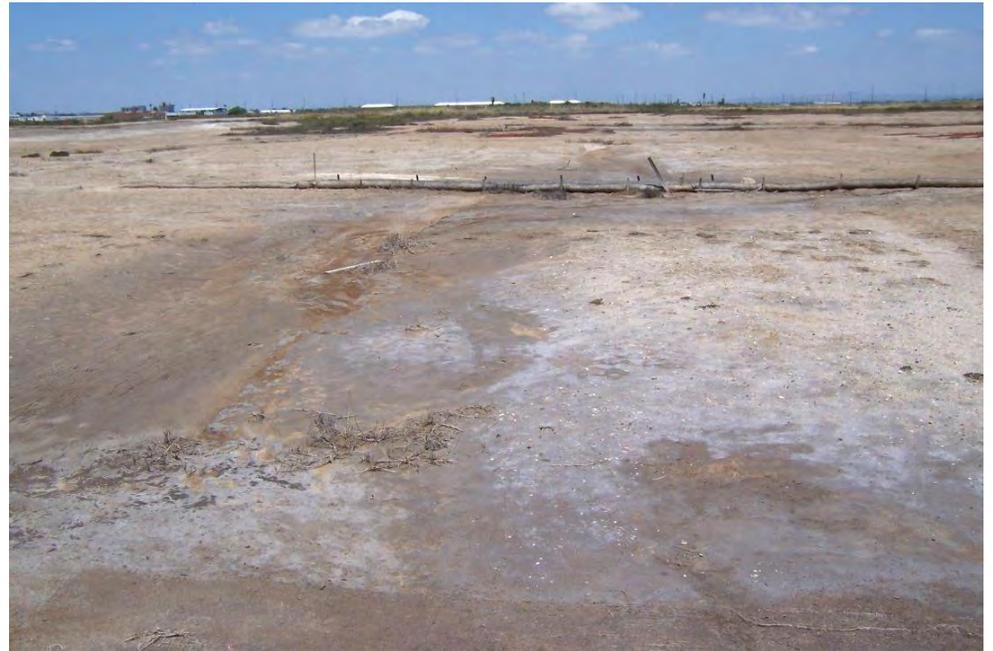
Photo 11: May 20, 2015 Post-Rain Inspection

Compared with Post-Rain Inspection Dec 2014. Looking north, past the central straw wattle, in the direction of the west section of jute mesh. No ponding.

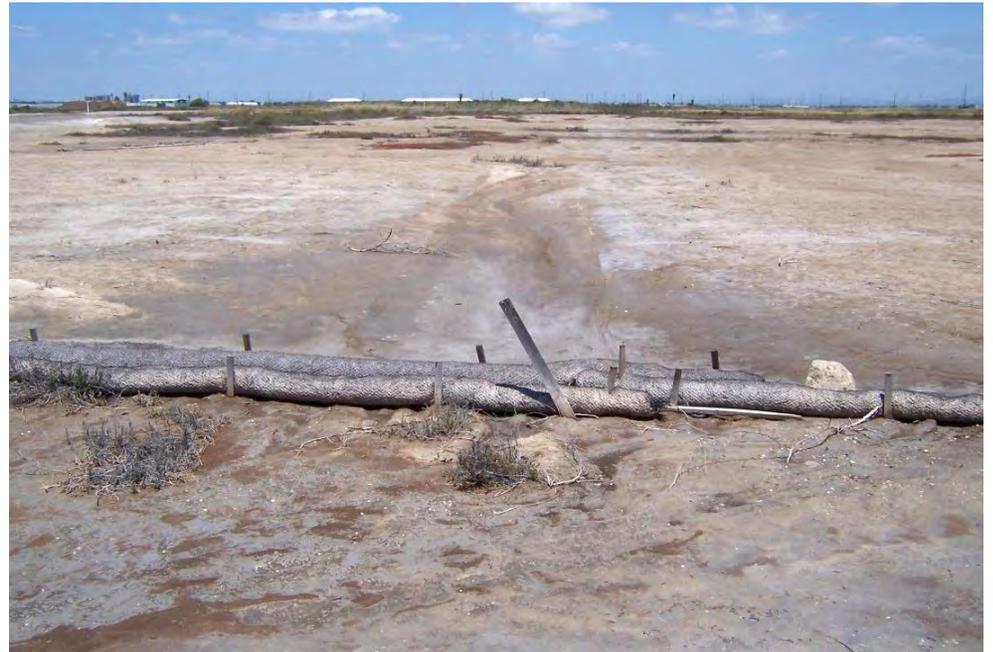
Photo 12: May 20, 2015 Post-Rain Inspection

Compared with Post-Rain Inspection Dec 2014. Looking north at east section of jute mesh located north of the central straw wattle. No ponding.

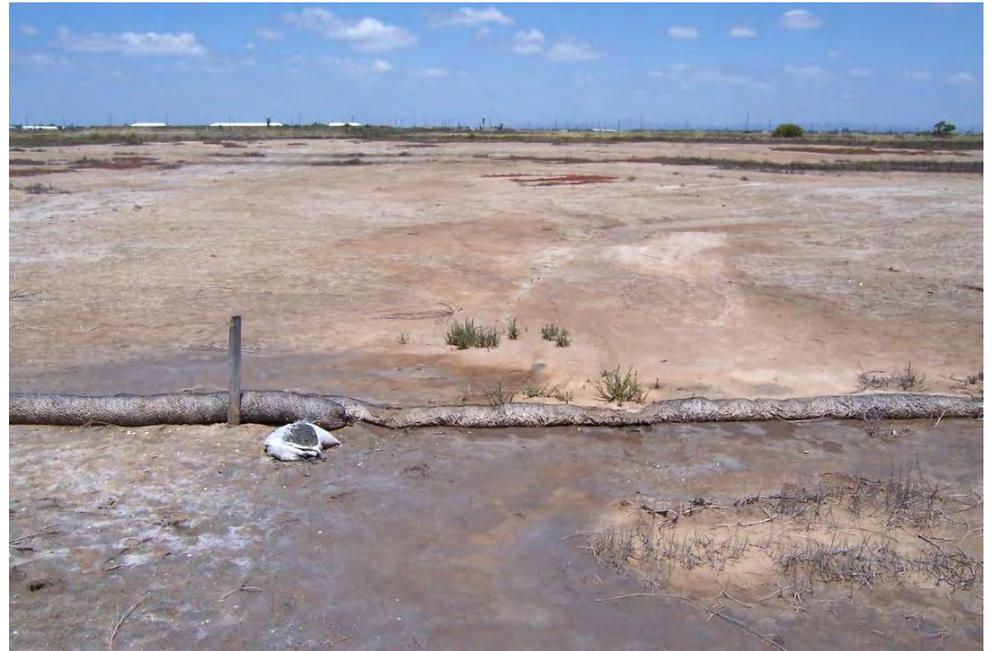
Photo 13: May 20, 2015 Post-Rain Inspection

Compared with Post-Rain Inspection Dec 2014. Looking east from south portion of west edge of the landfill cover. Photo shows western 1/3rd of the landfill cover. No ponding.

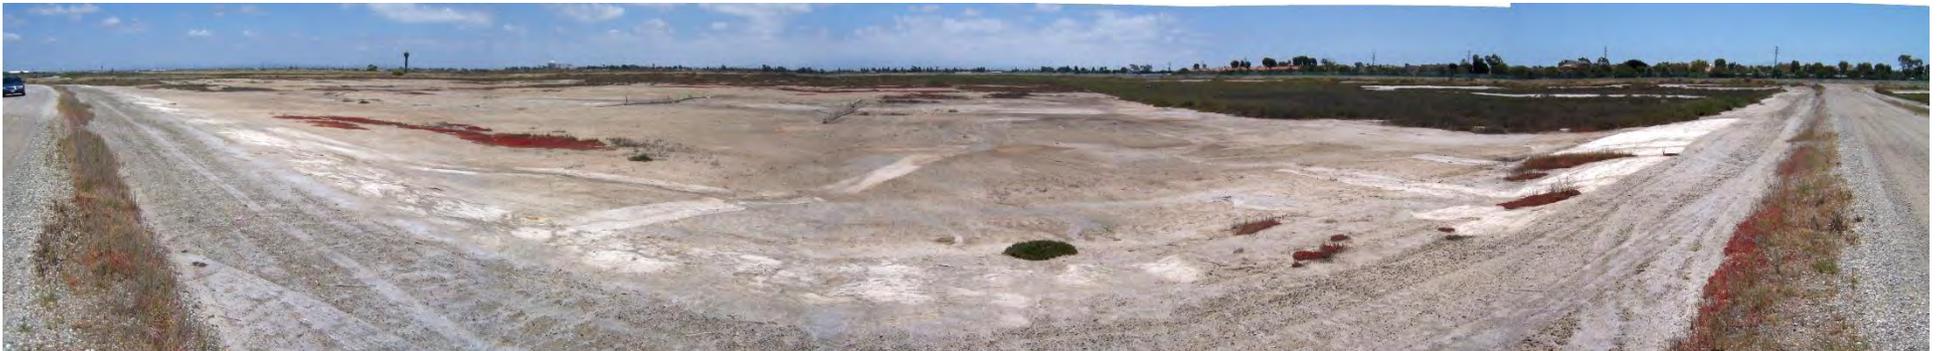
Photo 14: May 20, 2015 Post-Rain Inspection

Compared with Post-Rain Inspection Dec 2014. Looking northeast from south portion of west edge of landfill cover towards the west central margin of the landfill cover. No ponding.

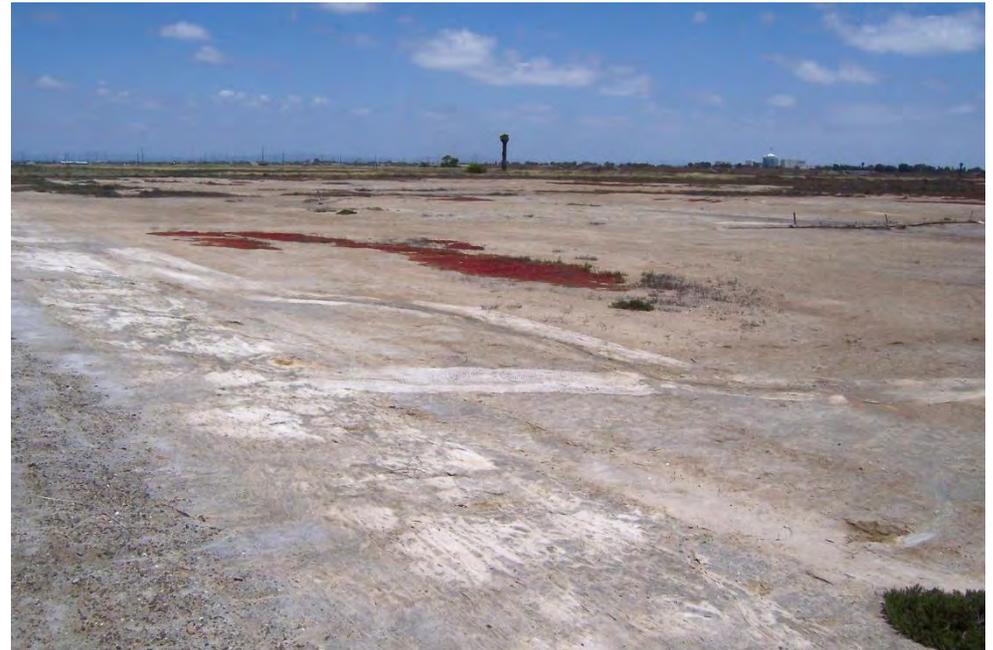
Photo 15: May 20, 2015 Post-Rain Inspection

Compared with Post-Rain Inspection Dec 2014. Looking east, along the southern edge of the landfill cover.
No ponding.

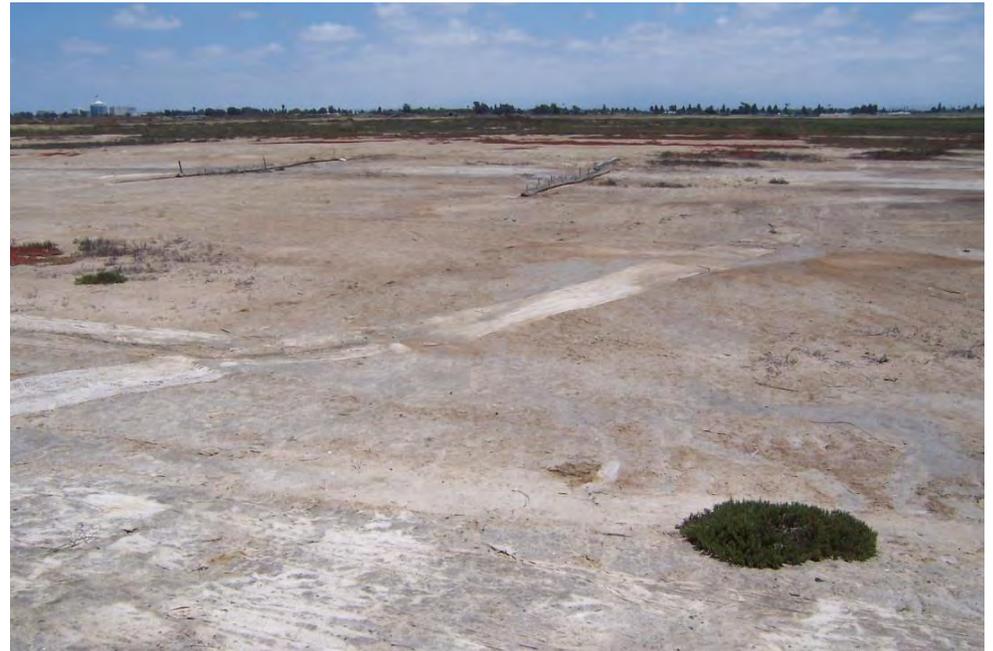
Photo 18: May 20, 2015 Post-Rain Inspection
Photo looking east at the central western margin of the landfill.
