Testing Results for Lead in Drinking Water for JEB Little Creek-Fort Story CDC - Building 531

Priority Areas Lead Testing and Corrective Actions (March 2013)
 JEB Little Creek-Fort Story Child Development Center
 Building 531

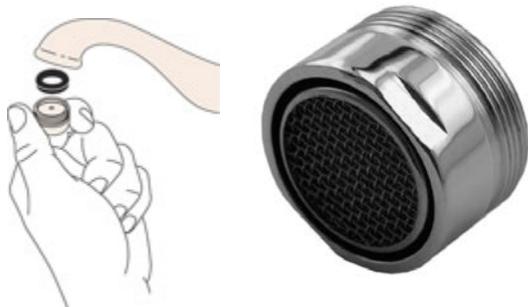
Follow-up sampling at the four hand-washing sinks was conducted after removing the faucet aerators. A **faucet aerator** (or tap aerator) is often found at the tip of modern indoor water

faucets. Without an aerator, water usually flows out of a faucet as one big stream. An aerator spreads this stream into many little droplets, which helps save water and reduce splashing. However, the aerator and screen can trap debris which can accumulate lead.

Follow-up sampling confirmed the source of lead contamination in the hand-washing sinks to be the faucet in room 21B and the faucet aerators in rooms 18A, 23B, and 24A. These four locations were permanently disconnected and the pipes capped since they were seldom used.
