**FALL 2011 & WINTER 2012 ANNUAL POST-CLOSURE  
INSPECTION AND MAINTENANCE REPORT**

**August 8, 2012**

**INSTALLATION RESTORATION PROGRAM SITE 7 AREA 1  
(FORMER STATION LANDFILL)**

**NAVAL WEAPONS STATION SEAL BEACH  
SEAL BEACH, CALIFORNIA**

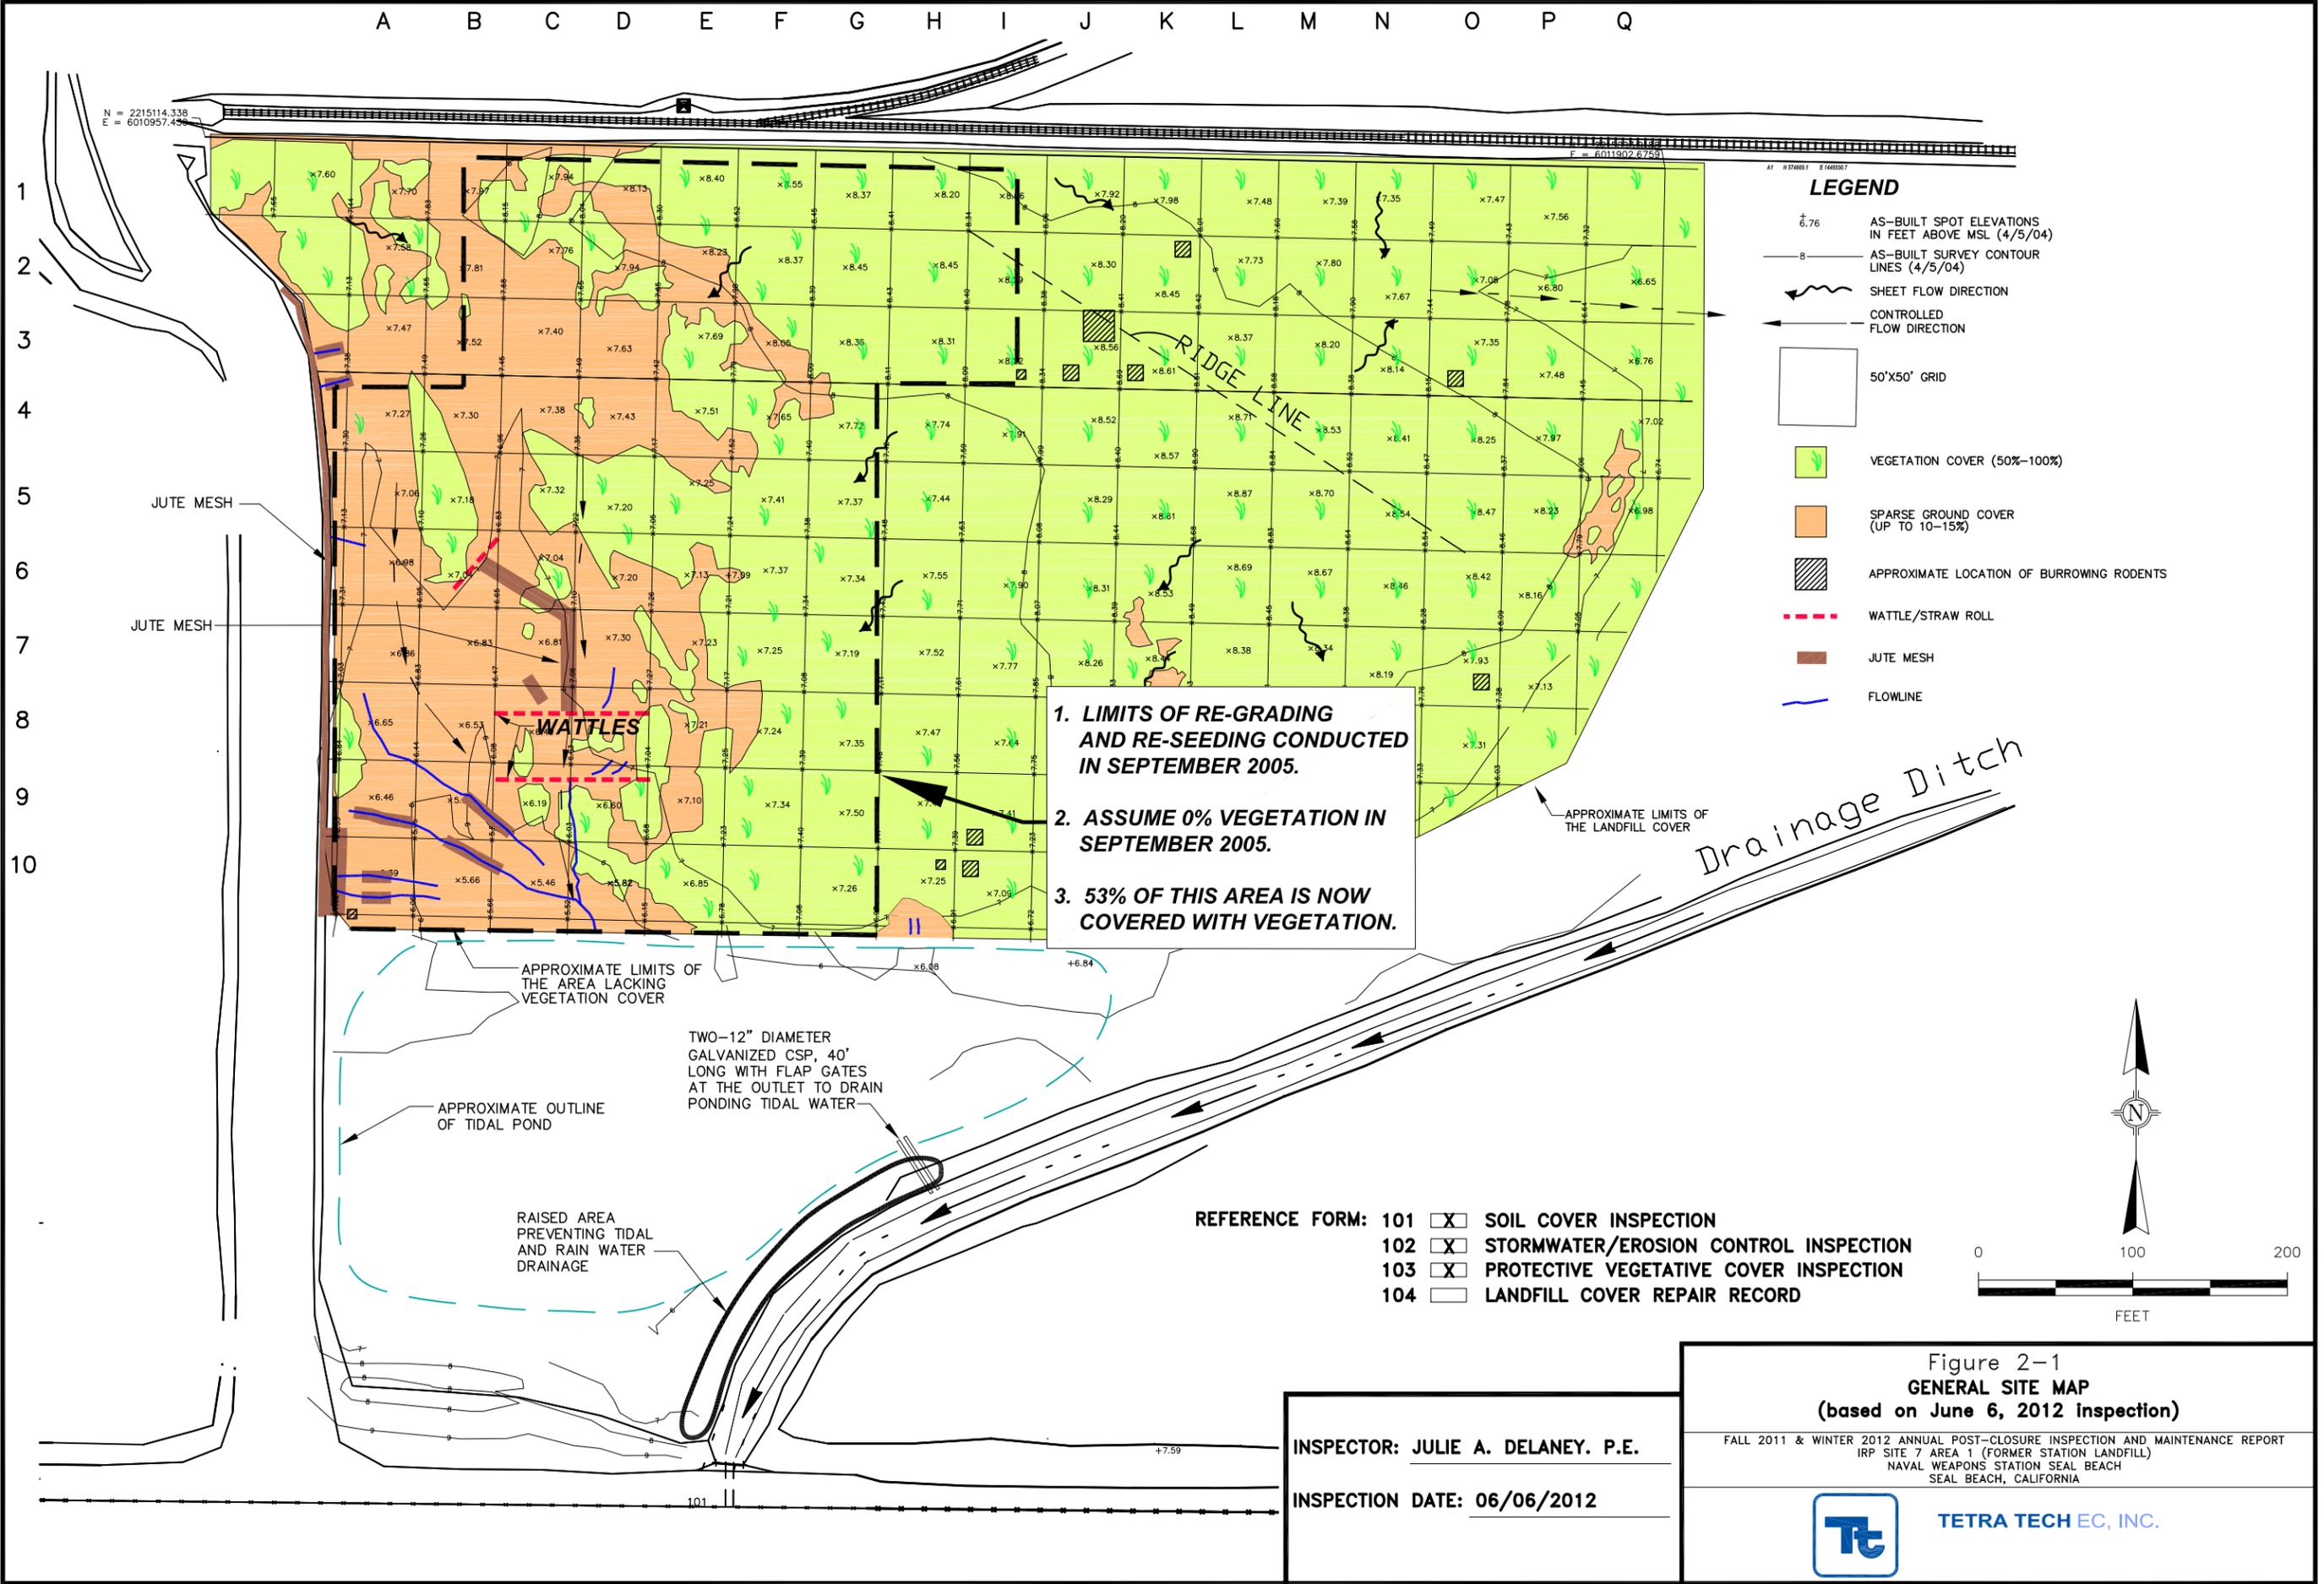
Figure 2-1  
**GENERAL SITE MAP**  
 (based on June 6, 2012 inspection)

During the inspections, a lack of complete vegetation cover, some minor erosion (less than 2 inches deep and less than 6 inches wide), some shallow depressions (less than 4 inches deep), and some signs of burrowing rodents (likely gophers) were observed in the western portion of the landfill (Figure 2-1). No cover failures resulting from stormwater runoff, and no waste exposure due to lack of soil cover, cracks, unstable cover, or burrowing rodents, were observed during the inspections. Overall, the landfill cover is stable. The areas of vegetation in the poorly vegetated western portion of the landfill did not appear to significantly increase in size during the reporting period, but the density of plants within the vegetated areas did appear to increase.

During the fall 2011 to winter 2012 inspections, the overall condition of the vegetative growth on the eastern portion of the landfill cover (approximately 8 acres) was observed to be satisfactory. The western portion of the landfill has areas of sparse vegetative growth as shown on Figure 2-1. The lack of vegetation in the western portion (approximately 2 acres) is possibly a result of the relatively elevated salinity levels in soil inhibiting plant growth.

In September 2005 (TtEC 2006a), the western portion of the landfill cover was regraded and reseeded. Assuming the area that was regraded and reseeded had zero percent vegetation in September 2005, it is estimated that approximately 53 percent of that area is now covered with adequate vegetation (Figure 2-1).

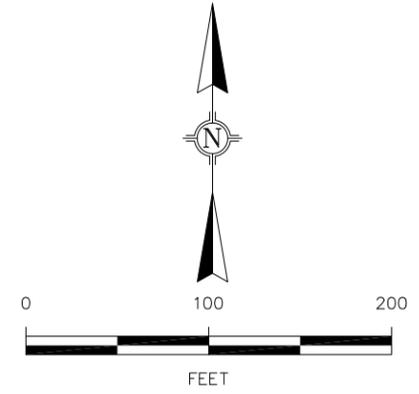
Figure A-1A  
**LANDFILL COVER INSPECTION MAP**  
**OCTOBER 4, 2011**

Evidence of burrowing rodents (probably gophers) was observed (See Figure A-1A). Ground holes and 2" to 3" loose soil mounding was observed in 11 areas in the eastern 2/3rds of the landfill cover. No trash exposure was observed.

**RECOMMENDATIONS:** Consider setting traps or installing four to six 8' to 10' high predatory bird perches in the vicinity of the burrowing rodents. Holes in disturbed areas should be filled and tamped when rodents are gone.

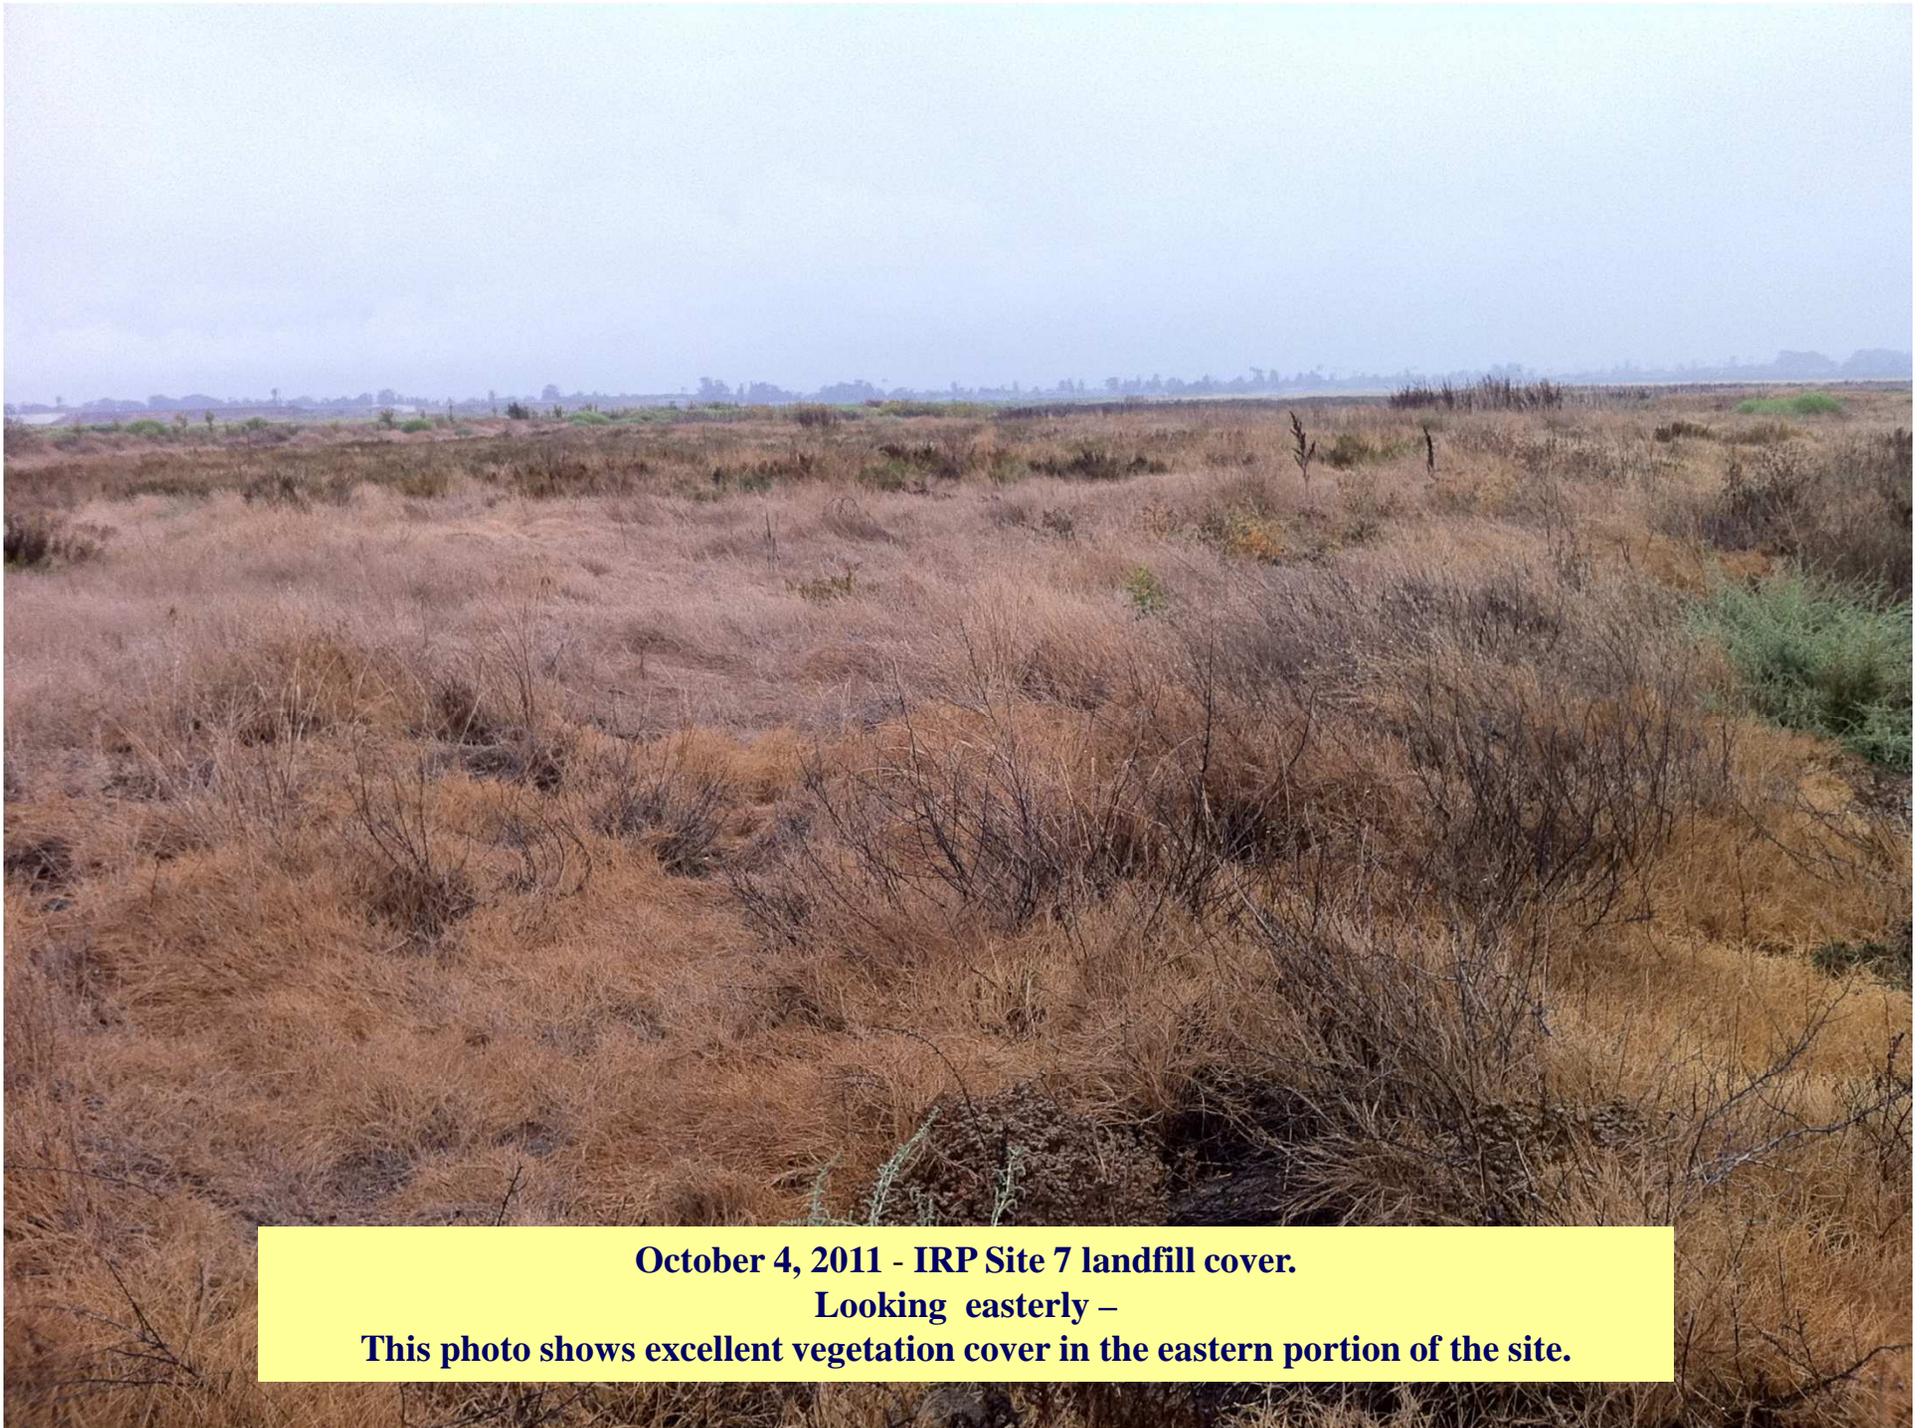
**This photo shows excellent vegetation cover in the eastern portion of the site.**

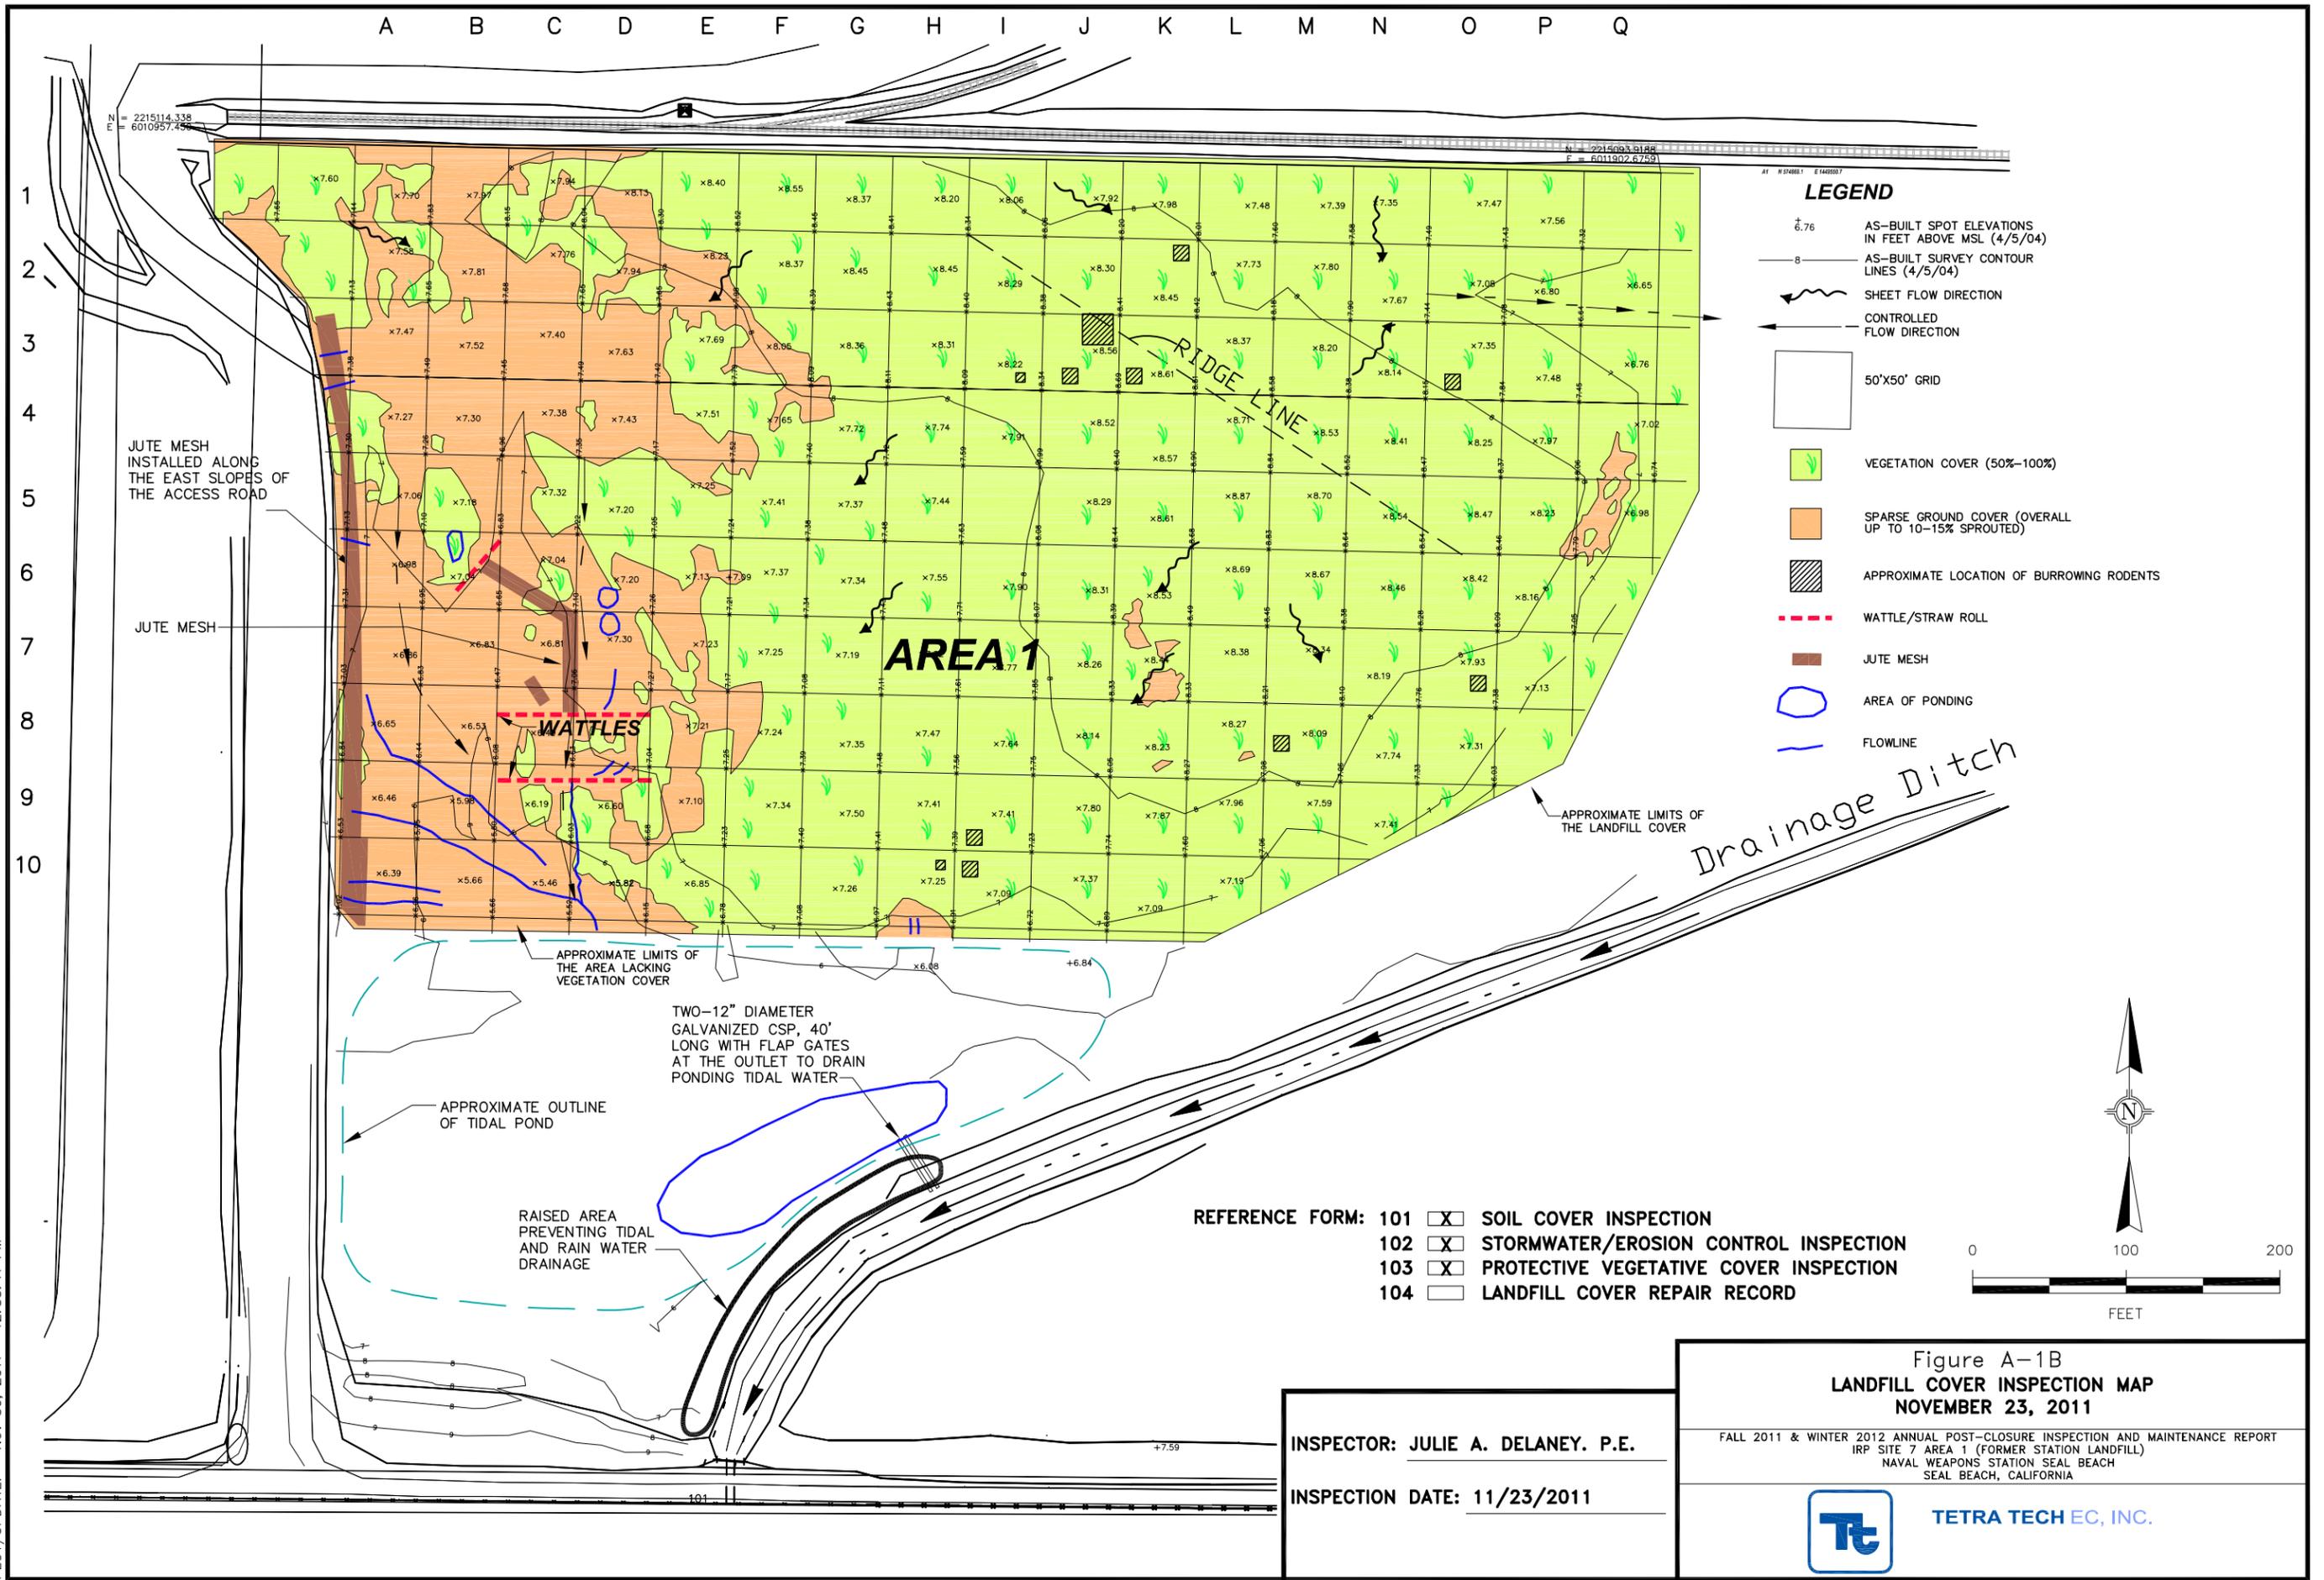
Figure A-1B  
**LANDFILL COVER INSPECTION MAP**  
**NOVEMBER 23, 2011**

The beginnings of shallow flow-lines formed in several places, all less than 2" in depth maximum.  
Ponding was observed in three small areas (see photos).

Shallow flow-lines were observed along the western edge and in the western 1/3 of the landfill  
cover. Three small areas of ponding were observed on the western 1/3 of the cover.

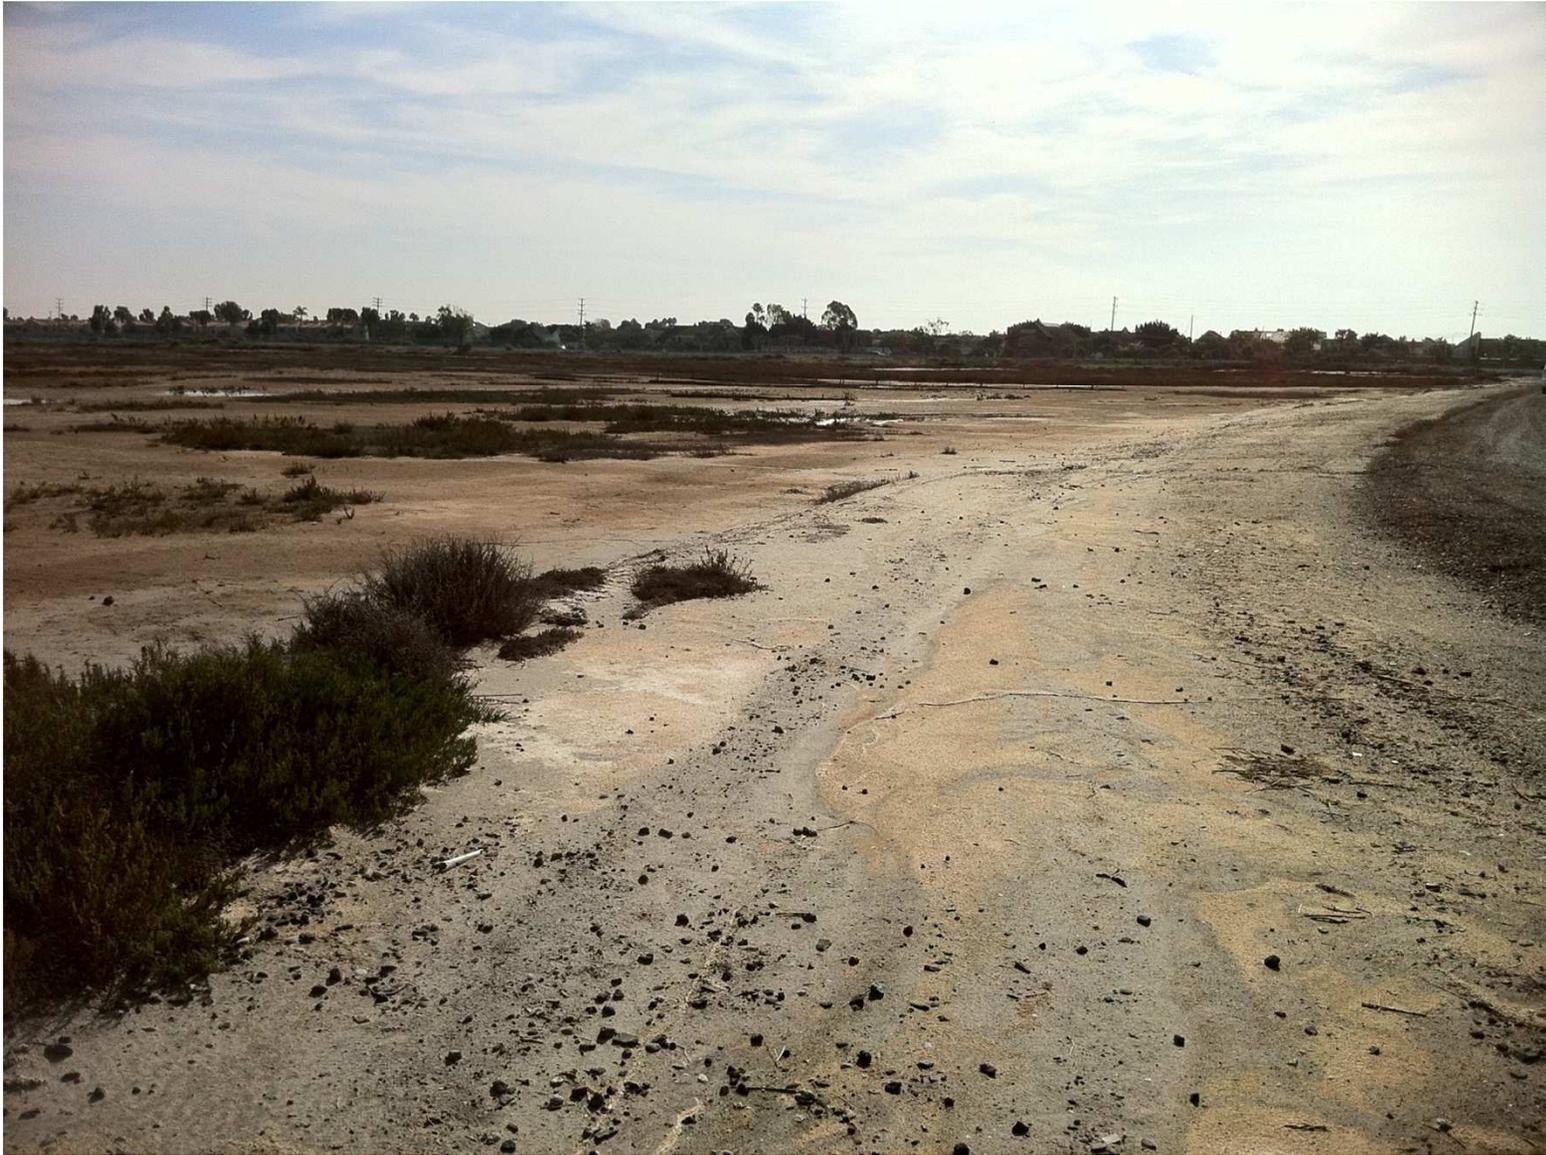
**November 23, 2011 - IRP Site 7 landfill cover.  
Looking southerly from west side of site –  
This photo shows the vegetation cover in the western portion of the site.**

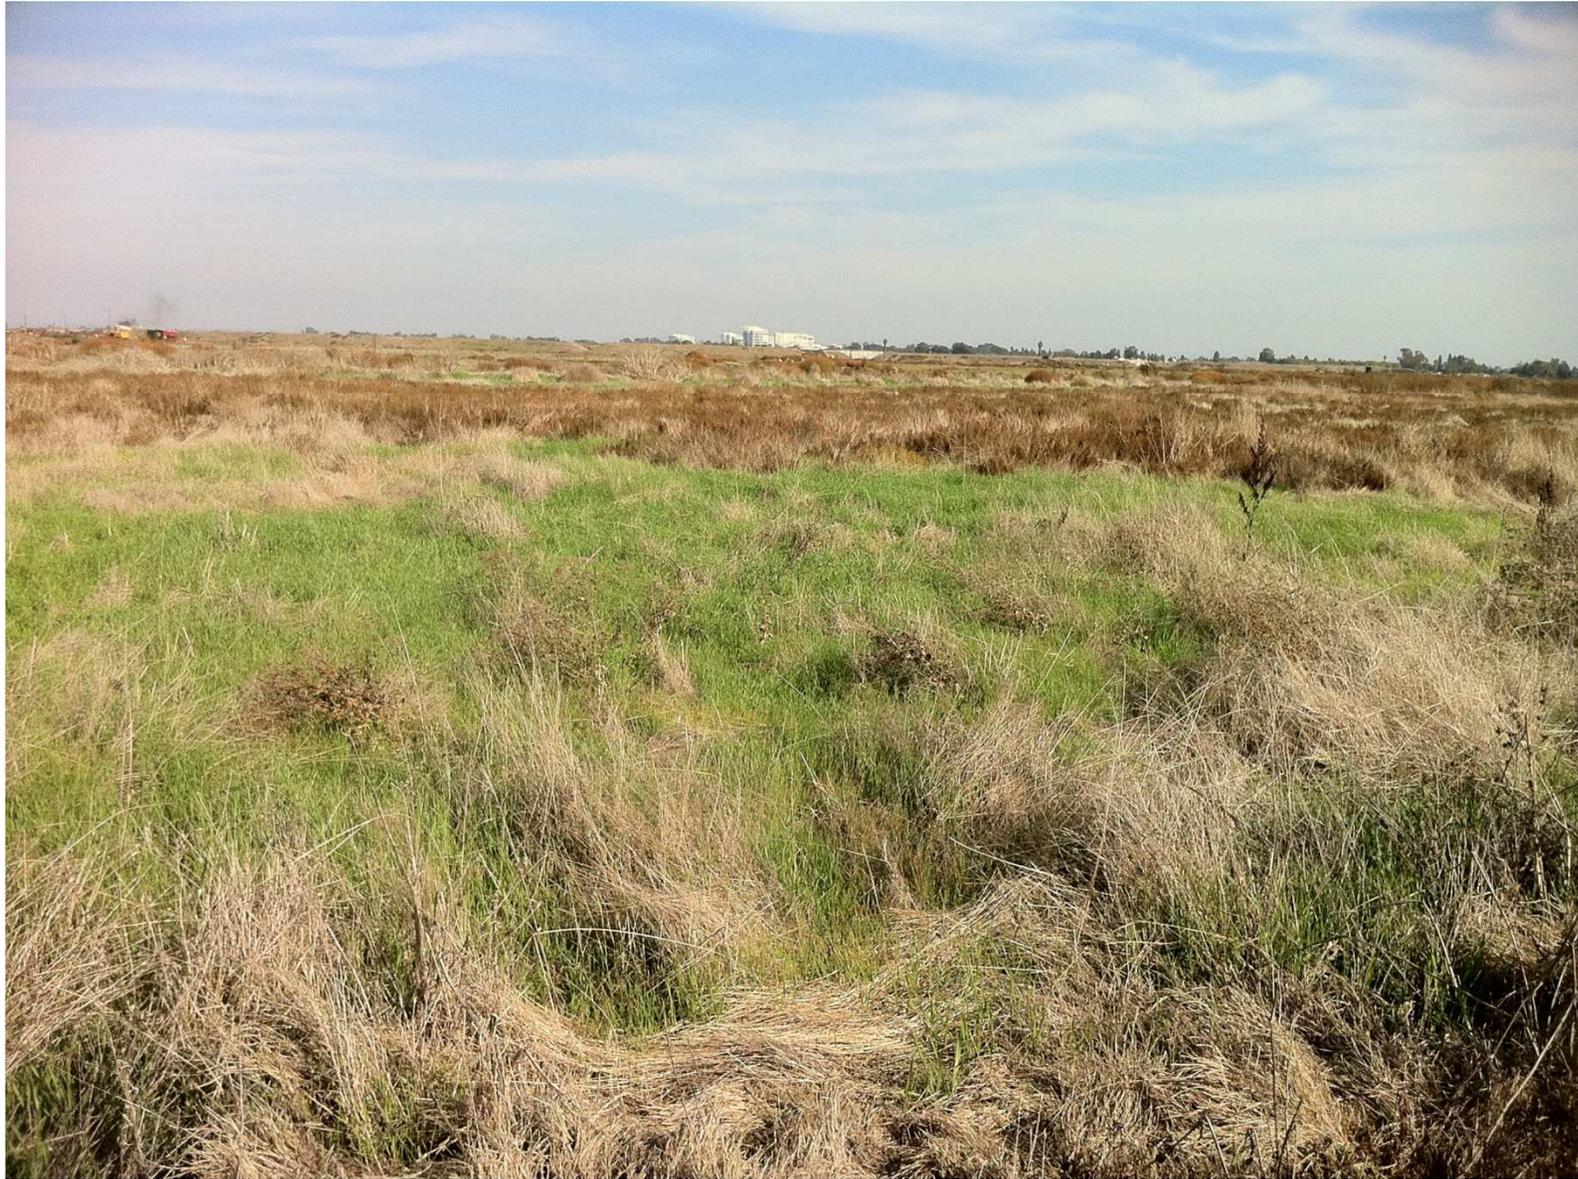
**November 23, 2011 - IRP Site 7 landfill cover.  
Looking easterly –  
This photo shows excellent vegetation cover in the eastern portion of the site.**

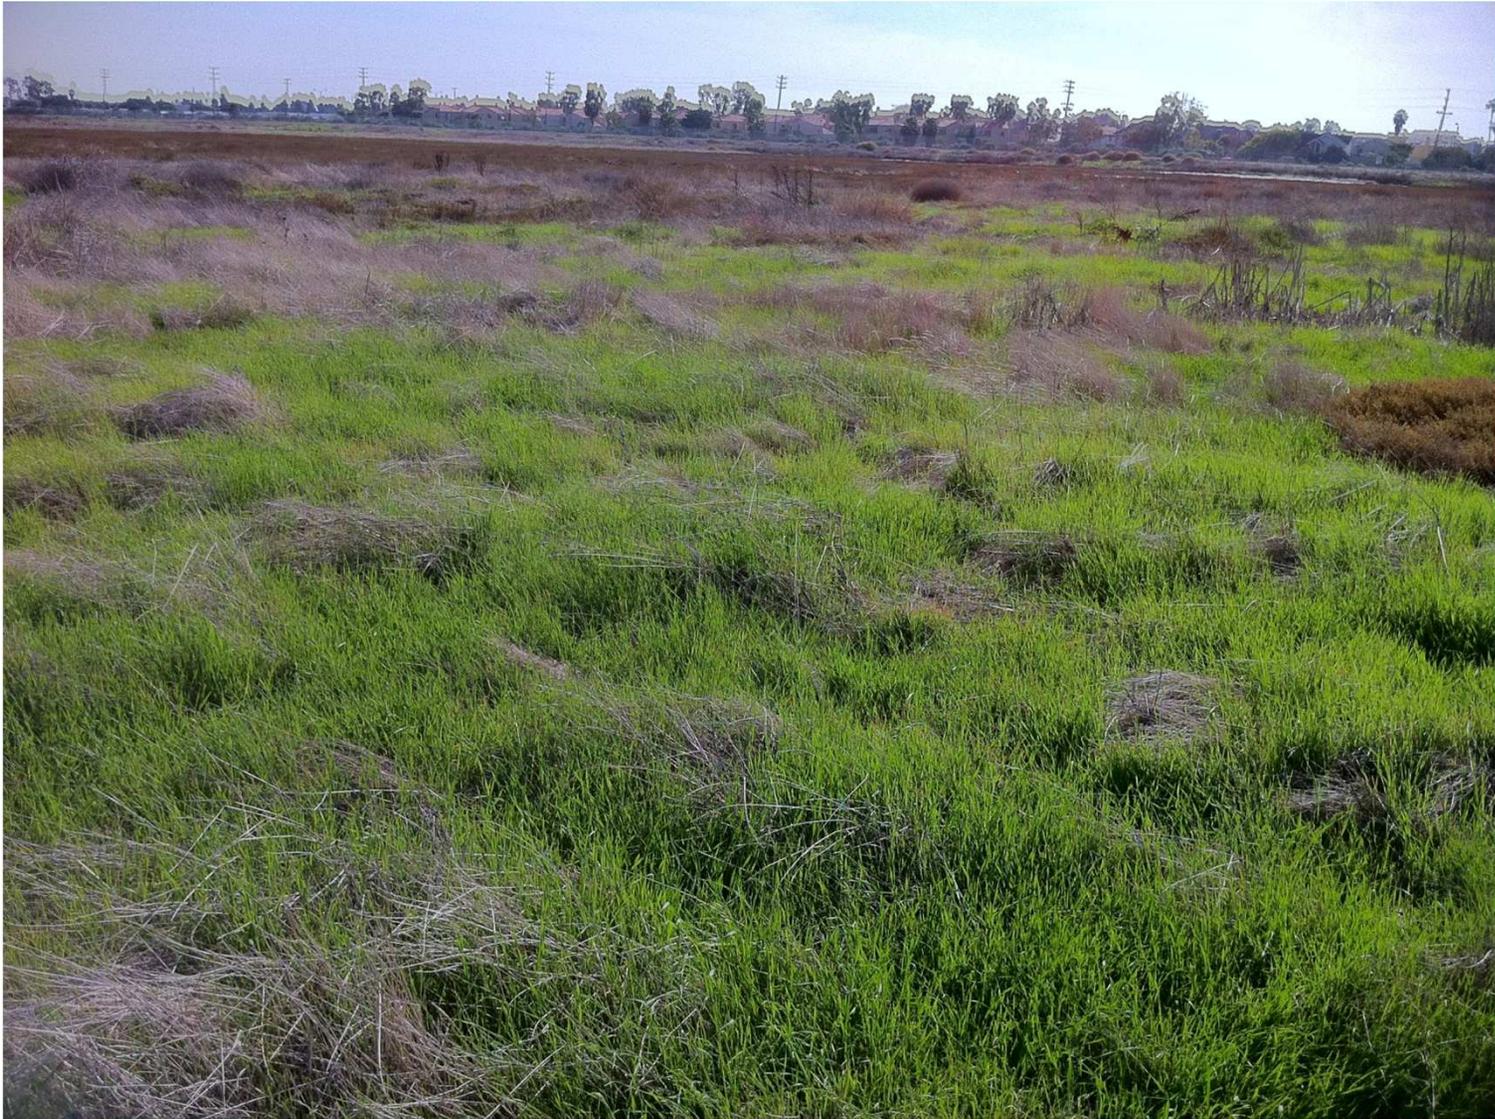
**November 23, 2011 - IRP Site 7 landfill cover.  
Looking southerly –  
This photo shows excellent vegetation cover in the eastern portion of the site.**

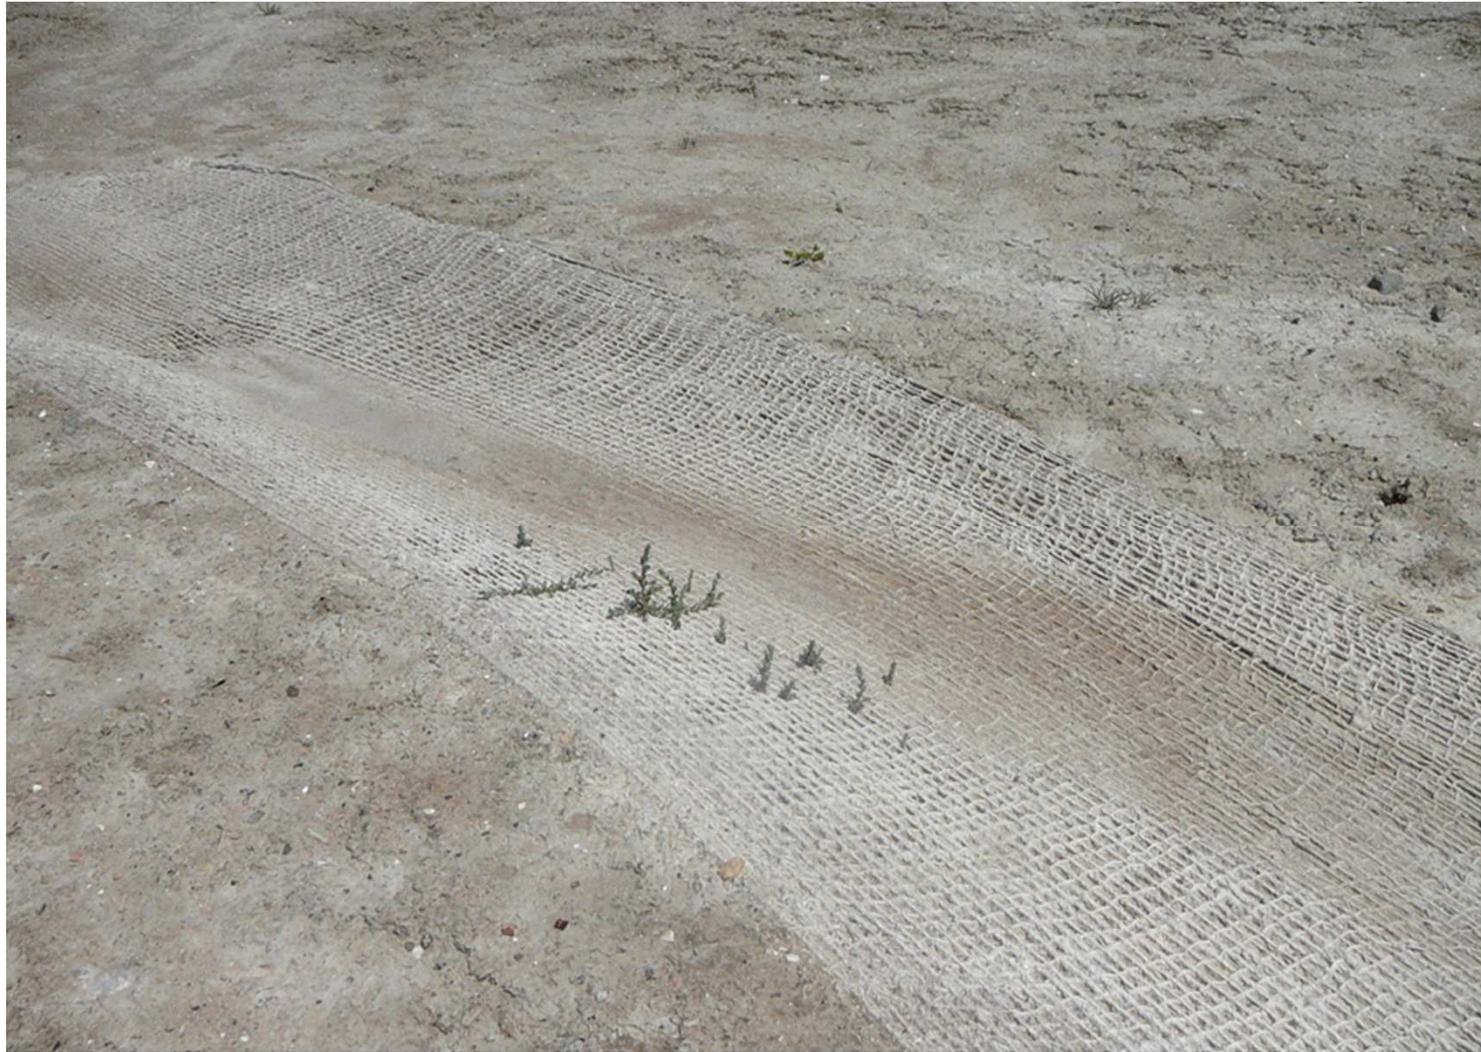
**June 6, 2012 - IRP Site 7 landfill cover.  
Typical jute mesh installation in a shallow drainage area.**
