**FALL 2014 AND WINTER 2015
ANNUAL POST-CLOSURE INSPECTION AND MAINTENANCE REPORT**

**INSTALLATION RESTORATION PROGRAM SITE 7 AREA 1
(FORMER STATION LANDFILL)
NAVAL WEAPONS STATION SEAL BEACH, SEAL BEACH, CALIFORNIA**

November 2015

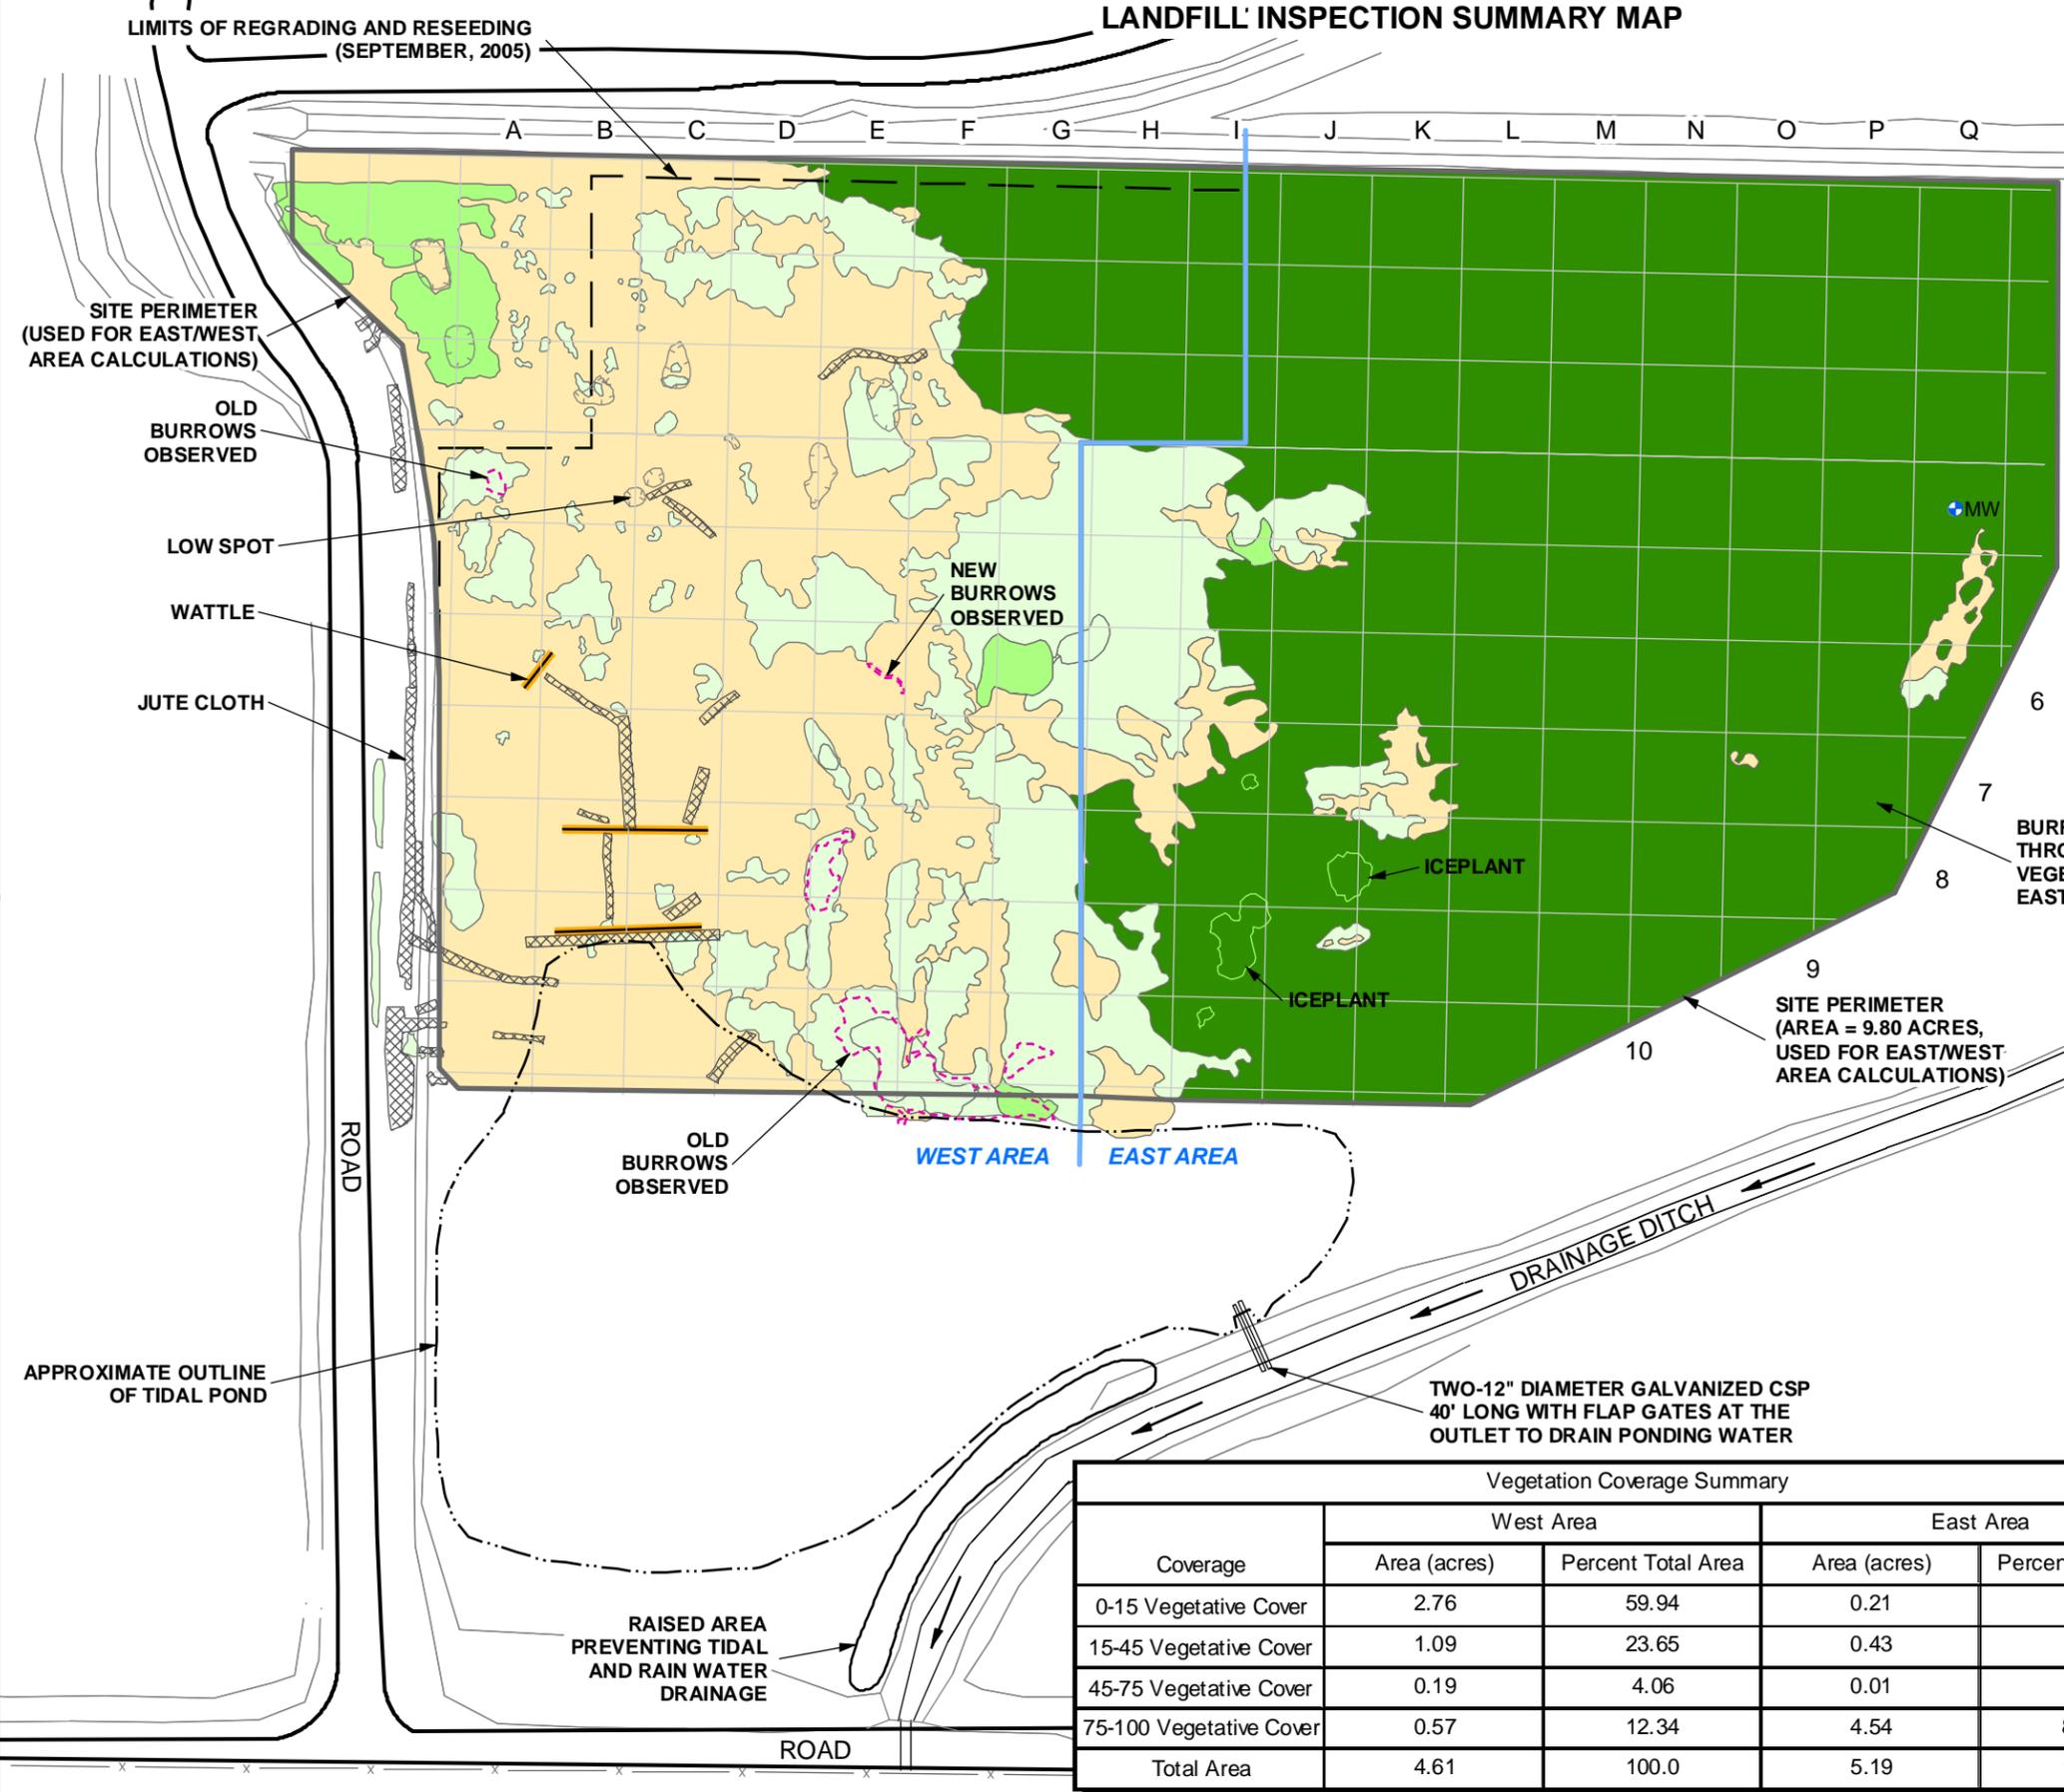
BURROWS OBSERVED THROUGHOUT THE 75-100% VEGETATION IN THE EAST AREA

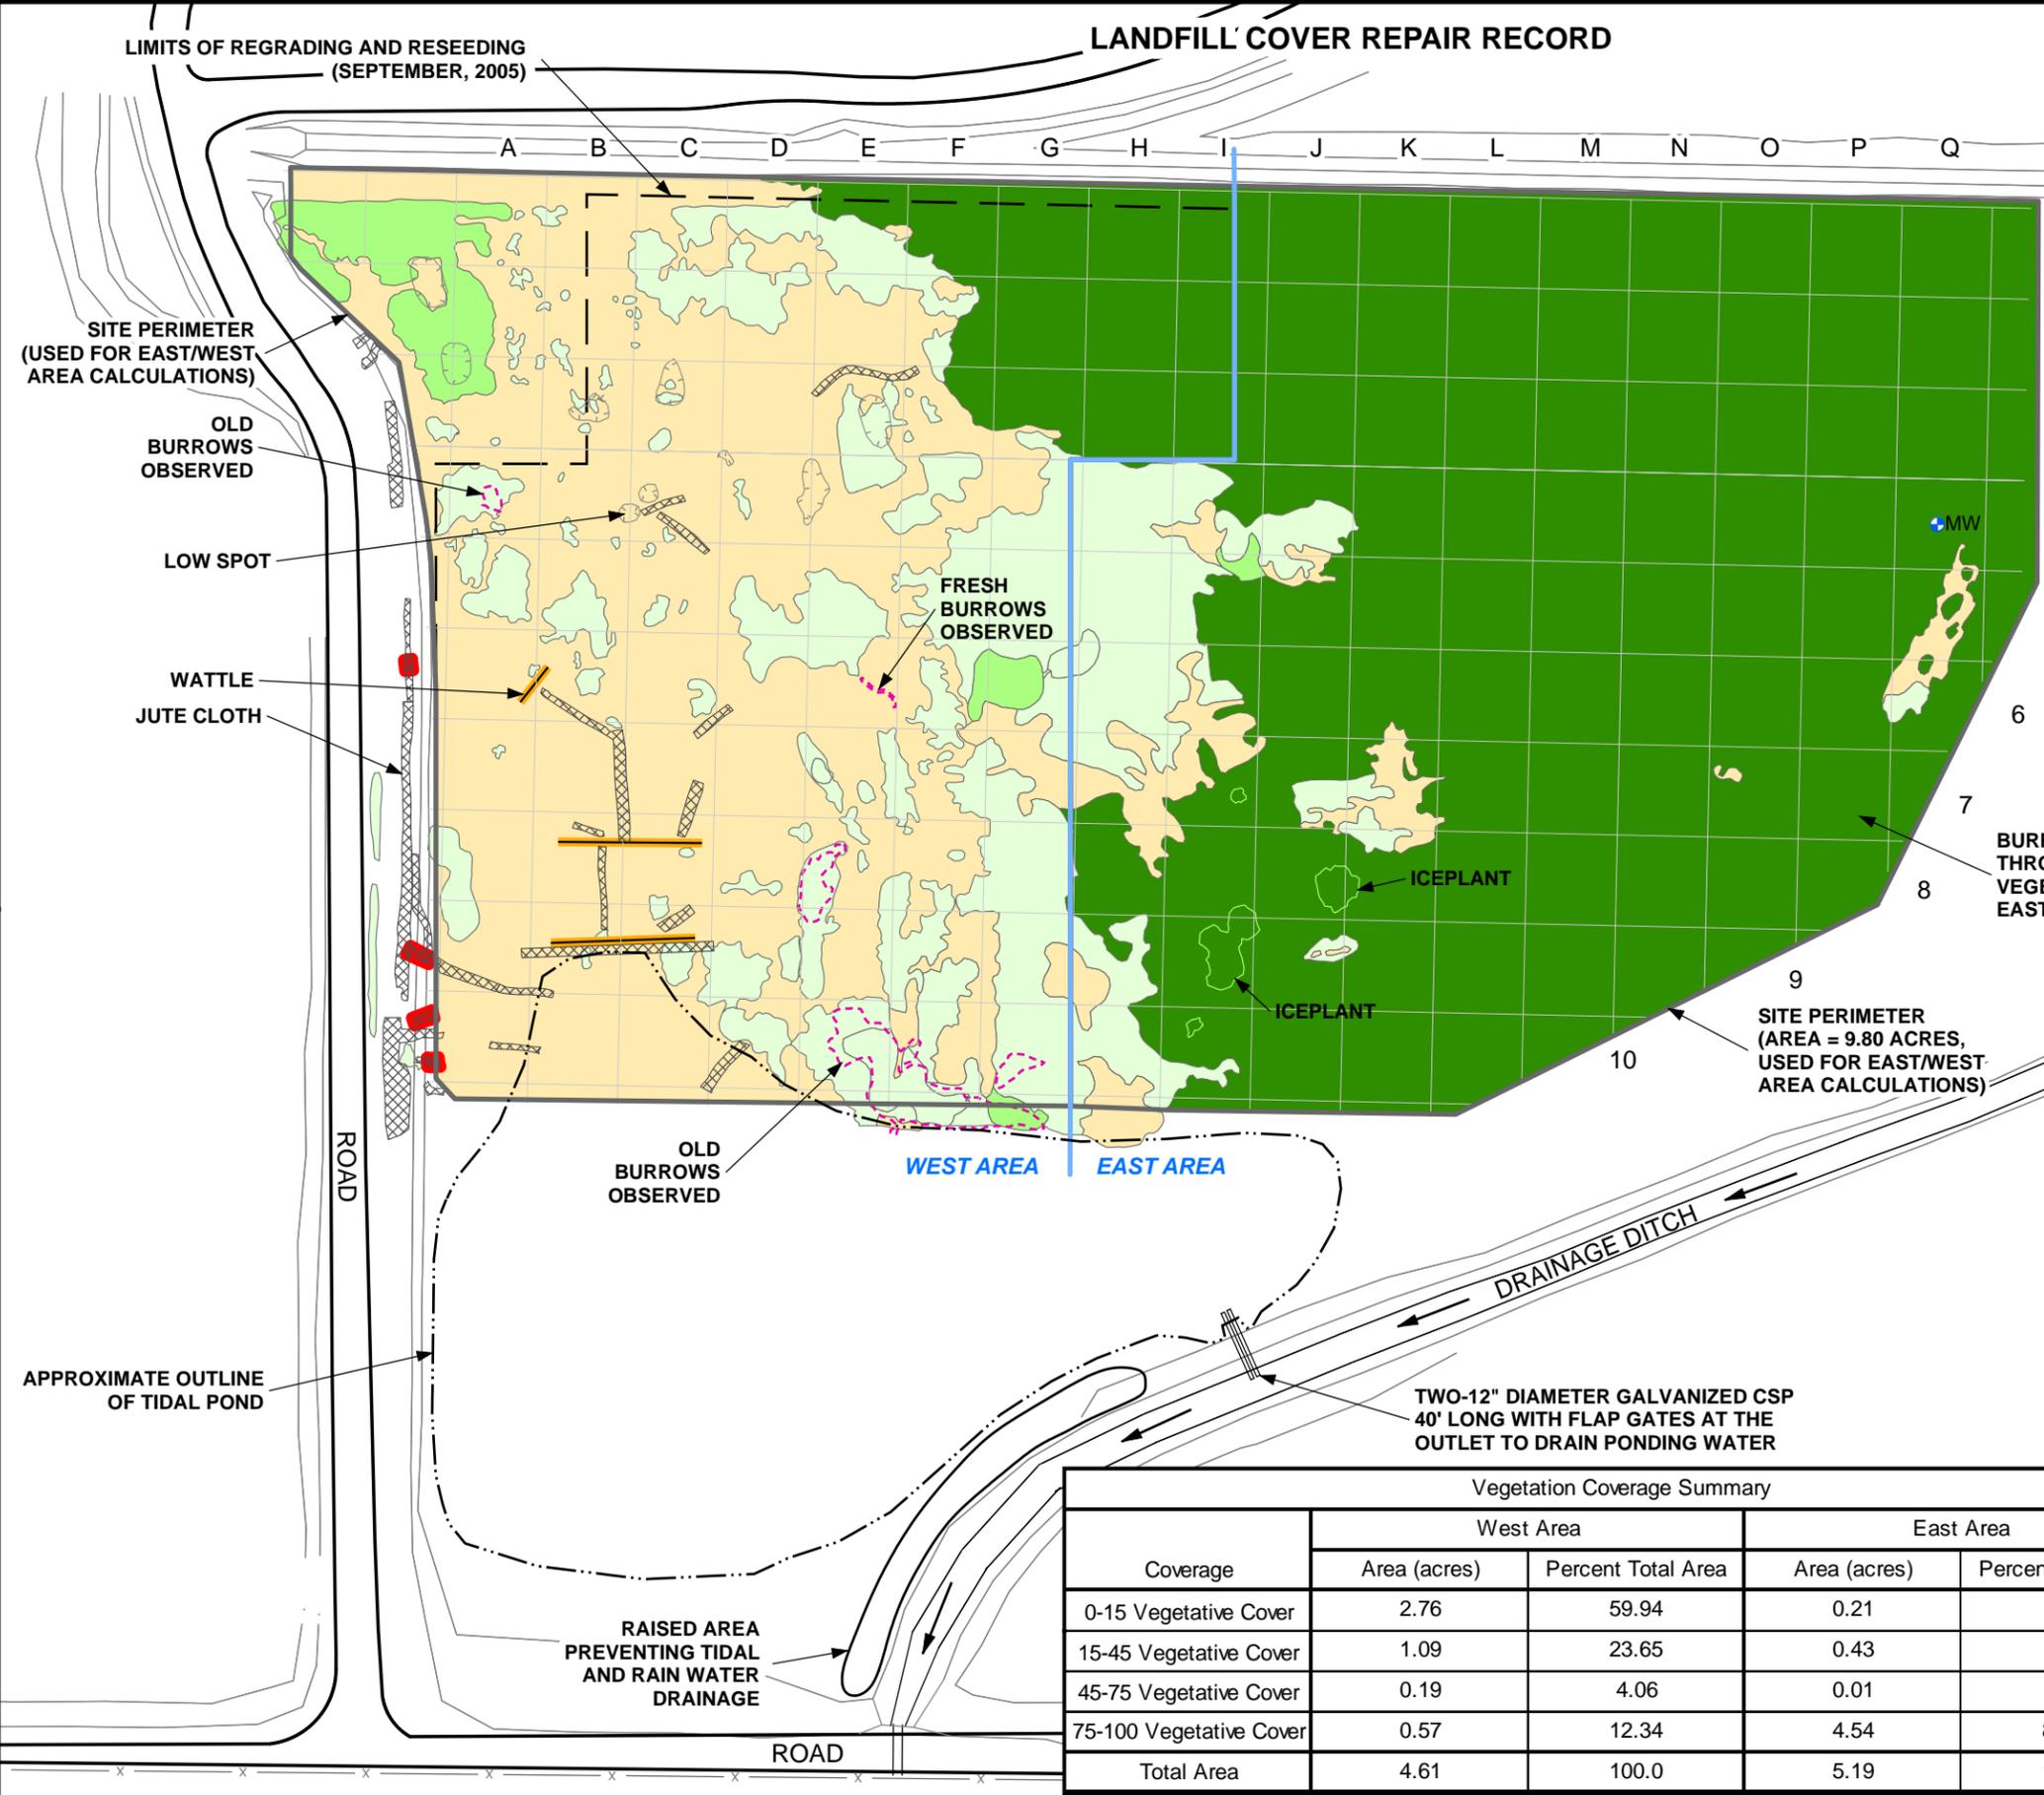
BURROWS OBSERVED THROUGHOUT THE 75-100% VEGETATION IN THE EAST AREA

- JUTE CLOTH GROUNDCOVER ADDED

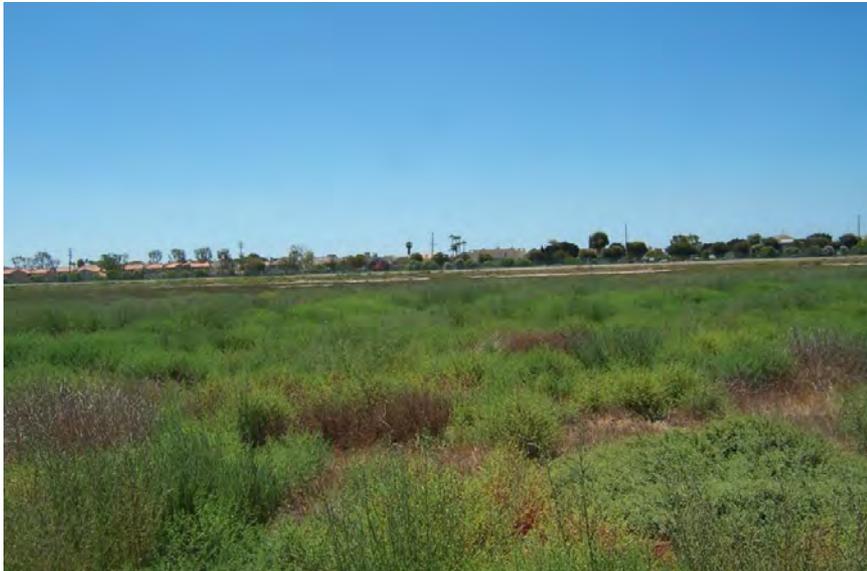
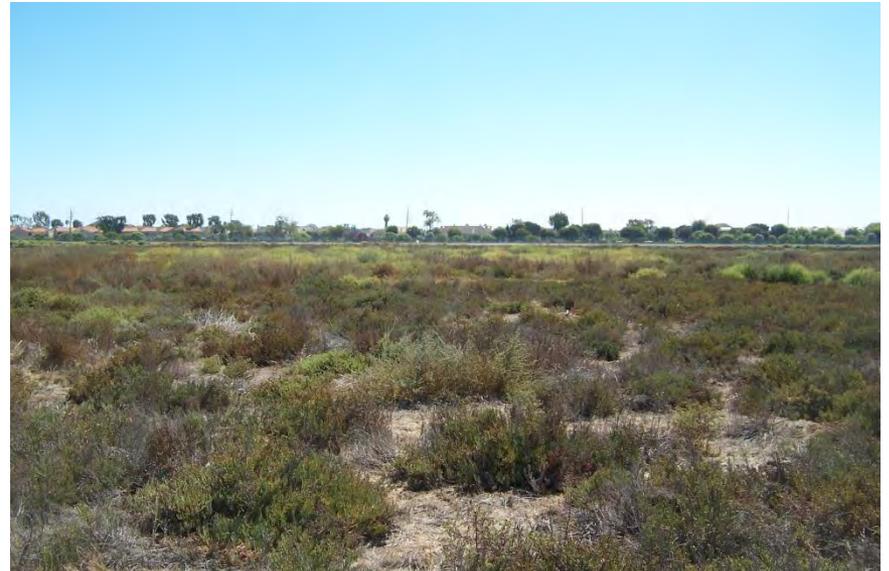
Compared with Post-Rain Season Inspection. Looking south from north-central area of the landfill.
Photo shows 75-100% vegetation coverage in eastern 2/3rds of landfill cover.

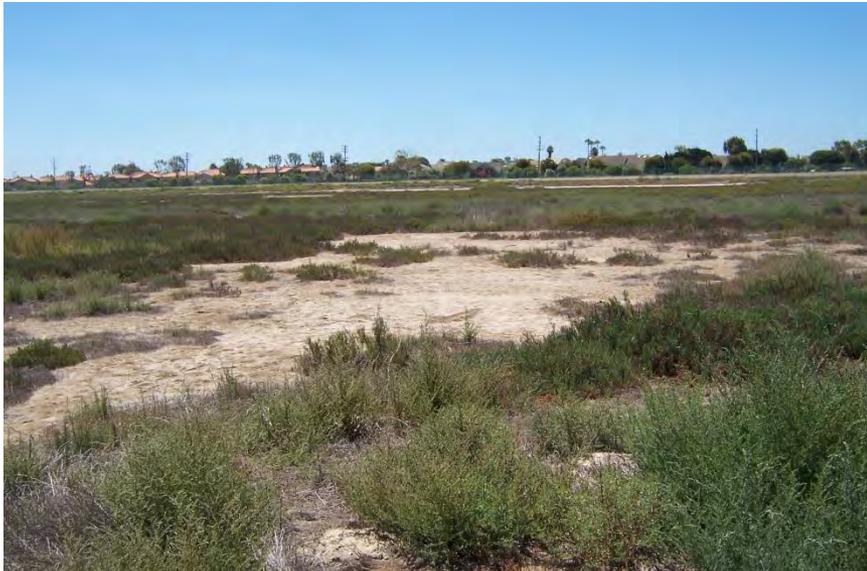
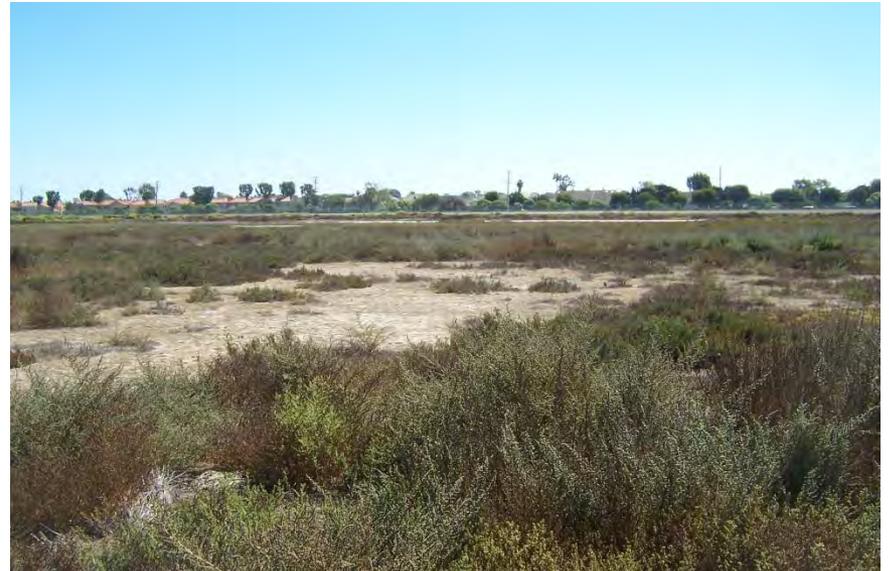
Photo 2: September 30, 2014 Pre-Rain Season Inspection

Compared with Post-Rain Season Inspection. Looking south from central portion of the landfill cover.
Small bare patch near middle of site.

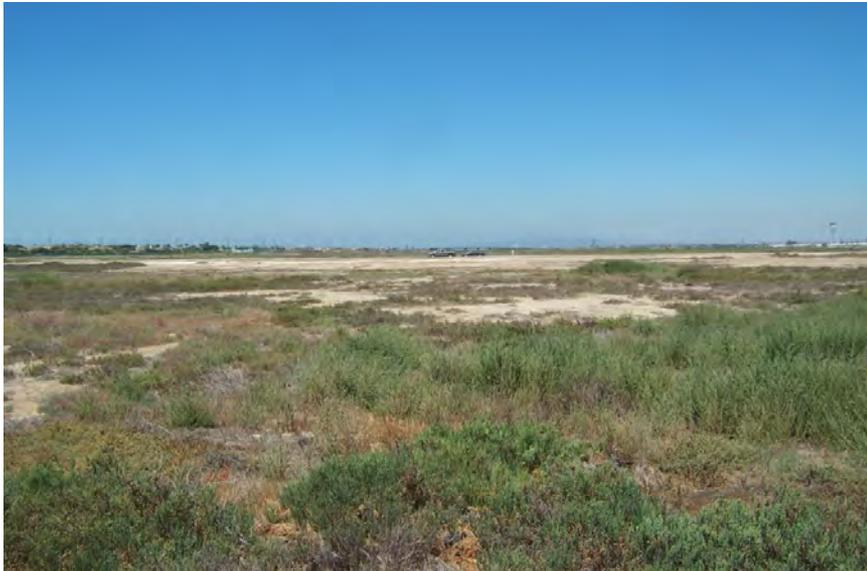
Photo 3: September 30, 2014 Pre-Rain Season Inspection

Compared with Post-Rain Season Inspection. Looking west from central portion of the landfill.
Typical view west of center of site – low groundcover, occasional shrub, bare areas in the western 1/3rd of the landfill in the distance.

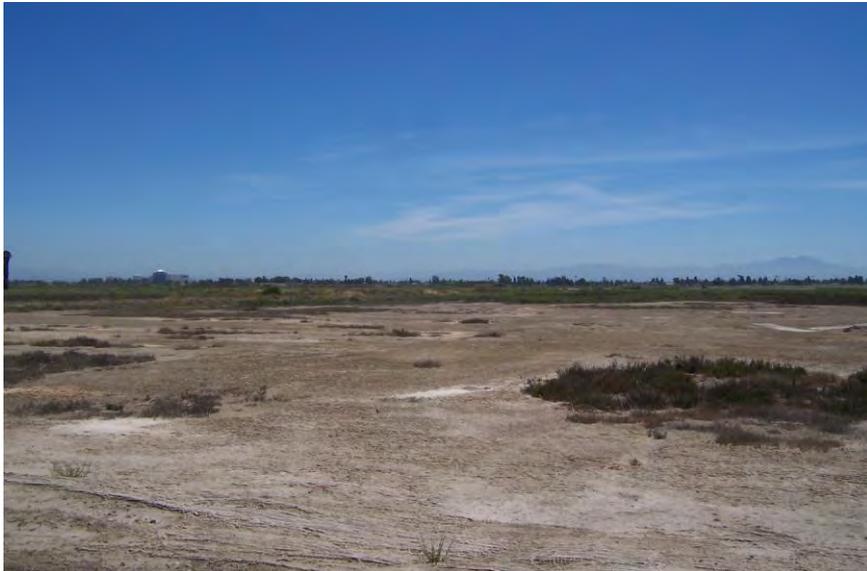
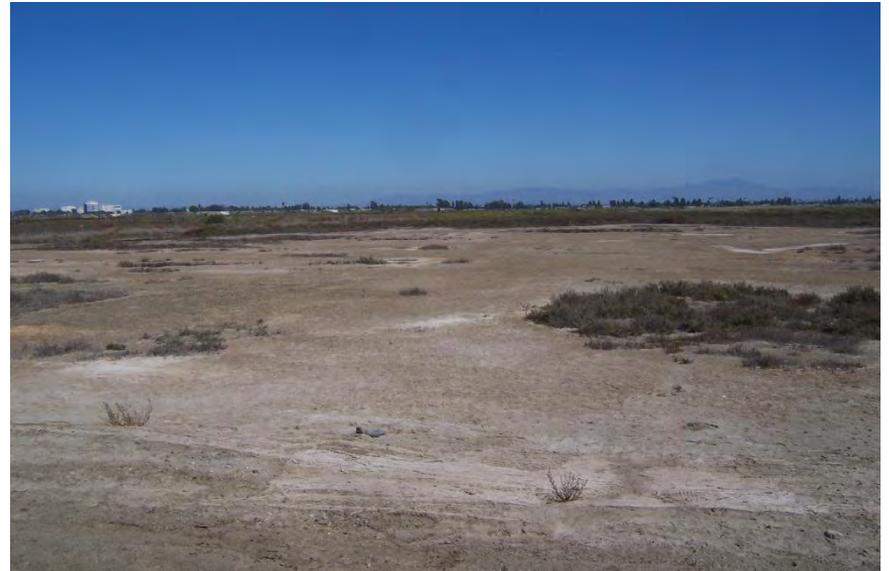
Compared with Post-Rain Season Inspection. Looking east, from the northern portion of the west edge of the landfill. Jute mesh in the northern portion of the western 1/3rd of the landfill is visible on the right side of the photo beyond the vegetated patch. Photo shows vegetation conditions in the western portion of the landfill after a dry year.

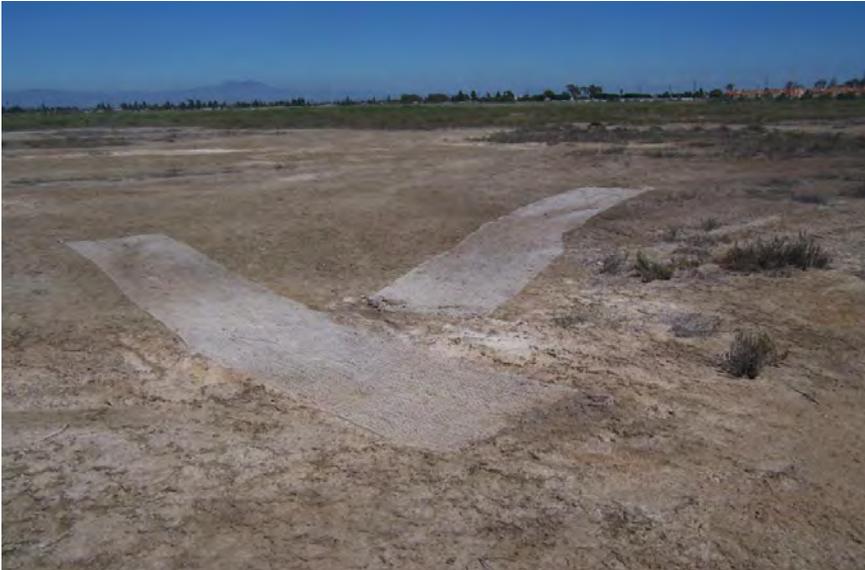
Photo 5: September 30, 2014 Pre-Rain Season Inspection

Compared with Post-Rain Season Inspection. Looking southeast at two 25 foot sections of jute mesh installed in the north portion of the western 1/3rd of the landfill

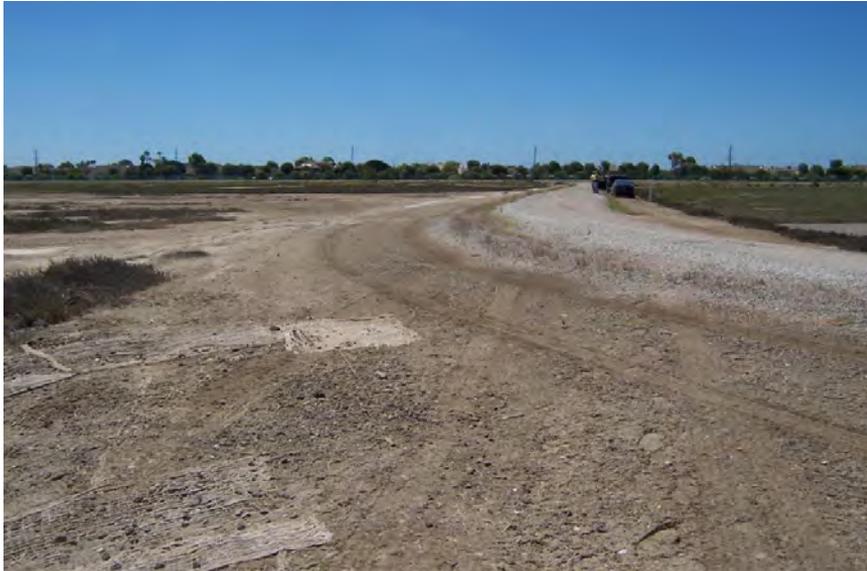
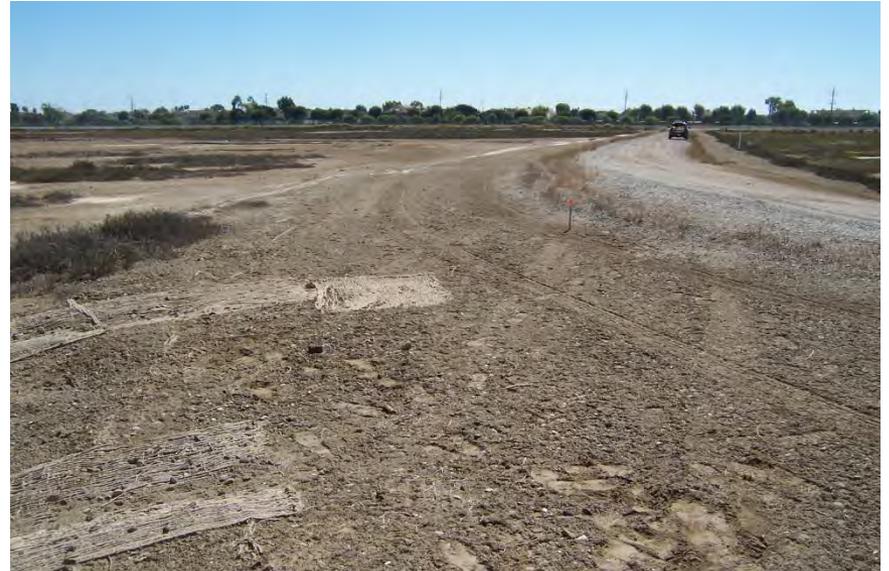
Compared with Post-Rain Season Inspection. Looking south from northwestern corner of landfill cover, adjacent to access road. Photo shows areas of vegetation cover and condition of access road.

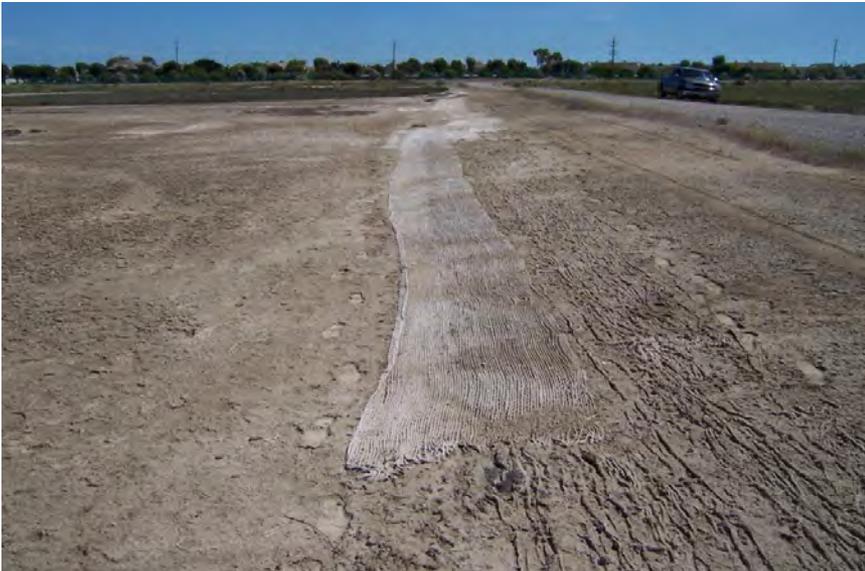
Photo 7: September 30, 2014 Pre-Rain Season Inspection

Compared with Post-Rain Season Inspection. Looking south along central portion of west edge of landfill at a 100 foot section of jute mesh installed on the slope parallel to the access road.

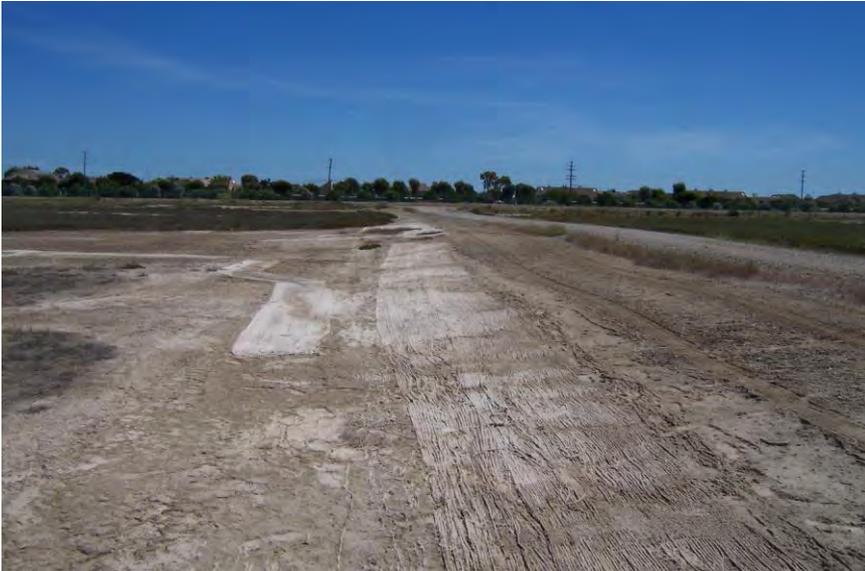
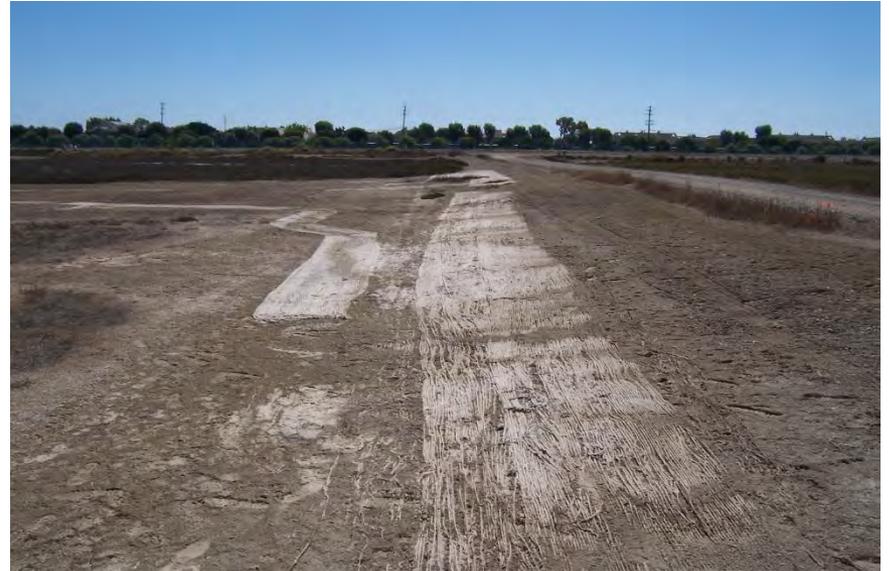
Compared with Post-Rain Season Inspection. Looking south along southern portion of west edge of landfill cover. Photo shows condition of jute mesh and access road.

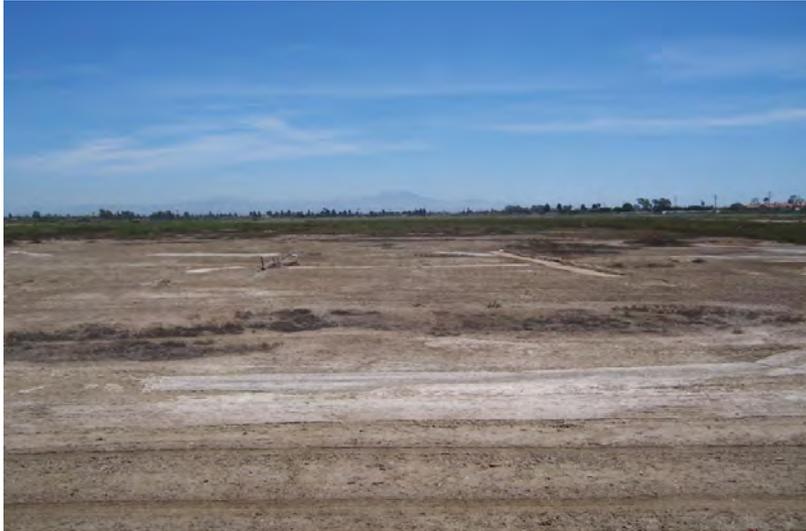
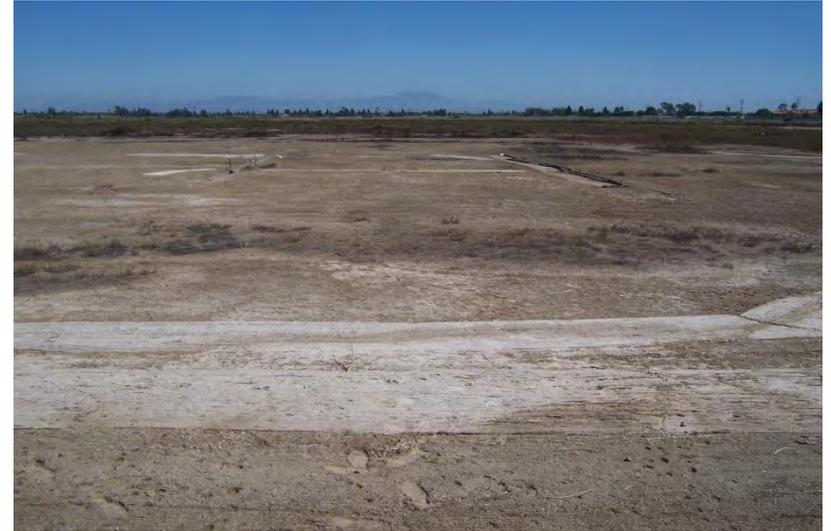
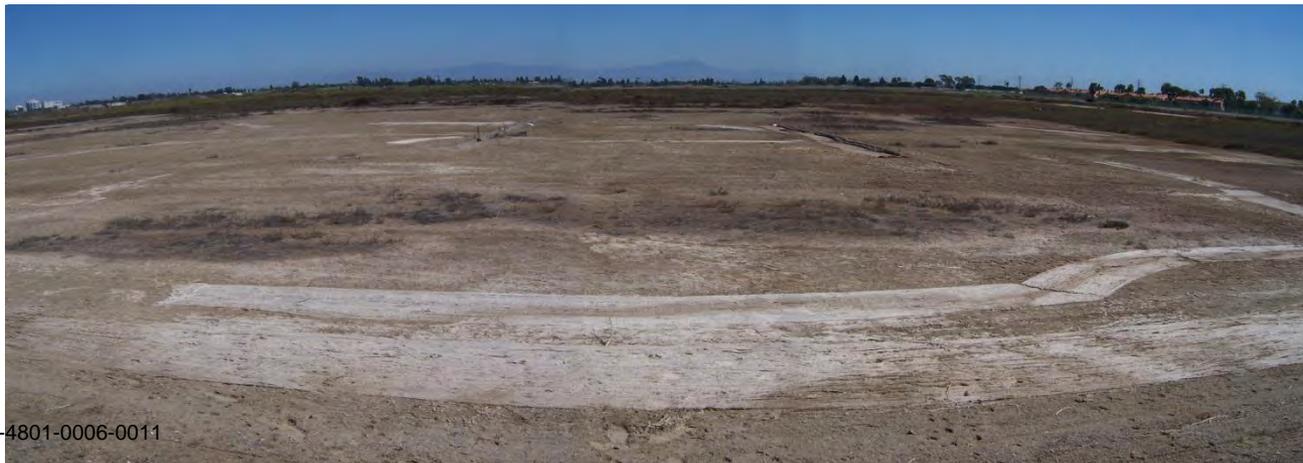
Photo 9: September 30, 2014 Pre-Rain Season Inspection

Compared with Post-Rain Season Inspection. Looking east from the south portion of west edge of landfill cover. Photo shows central and southern wattles and jute mesh. Note established vegetation in foreground is thinner after the dry summer.

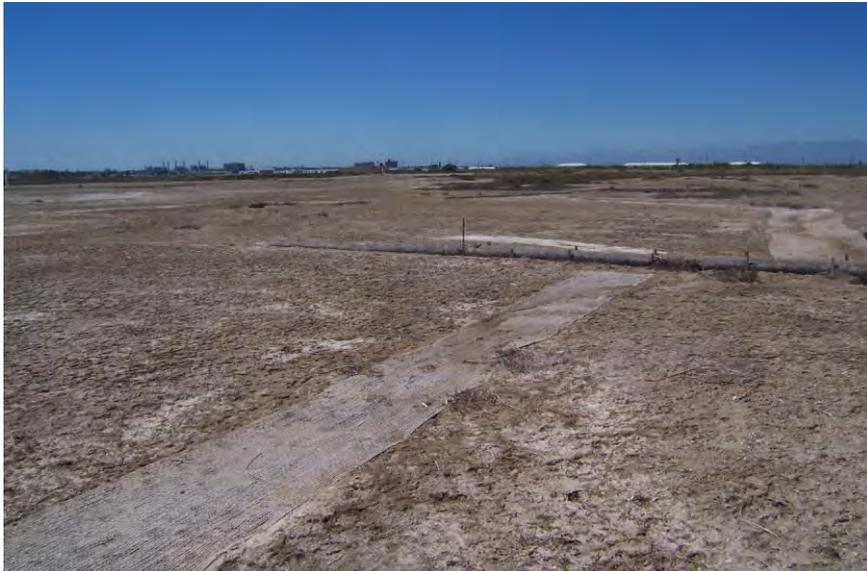
Photo 10: September 30, 2014 Pre-Rain Season Inspection

Compared with Post-Rain Season Inspection. Looking northwest at 30 foot section of jute mesh installed between central and southern sections of wattles. .

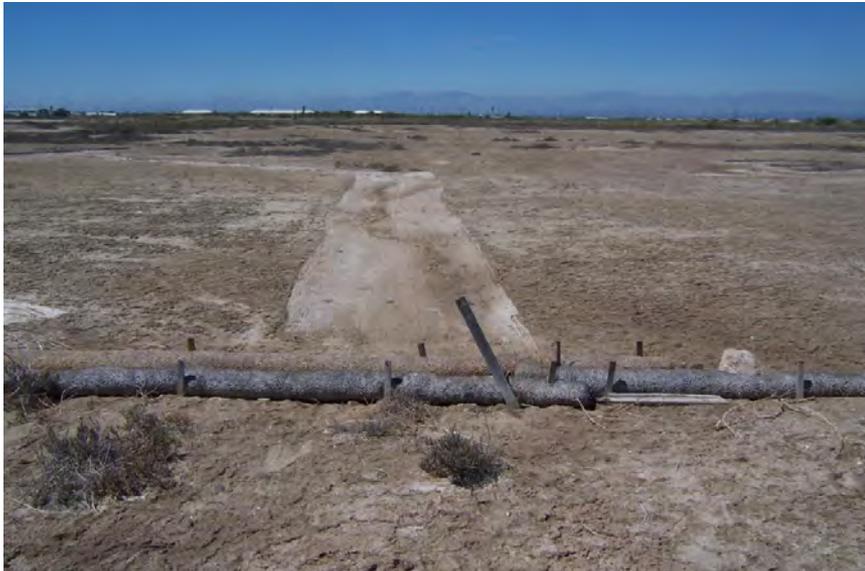
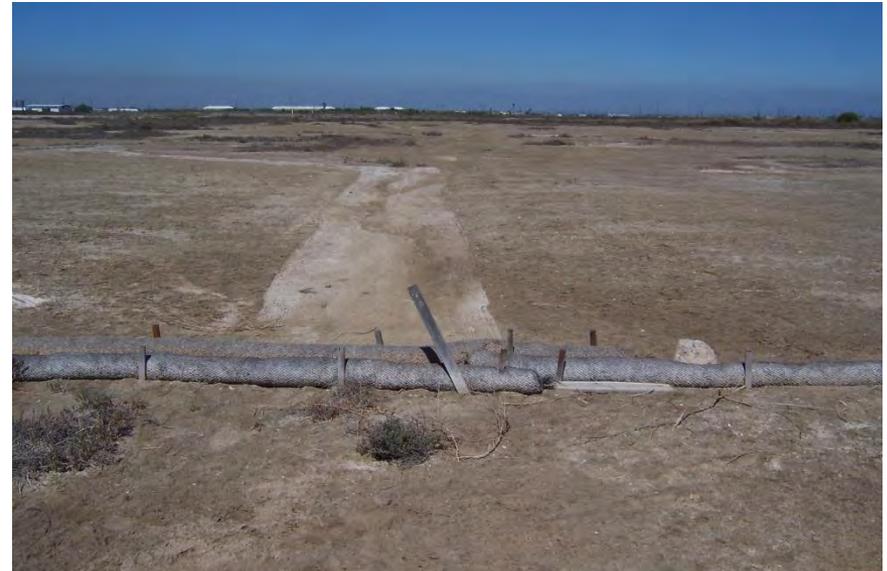
Compared with Post-Rain Season Inspection. Looking north, past the central straw wattle, in the direction of the west section of jute mesh. Photo shows the condition of the wattle, jute mesh, and the sheet flow drainage patterns.

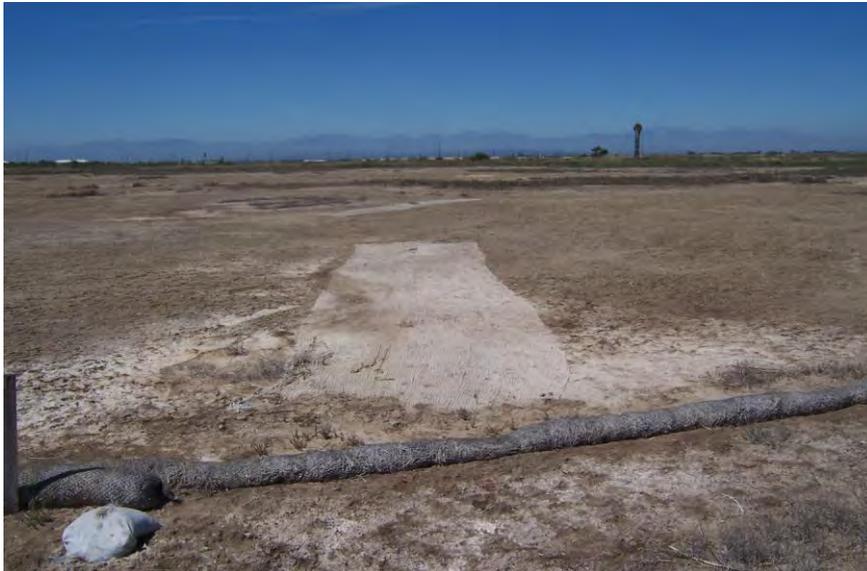
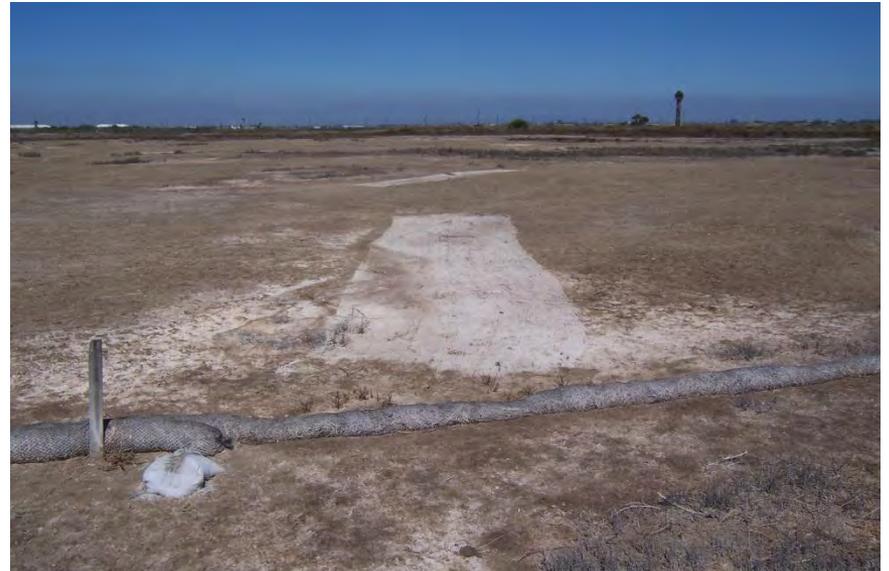
Photo 12: September 30, 2014 Pre-Rain Season Inspection

Compared with Post-Rain Season Inspection. Looking north at east section of jute mesh located north of the central straw wattle.

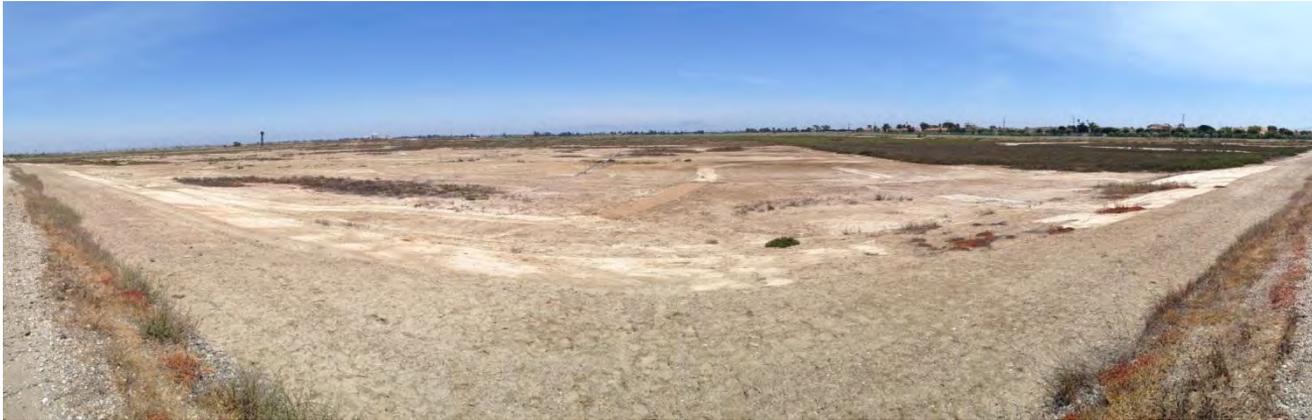
Photo 13: September 30, 2014 Pre-Rain Season Inspection

Compared with Post-Rain Season Inspection. Looking east from south portion of west edge of the landfill cover.
Photo shows western 1/3rd of the landfill cover.

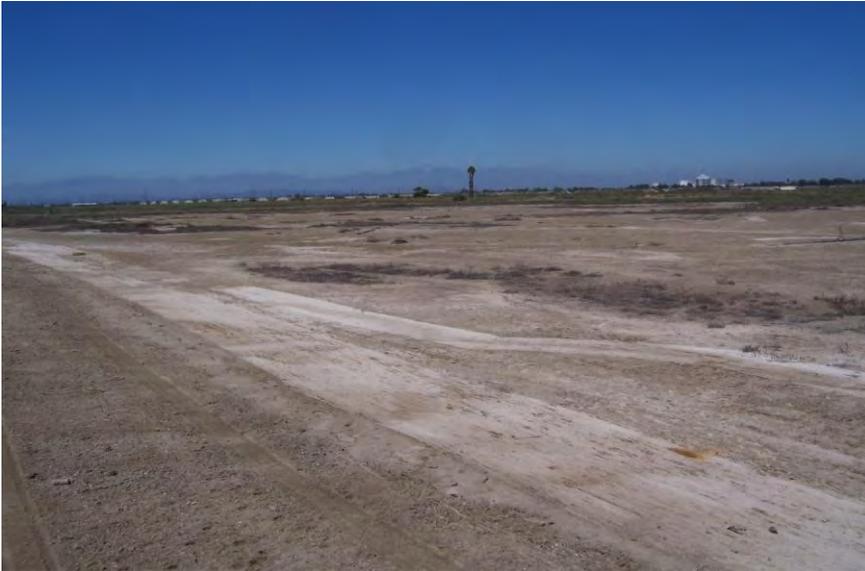
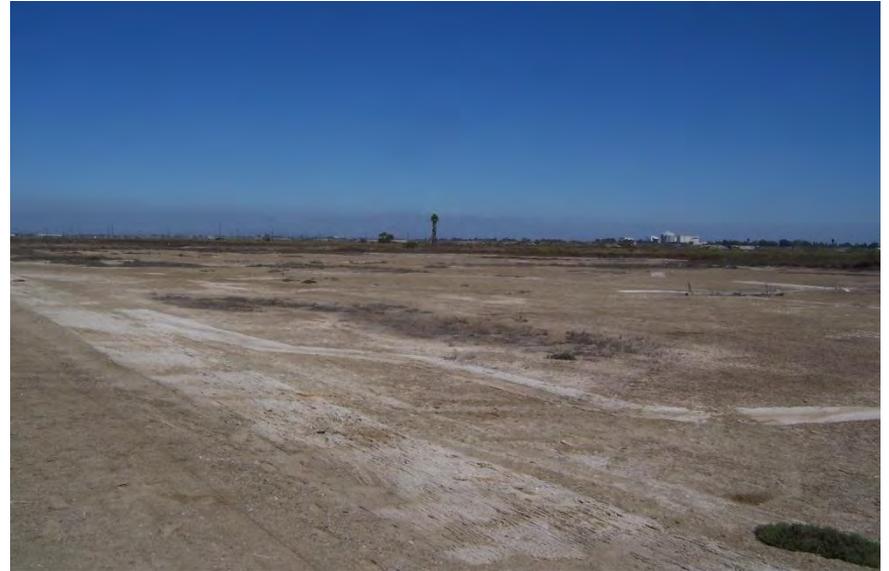
Compared with Post-Rain Season Inspection. Looking northeast from south portion of west edge of landfill cover. Photo shows condition of jute mesh.

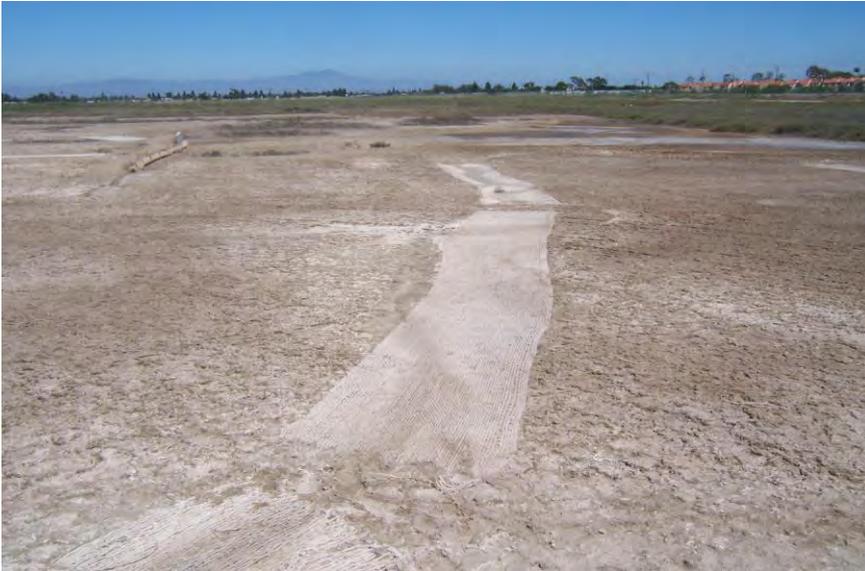
Photo 15: September 30, 2014 Pre-Rain Season Inspection

Compared with Post-Rain Season Inspection. Looking east, along the southern edge of the landfill cover.
July 2014 photo shows damp soils in the distance in the area adjacent to the tidal pond.

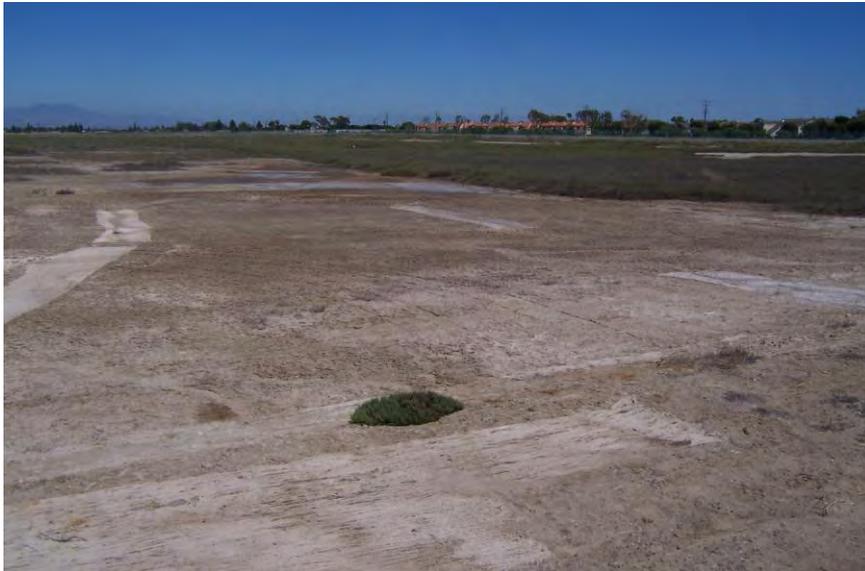
Compared with Post-Rain Season Inspection. Looking southeast, along the southern edge of the landfill cover.
July 2014 photo shows damp soils in the distance in the area adjacent to the tidal pond.
No damp soils were observed in this area during the September 2014 Inspection.

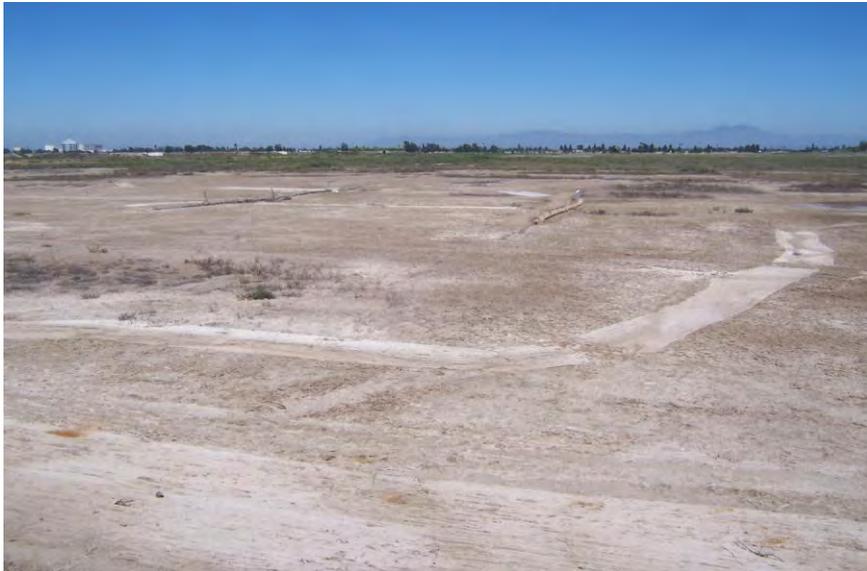
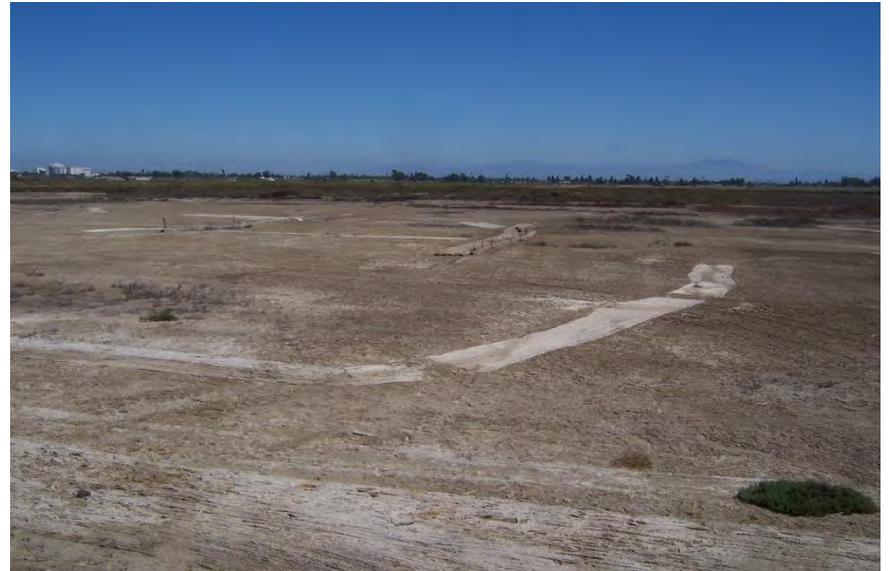
Compared with Post-Rain Season Inspection. Looking northeast, from the southwest corner of the landfill. Photo shows jute mesh, wattles, and vegetation conditions in the western portion of the landfill after a dry winter.

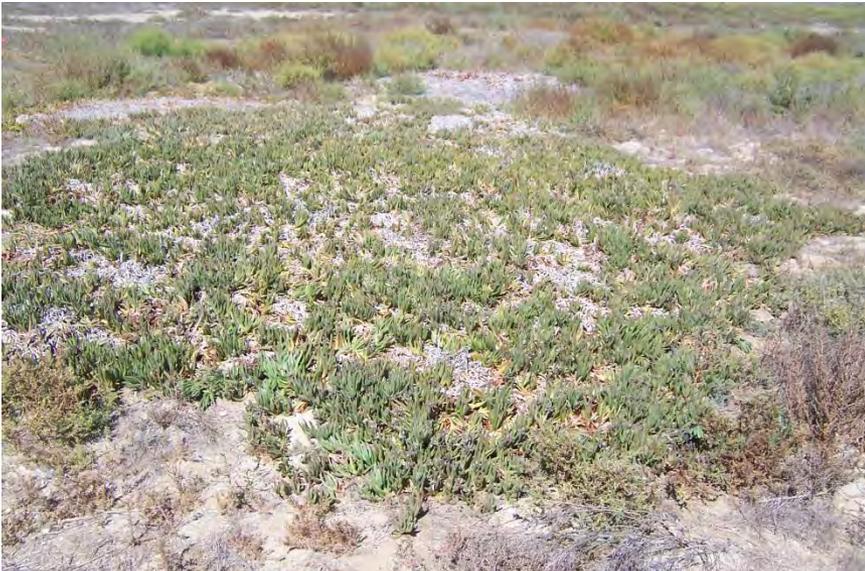
Western Patch

Photo 18: September 30, 2014 Pre-Rain Season Inspection
Iceplant patches in south-central portion of landfill after a dry year.
