**FALL 2014 AND WINTER 2015
ANNUAL POST-CLOSURE INSPECTION AND MAINTENANCE REPORT**

**INSTALLATION RESTORATION PROGRAM SITE 7 AREA 1
(FORMER STATION LANDFILL)
NAVAL WEAPONS STATION SEAL BEACH, SEAL BEACH, CALIFORNIA**

November 2015

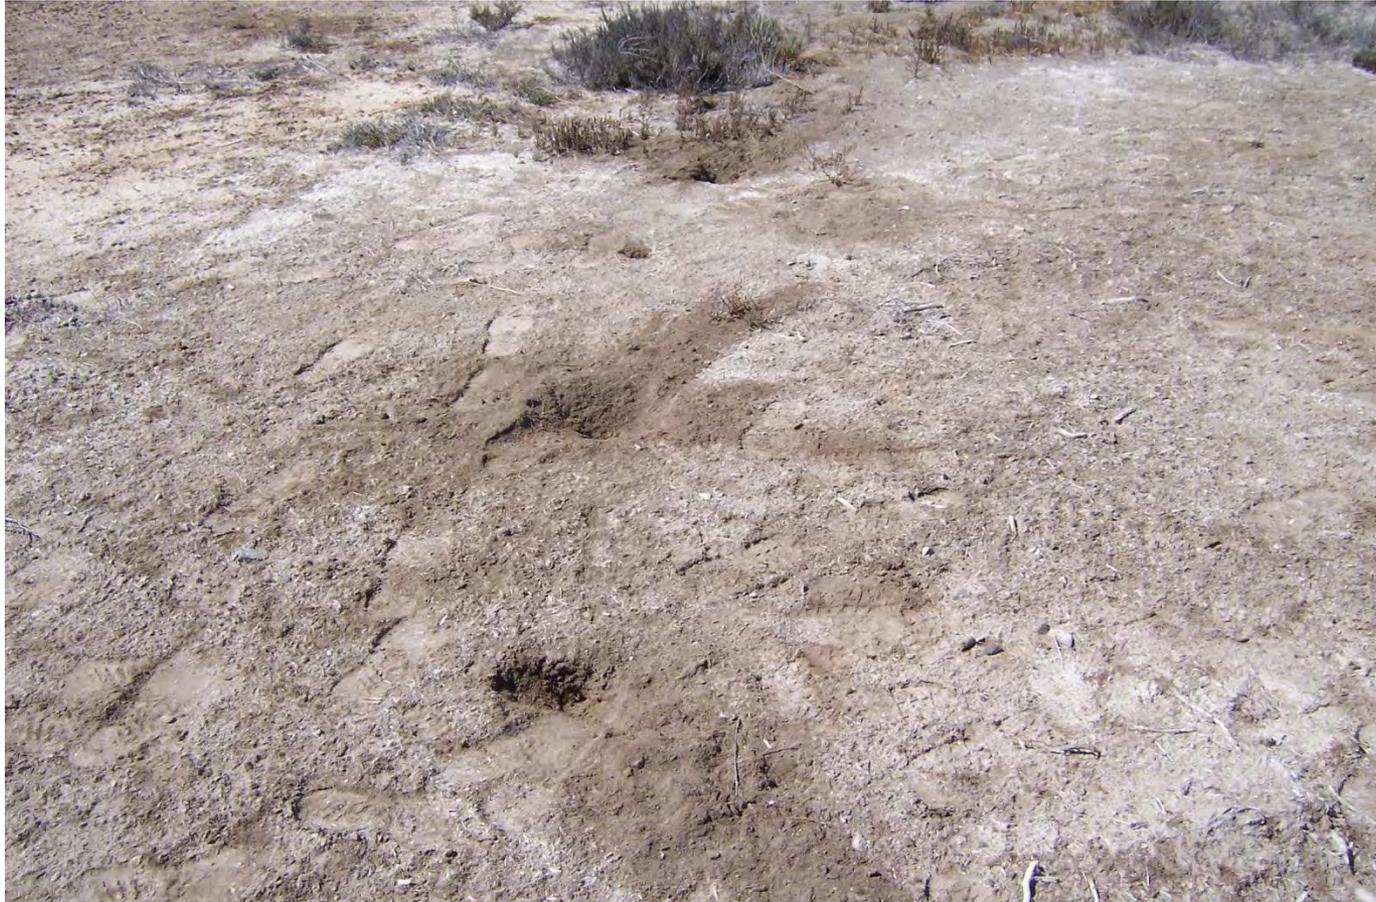
Photo 19: September 30, 2014 Pre-Rain Season Inspection
Fresh burrows observed in central portion of western 1/3rd of landfill.

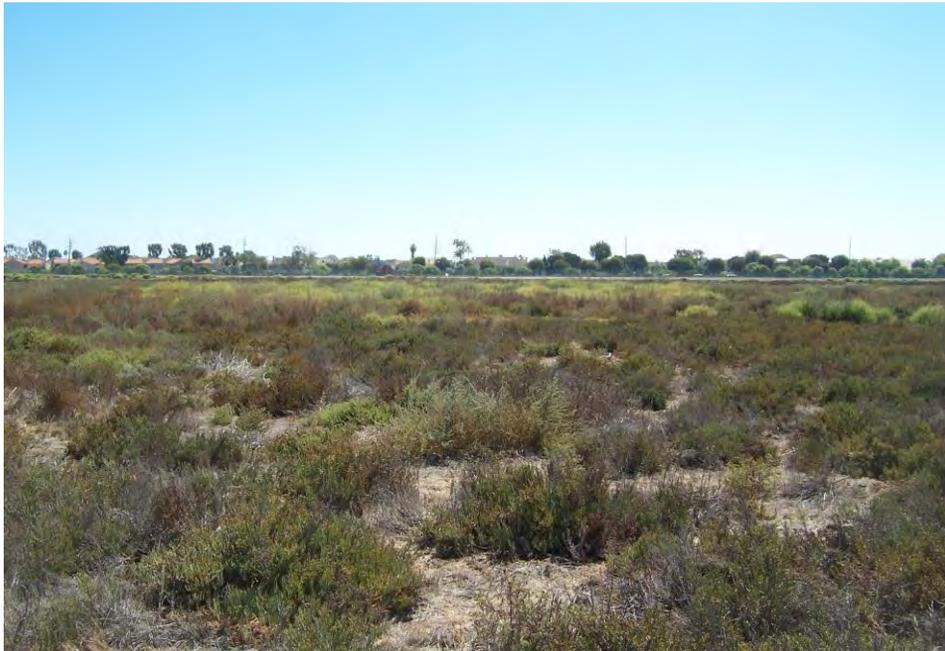
Compared with Pre-Rain Season Inspection. Looking south from north-central area of the landfill.
Photo shows 75-100% vegetation coverage in eastern 2/3rds of landfill cover. No ponding.

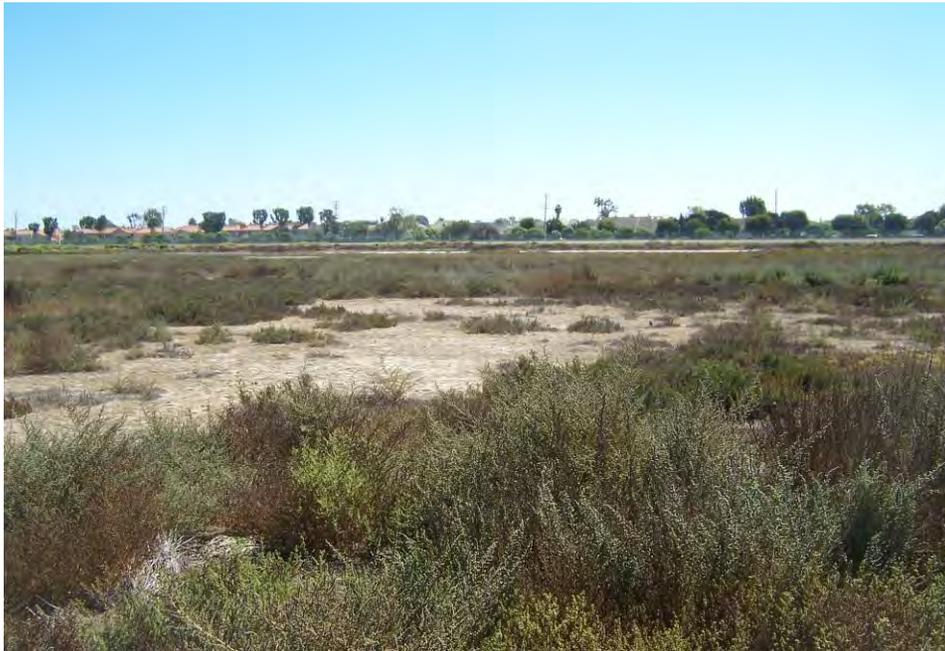
Compared with Pre-Rain Season Inspection. Looking south from central portion of the landfill cover.
Small bare patch near middle of site. No ponding.

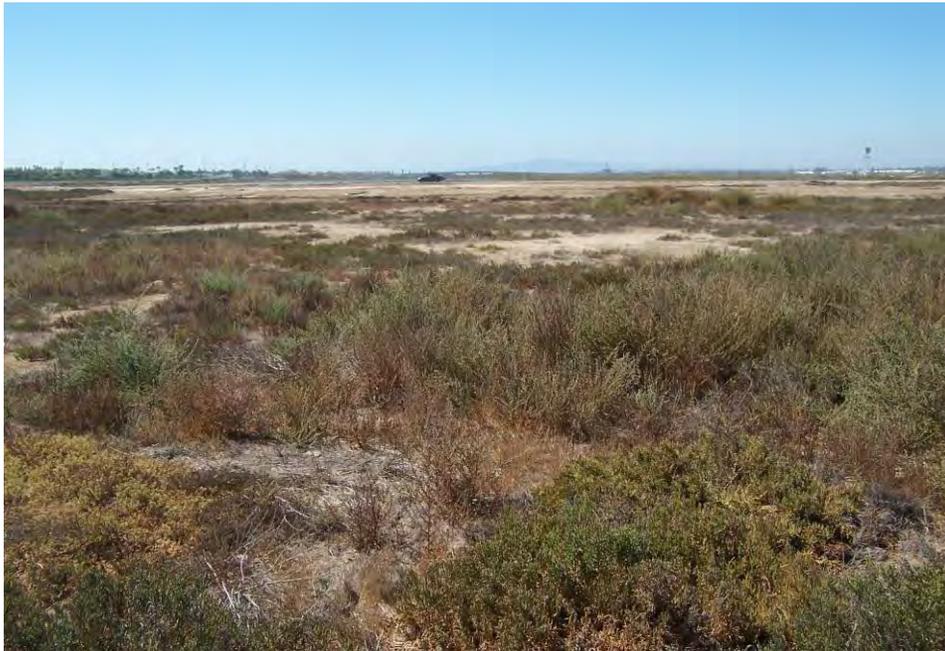
Photo 3: December 4, 2014 Post-Rain Inspection

Compared with Pre-Rain Season Inspection. Looking west from central portion of the landfill.
Typical view west of center of site – low groundcover, occasional shrub, bare areas in the western 1/3rd of the landfill in the distance. No ponding.

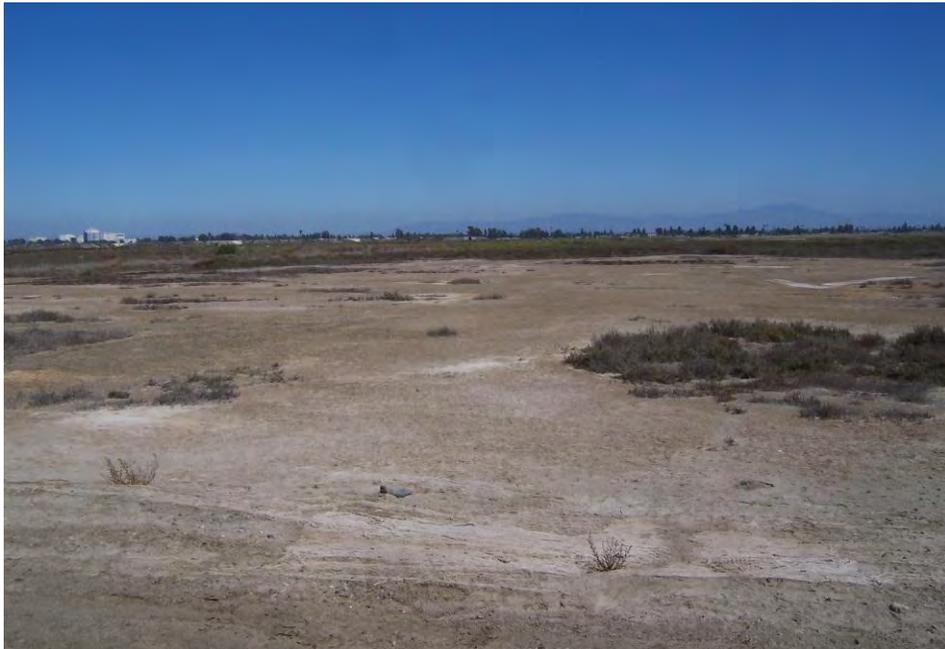
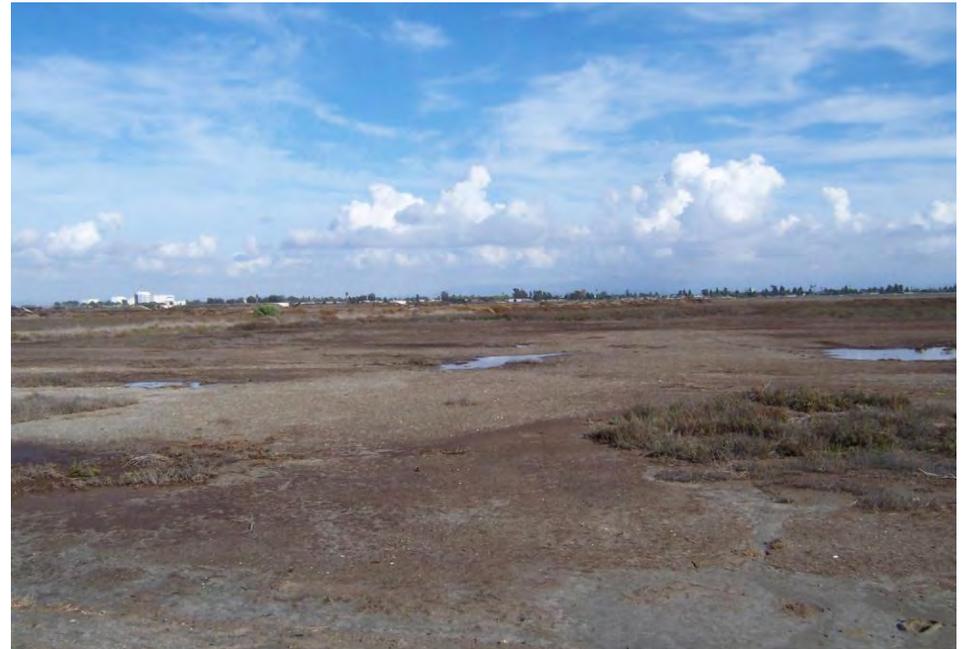
Compared with Pre-Rain Season Inspection. Looking east, from the northern portion of the west edge of the landfill. Three small ponds, including pond at location of jute mesh in the northern portion of the western 1/3rd of the landfill on the right side of the photo beyond the vegetated patch.

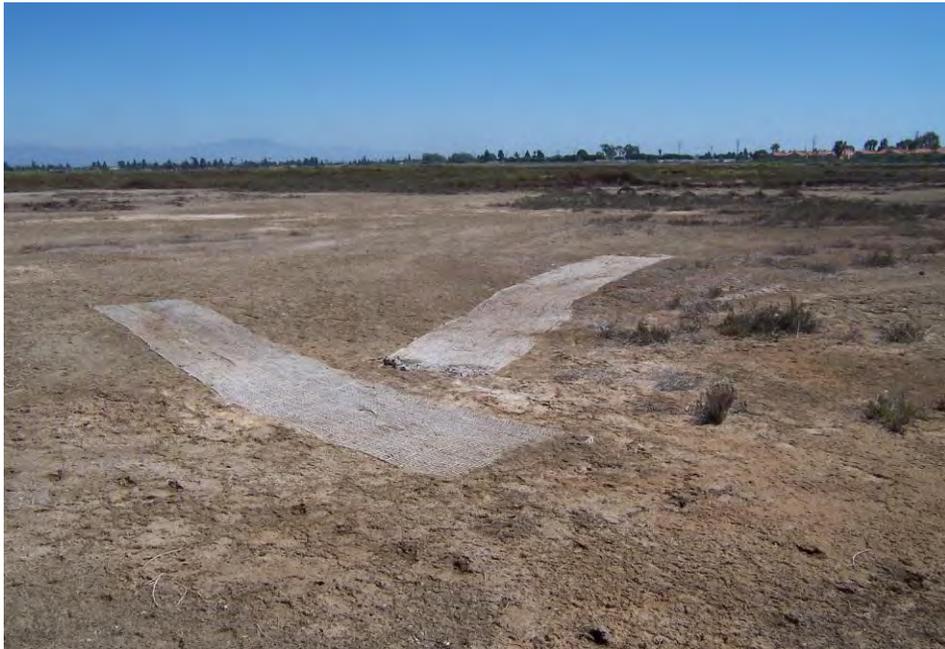
Photo 5: December 4, 2014 Post-Rain Inspection

Compared with Pre-Rain Season Inspection. Closer view of jute mesh and pond described in the previous photograph. Looking southeast at two 25 foot sections of jute mesh installed in the north portion of the western 1/3rd of the landfill.

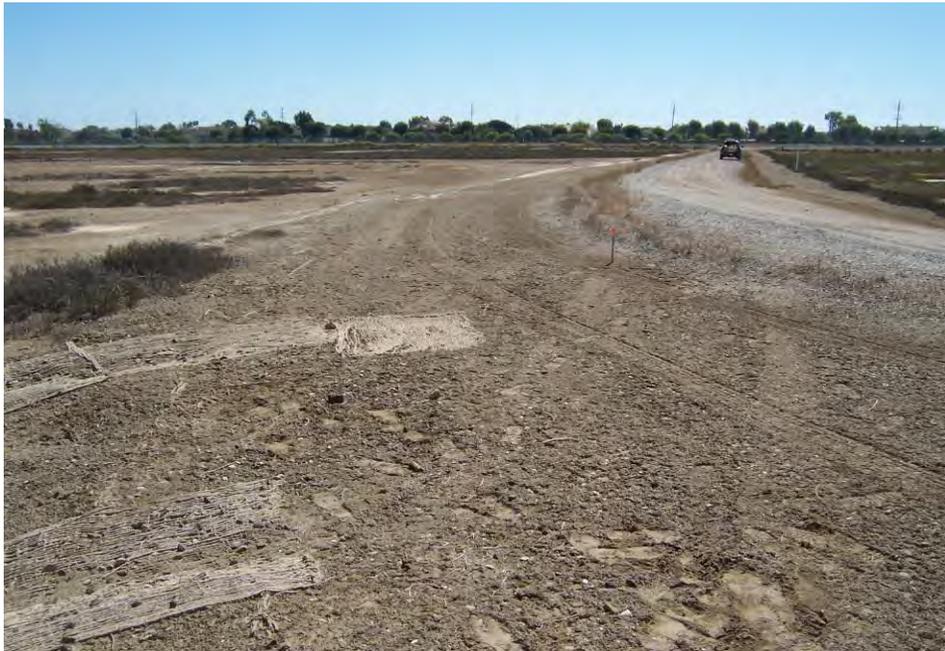
Photo 6: December 4, 2014 Post-Rain Inspection

Compared with Pre-Rain Season Inspection. Looking south from northwestern corner of landfill cover, adjacent to access road. Photo shows areas of vegetation cover and condition of access road.

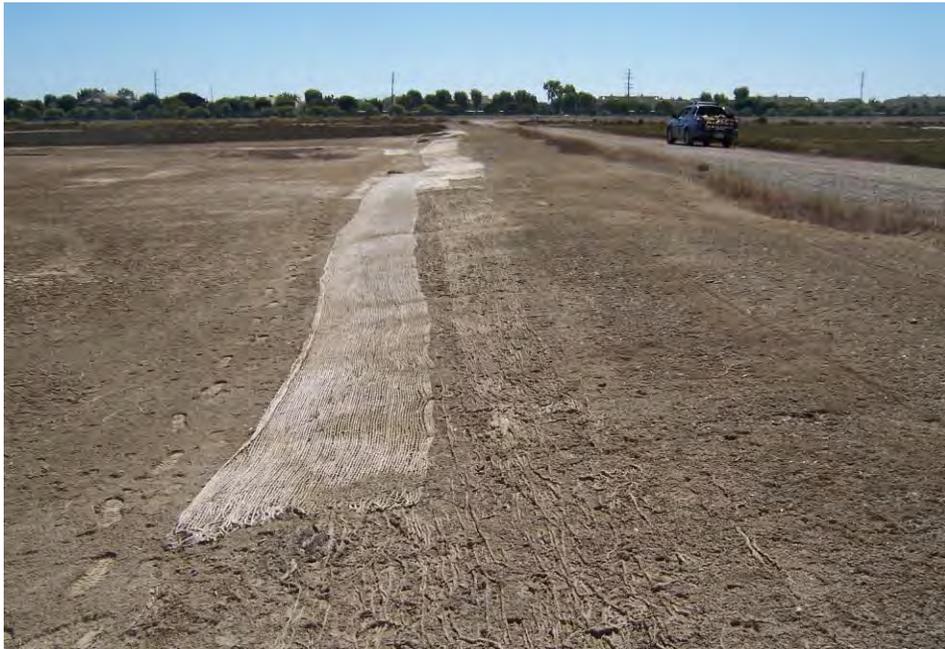
Compared with Pre-Rain Season Inspection. Looking south along central portion of west edge of landfill at a 100 foot section of jute mesh installed on the slope parallel to the access road. No new erosion or flow lines were present.

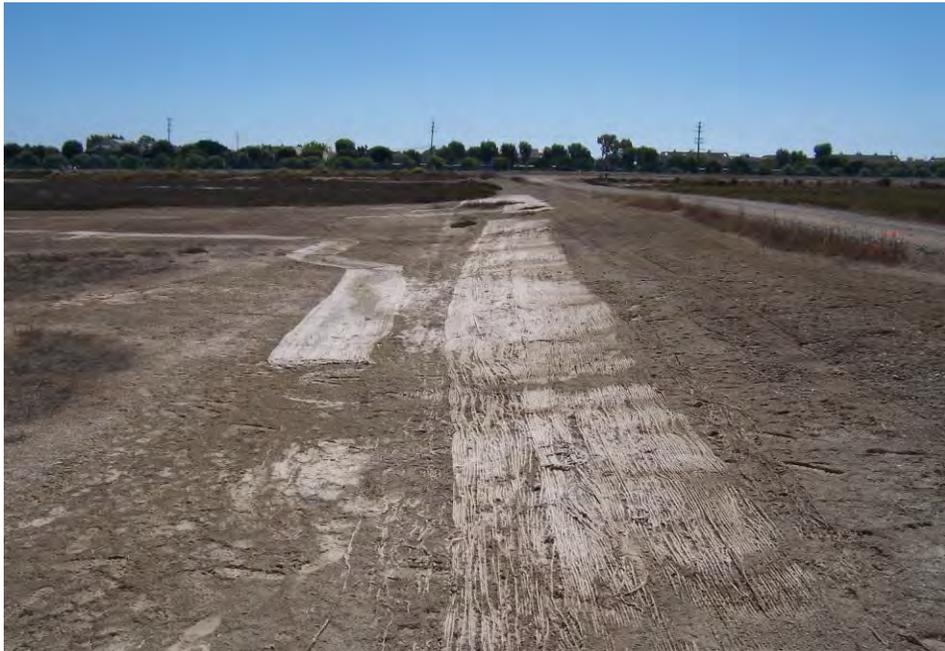
Compared with Pre-Rain Season Inspection. Looking south along southern portion of west edge of landfill cover. Photo shows condition of jute mesh and access road. No new erosion or flow lines were present.

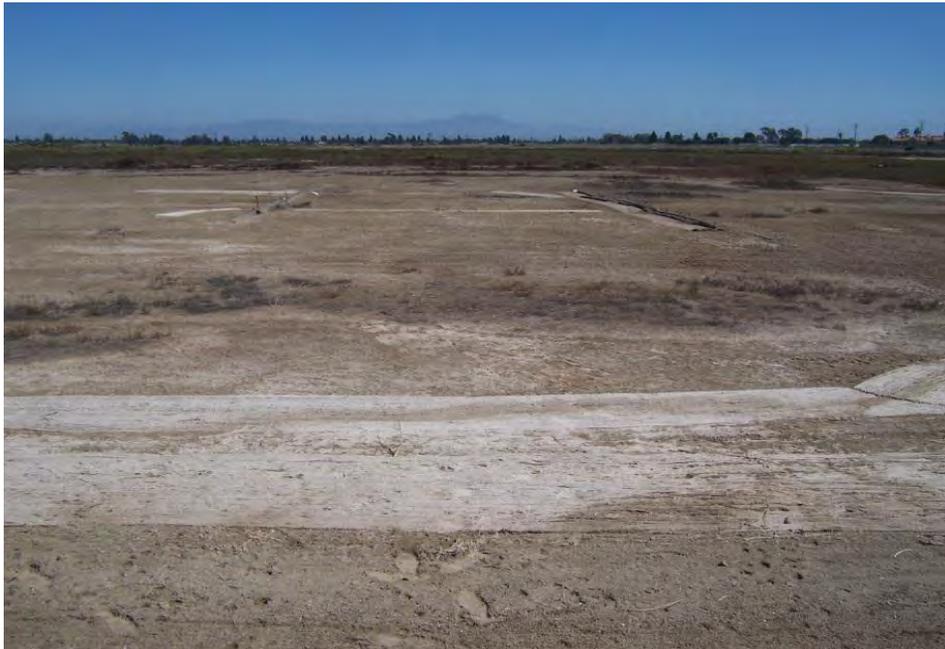
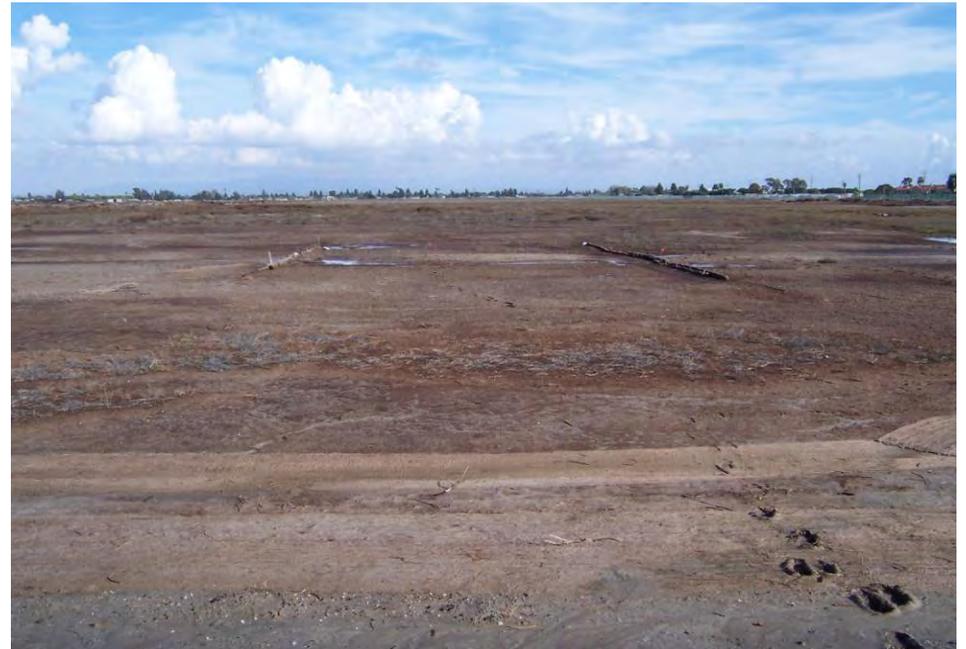
Compared with Pre-Rain Season Inspection. Looking east from the south portion of west edge of landfill cover. Photo shows central and southern wattles and jute mesh, small ponds in distance.

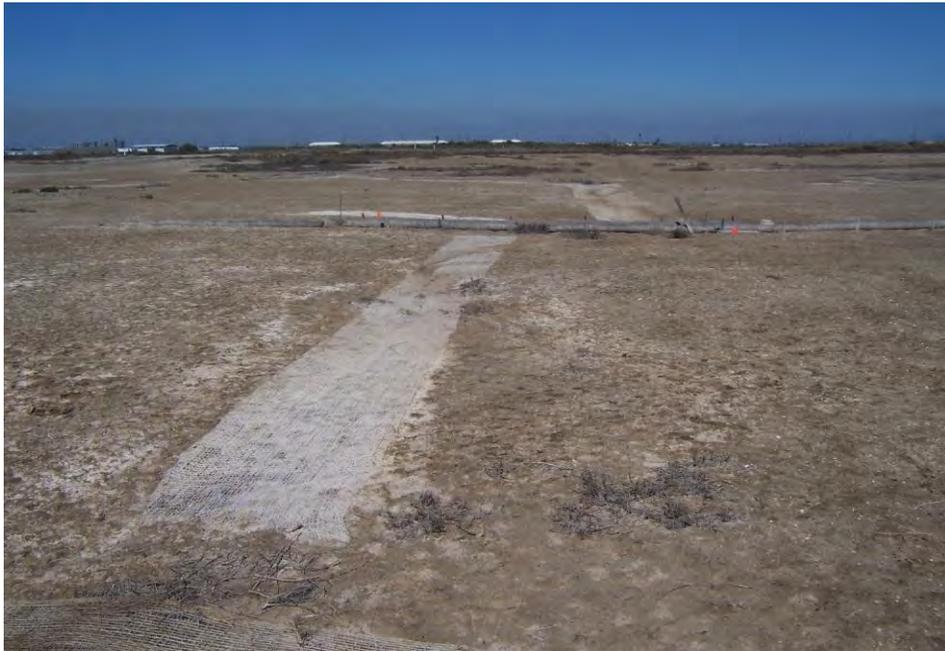
Photo 10: December 4, 2014 Post-Rain Inspection

Compared with Pre-Rain Season Inspection. Looking northwest at small pond and 30 foot section of jute mesh installed between central and southern sections of wattles.

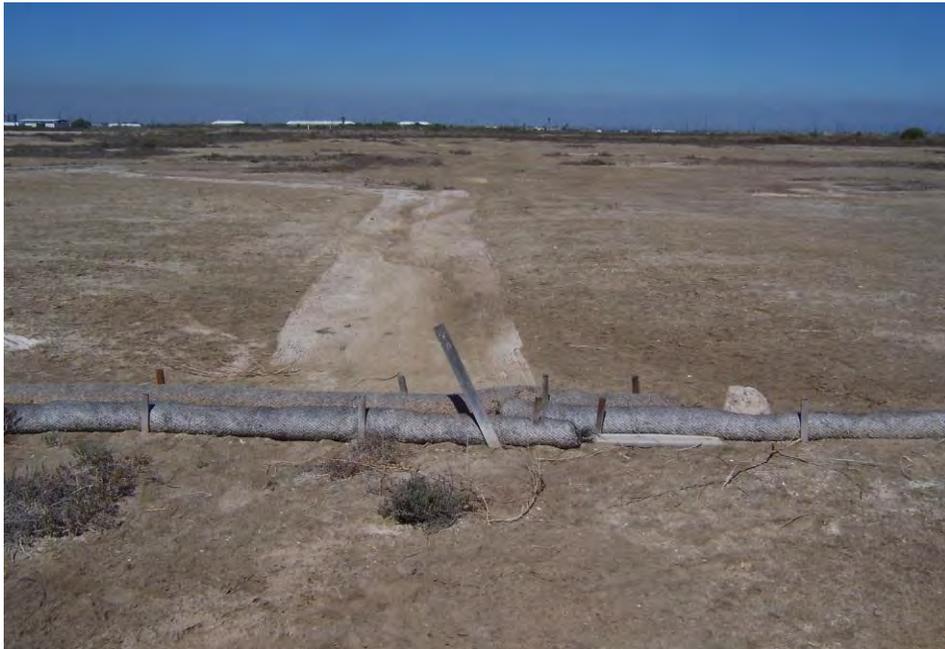
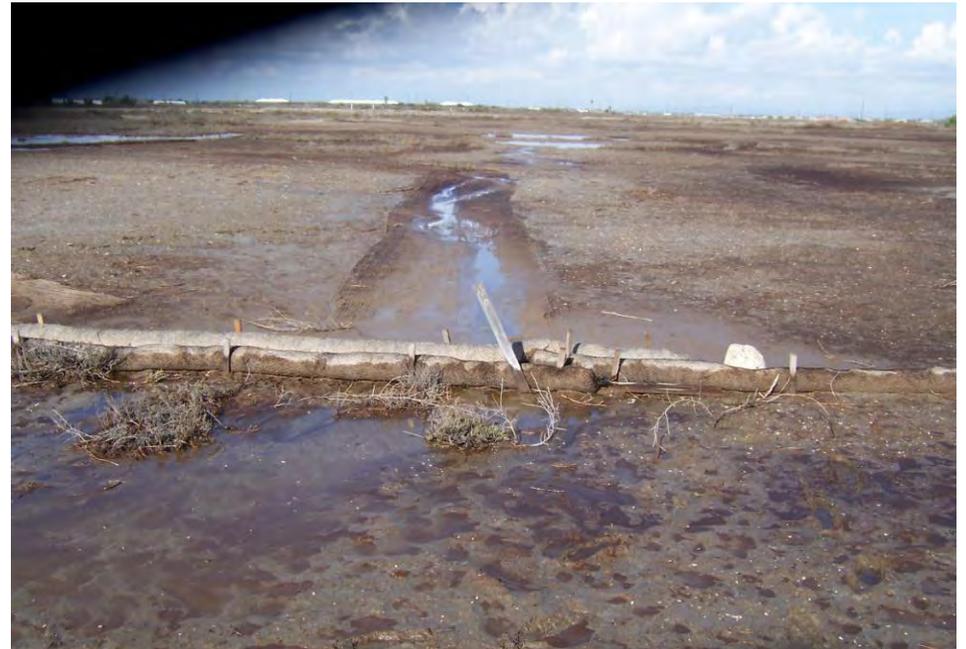
Compared with Pre-Rain Season Inspection. Looking north, past the central straw wattle, in the direction of the west section of jute mesh. Photo shows the drainage and ponding.

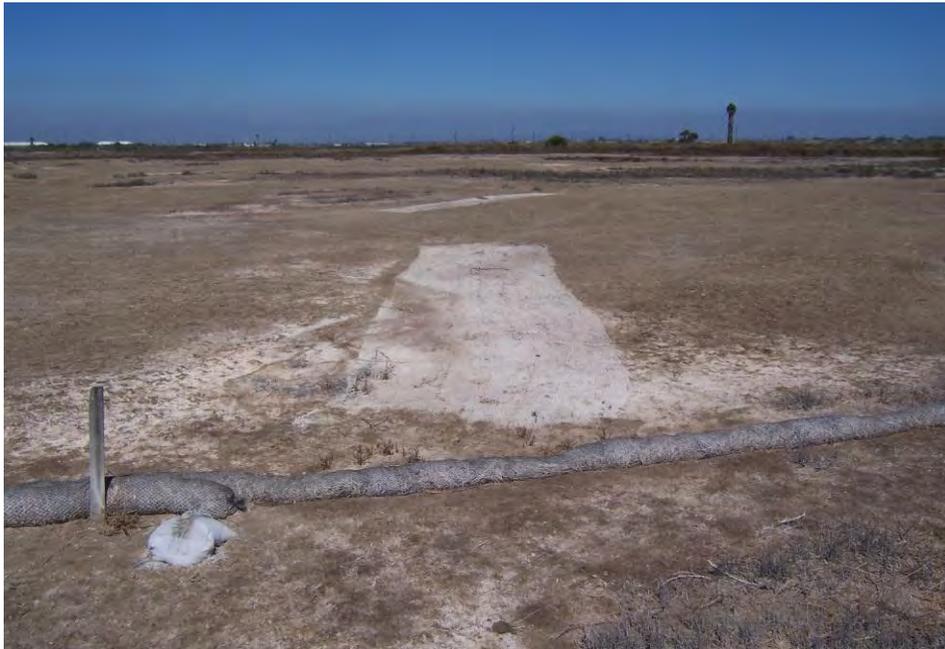
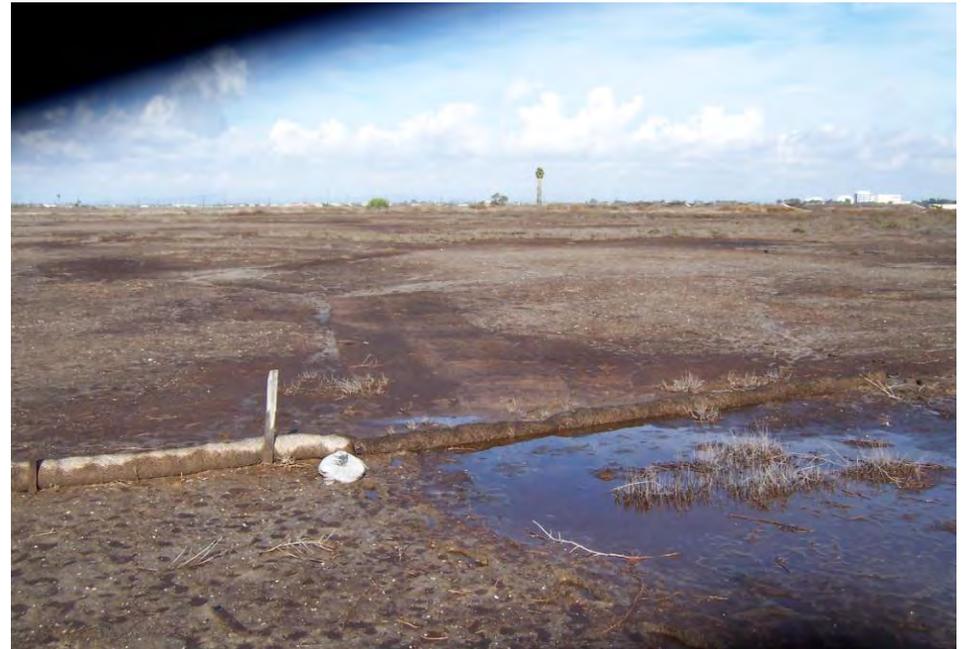
Photo 12: December 4, 2014 Post-Rain Inspection

Compared with Pre-Rain Season Inspection. Looking north at east section of jute mesh located north of the central straw wattle, and ponding south of the wattle.

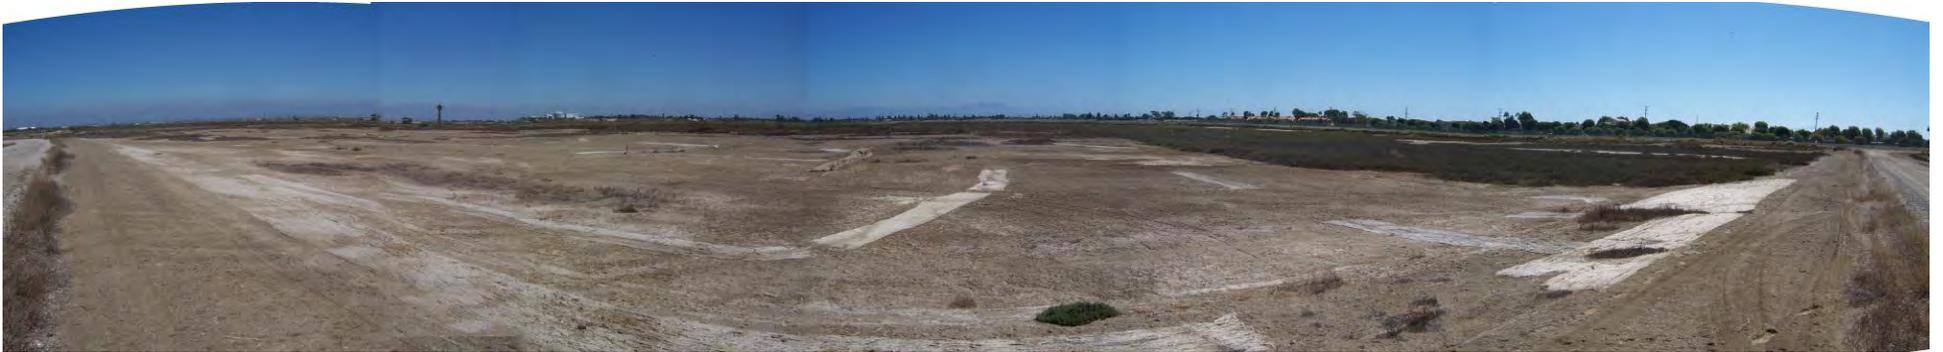
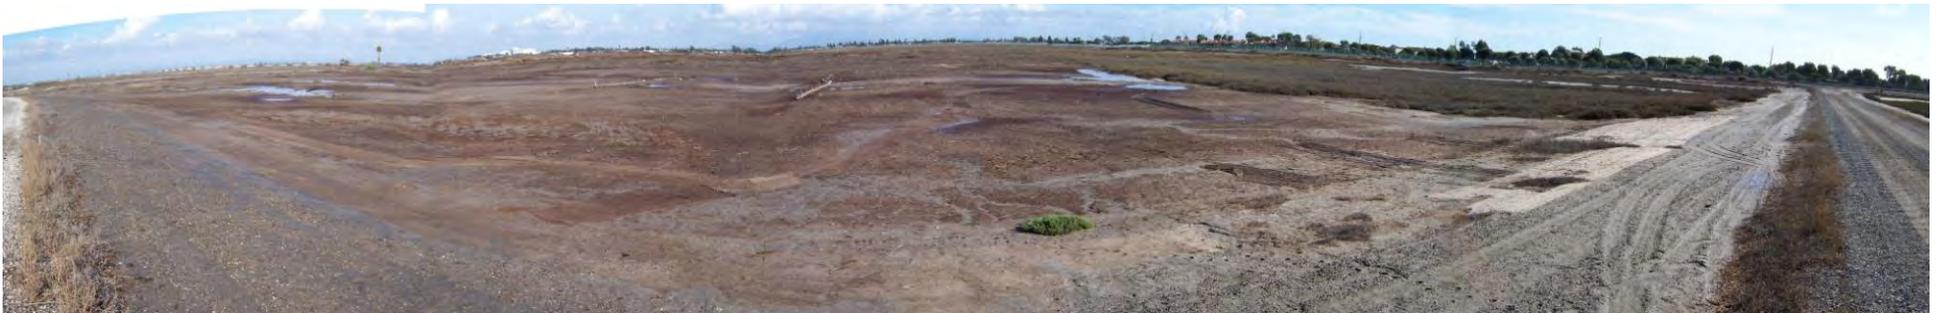
Photo 13: December 4, 2014 Post-Rain Inspection

Compared with Pre-Rain Season Inspection. Looking east from south portion of west edge of the landfill cover.

Photo shows western 1/3rd of the landfill cover, ponding near the tidal area to the right on the south boundary, and ponding in the distance to the left on the west central margin of the landfill cover.

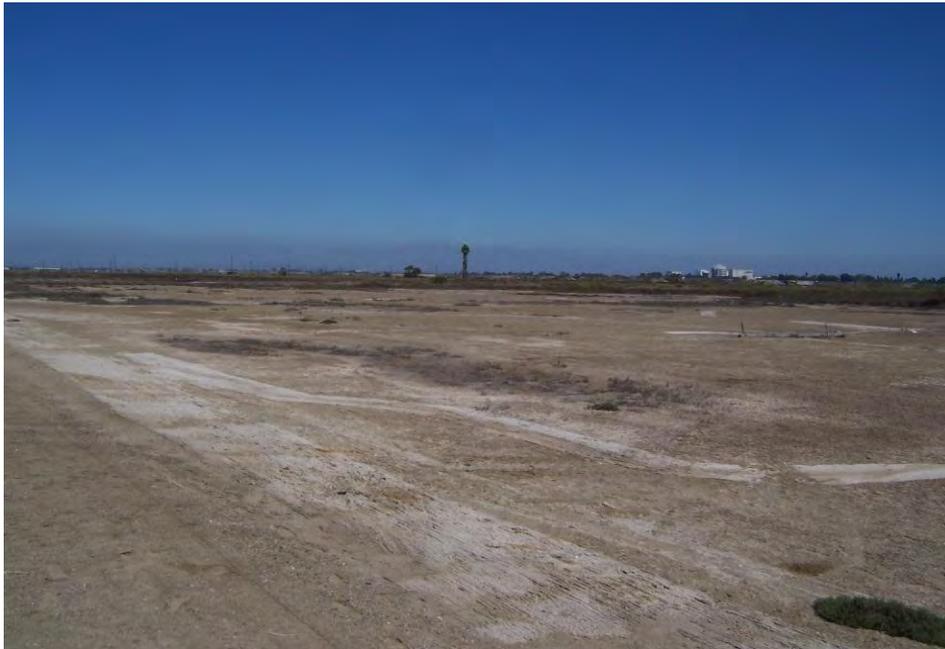
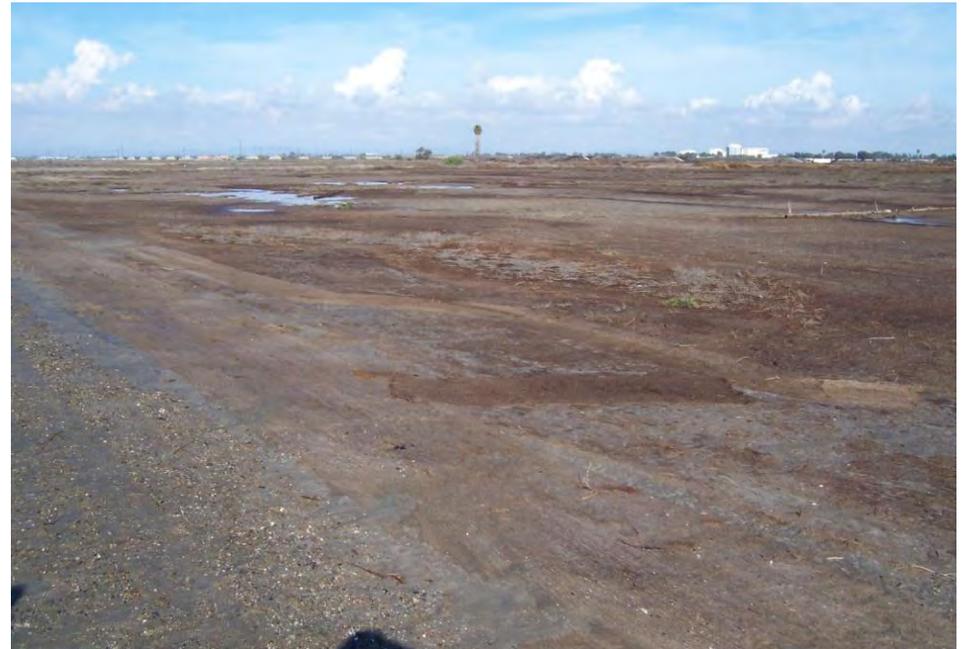
Photo 14: December 4, 2014 Post-Rain Inspection

Compared with Pre-Rain Season Inspection. Looking northeast from south portion of west edge of landfill cover towards ponding in the distance on the west central margin of the landfill cover.

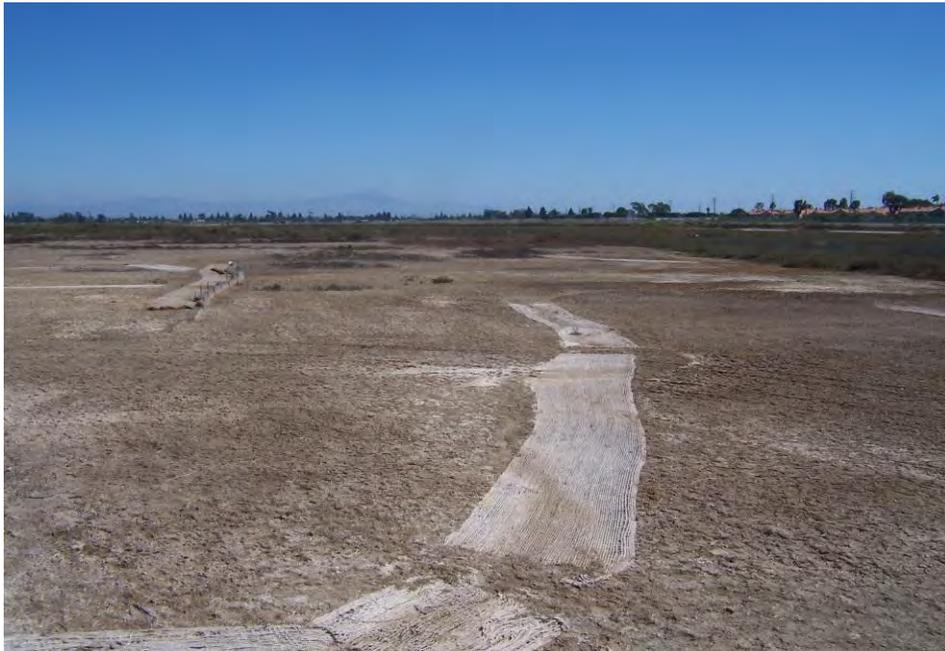
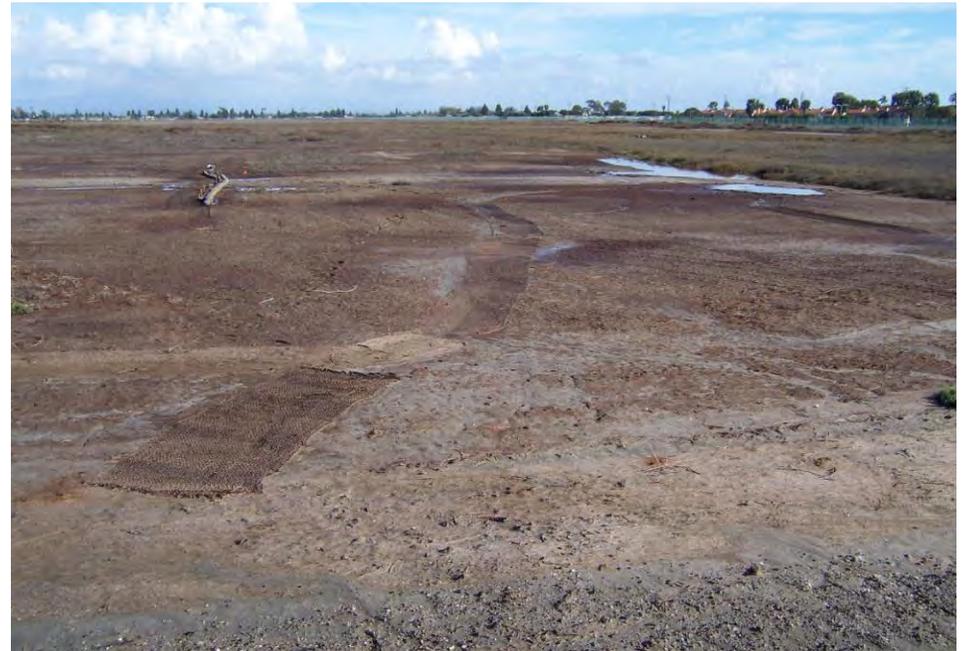
Photo 15: December 4, 2014 Post-Rain Inspection

Compared with Pre-Rain Season Inspection. Looking east, along the southern edge of the landfill cover. December 2014 photo shows ponding in the distance in the area adjacent to the tidal pond.

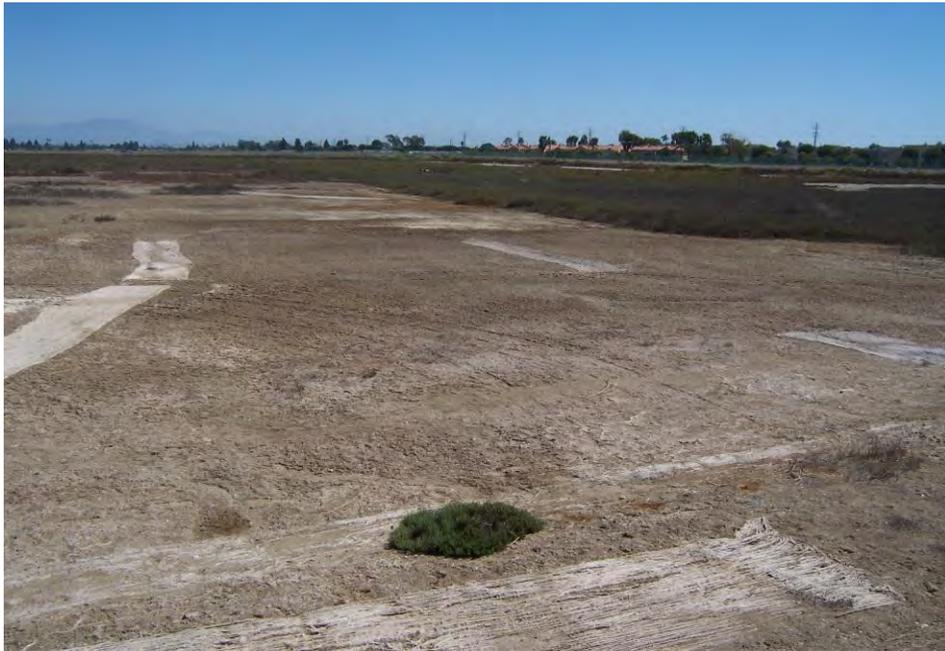
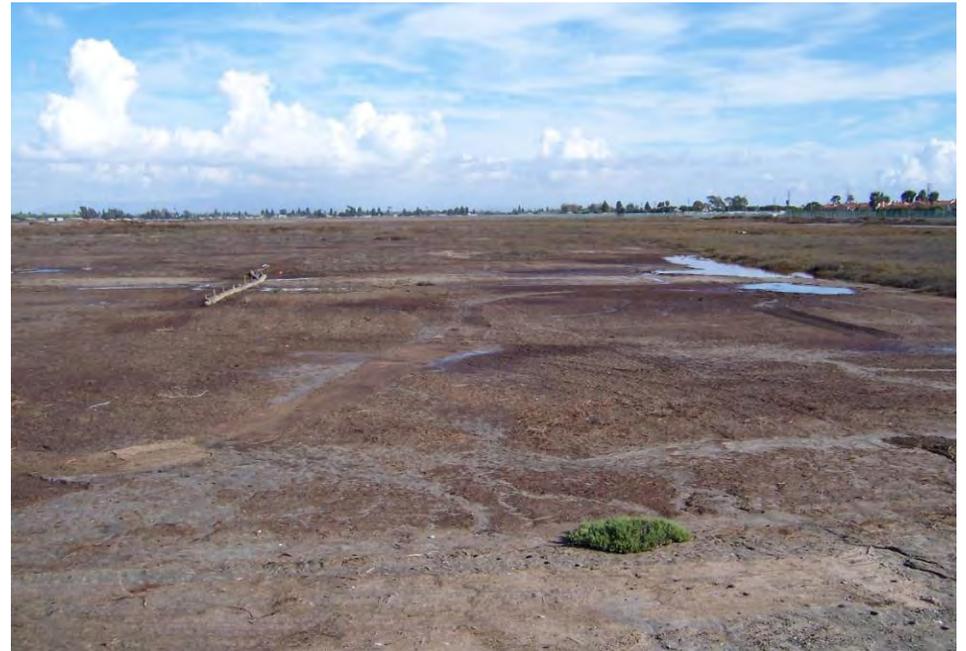
Photo 16: December 4, 2014 Post-Rain Inspection

Compared with Pre-Rain Season Inspection. Looking southeast, along the southern edge of the landfill cover.

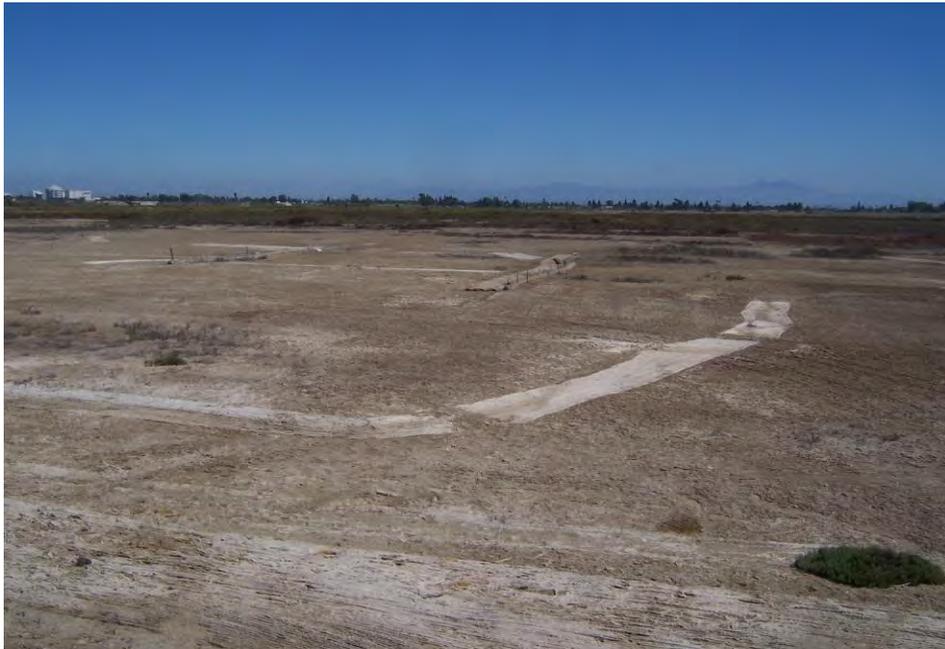
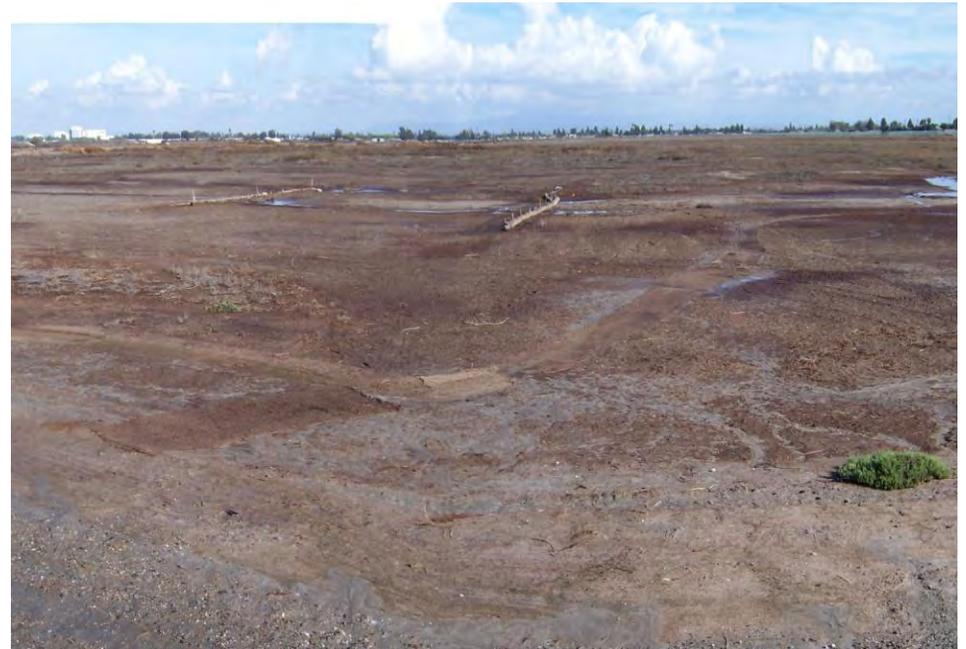
Photo 17: December 4, 2014 Post-Rain Inspection

Compared with Pre-Rain Season Inspection. Looking northeast, from the southwest corner of the landfill.
Photo shows jute mesh, wattles, and vegetation conditions in the western portion of the landfill.

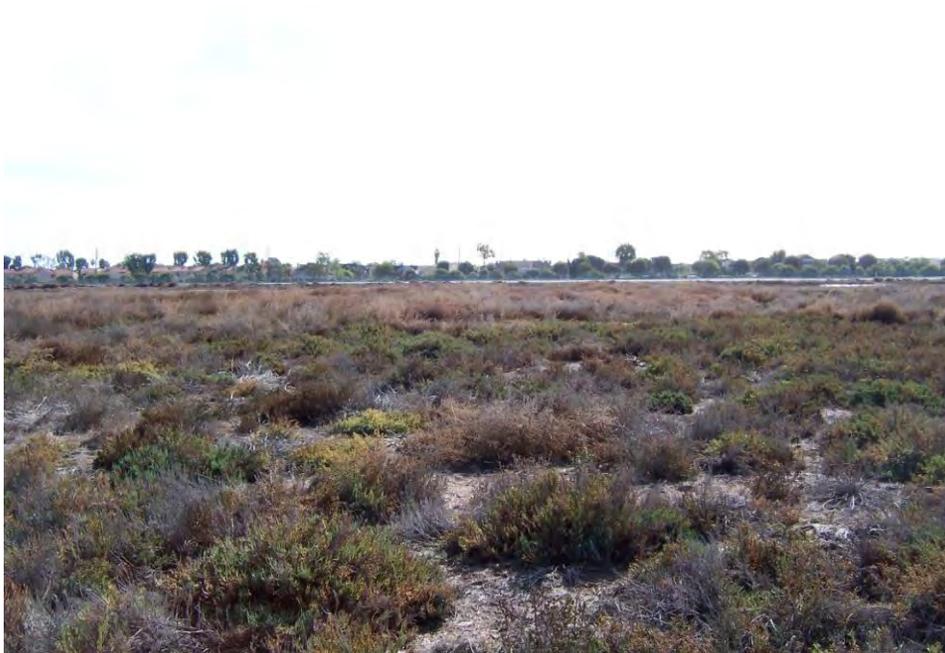
Compared with Post-Rain Inspection Dec 2014. Looking south from north-central area of the landfill.
Photo shows 75-100% vegetation coverage in eastern 2/3rds of landfill cover. No ponding.

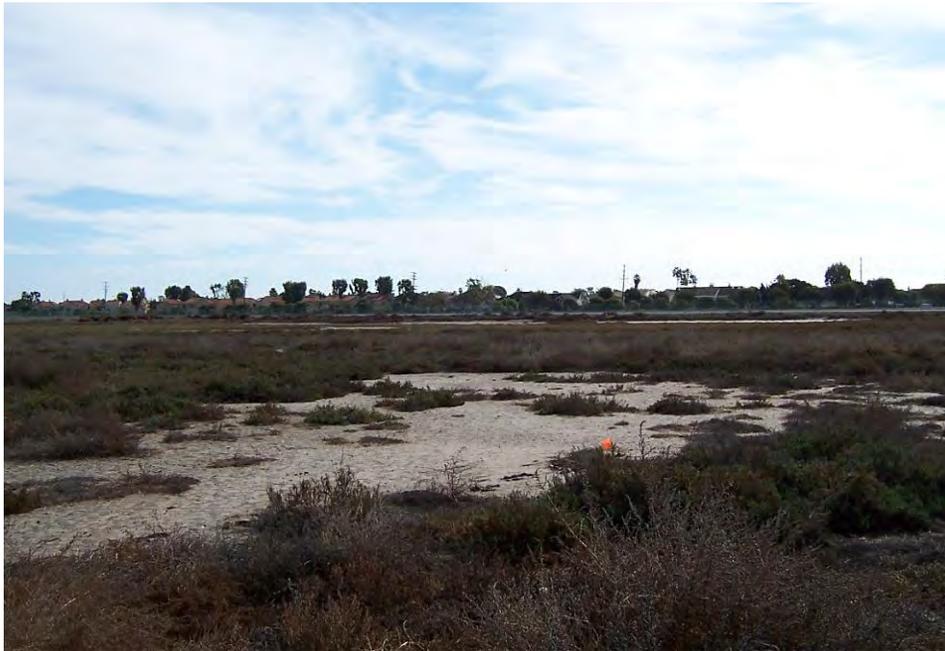
Compared with Post-Rain Inspection Dec 2014. Looking south from central portion of the landfill cover.
Small bare patch near middle of site. No ponding.

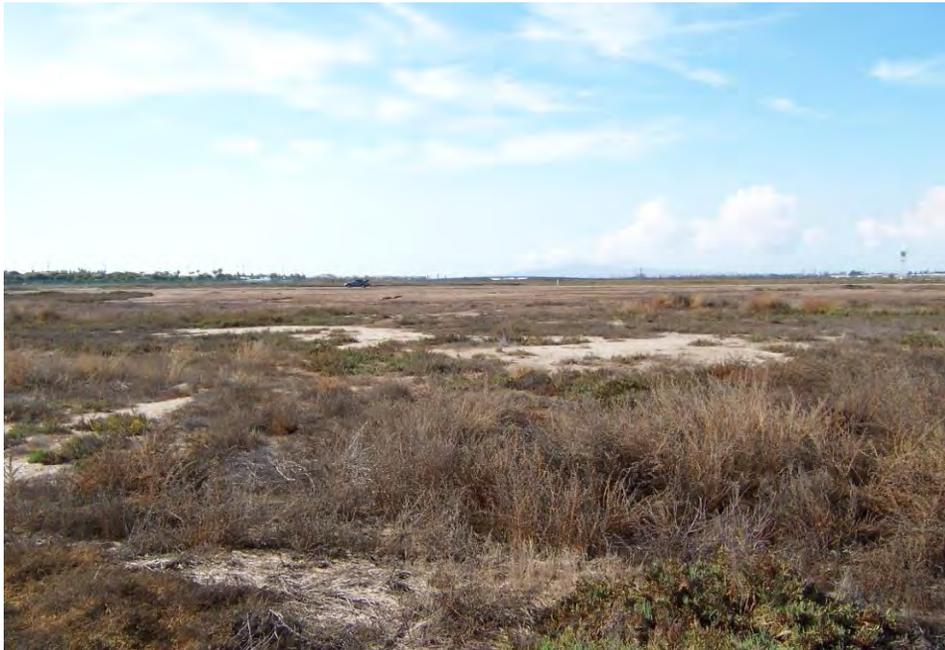
Compared with Post-Rain Inspection Dec 2014. Looking west from central portion of the landfill. Typical view west of center of site – low groundcover, occasional shrub, bare areas in the western 1/3rd of the landfill in the distance. No ponding.

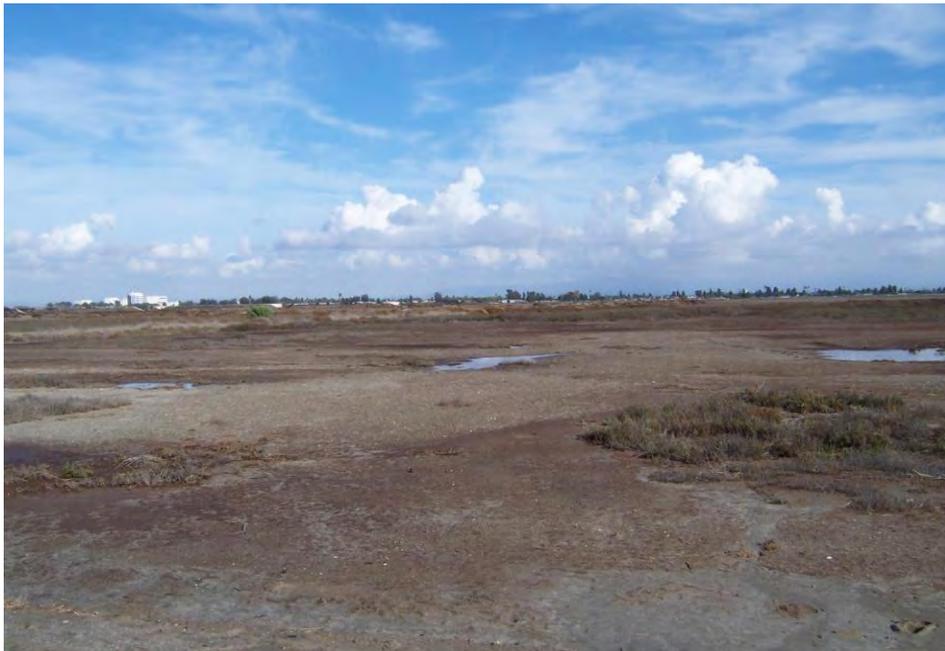
Compared with Post-Rain Inspection Dec 2014. Looking east, from the northern portion of the west edge of the landfill. No ponding.

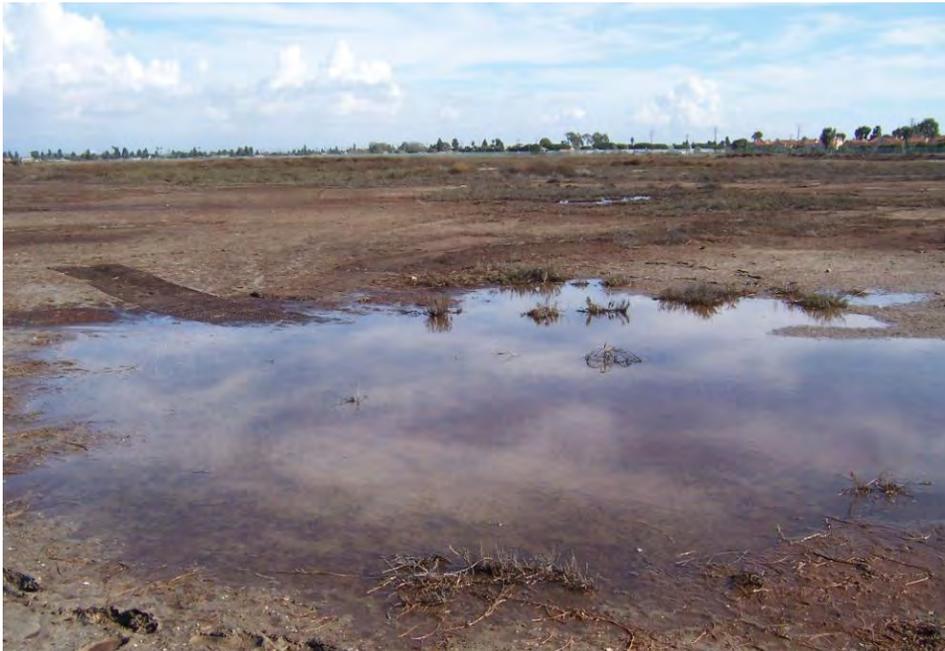
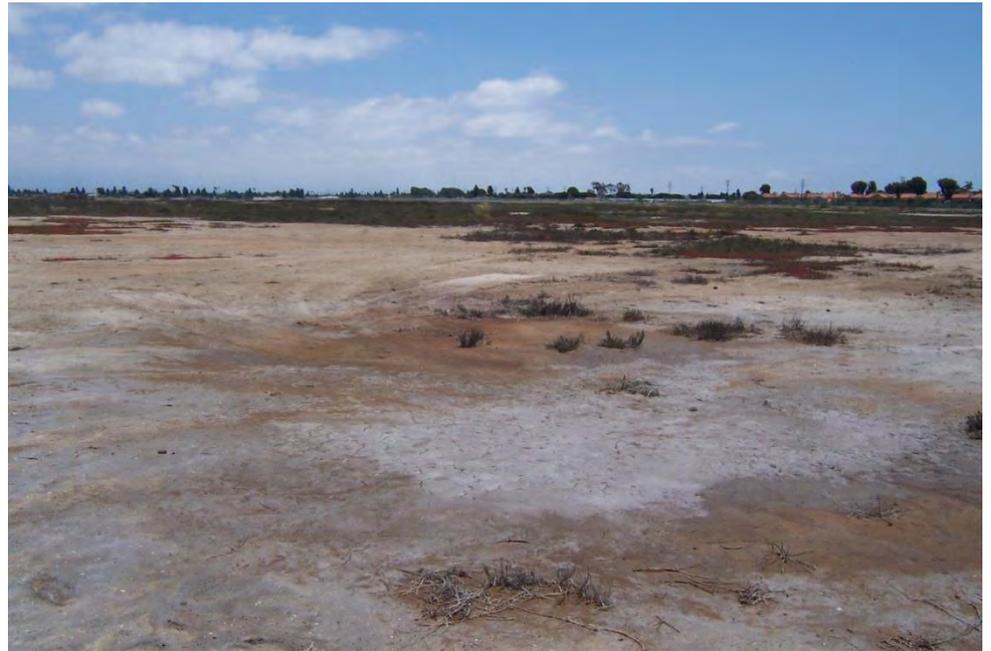
Photo 5: May 20, 2015 Post-Rain Inspection

Compared with Post-Rain Inspection Dec 2014. Looking southeast at two 25 foot sections of jute mesh installed in the north portion of the western 1/3rd of the landfill. No ponding.

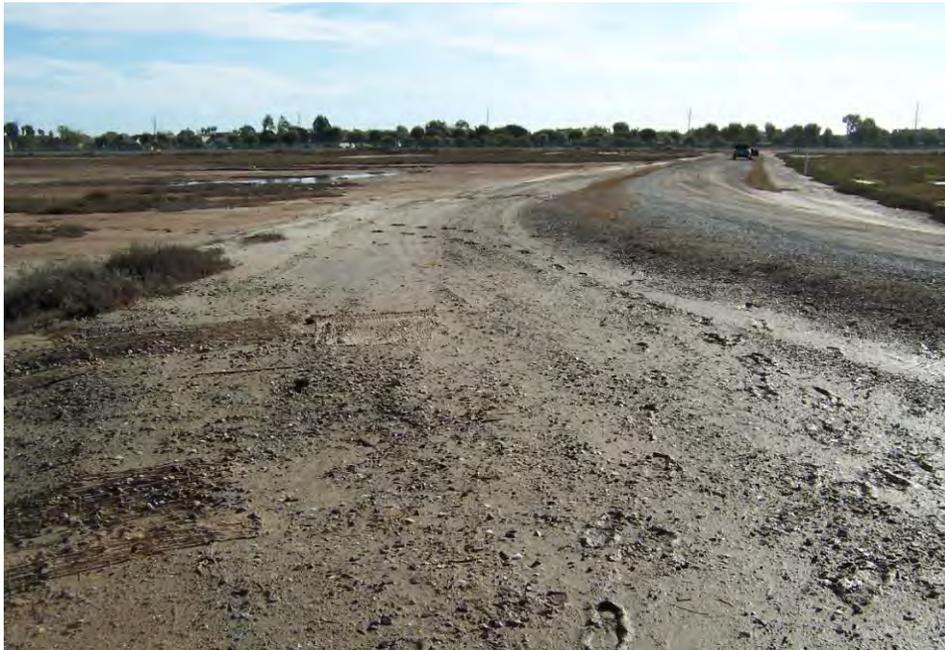
Photo 6: May 20, 2015 Post-Rain Inspection

Compared with Post-Rain Inspection Dec 2014. Looking south from northwestern corner of landfill cover, adjacent to access road. Photo shows areas of vegetation cover and condition of access road.
