**FALL 2014 AND WINTER 2015
ANNUAL POST-CLOSURE INSPECTION AND MAINTENANCE REPORT**

**INSTALLATION RESTORATION PROGRAM SITE 7 AREA 1
(FORMER STATION LANDFILL)
NAVAL WEAPONS STATION SEAL BEACH, SEAL BEACH, CALIFORNIA**

November 2015

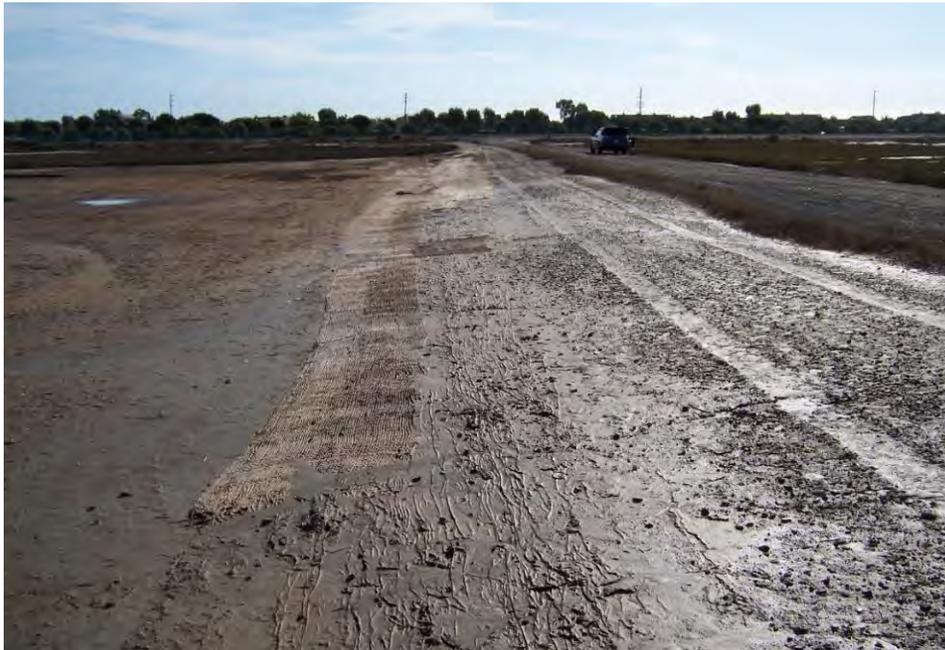
Compared with Post-Rain Inspection Dec 2014. Looking south along central portion of west edge of landfill at a 100 foot section of jute mesh installed on the slope parallel to the access road. No new erosion or flow lines were present.

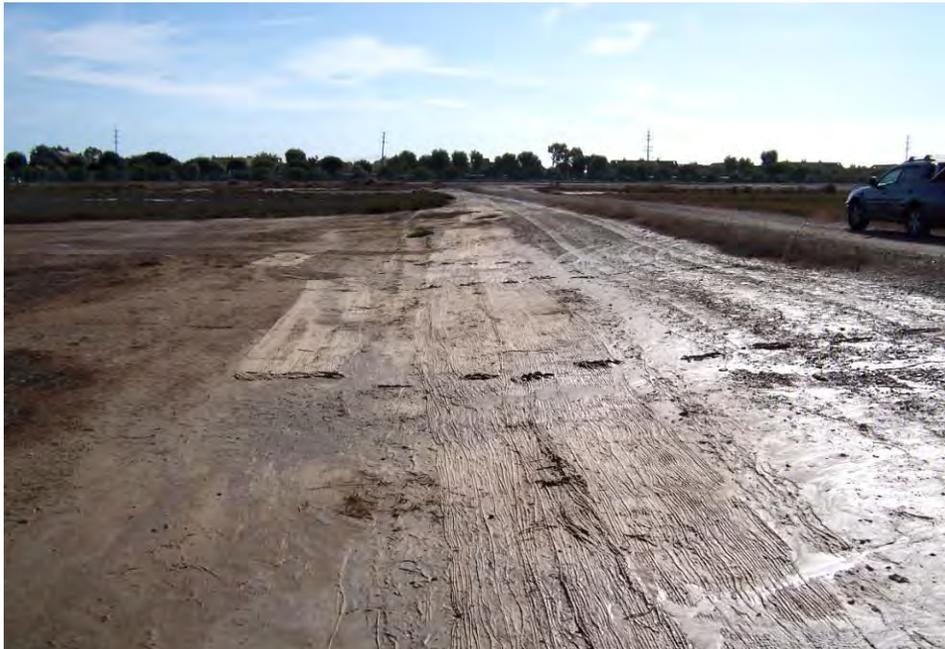
Compared with Post-Rain Inspection Dec 2014. Looking south along southern portion of west edge of landfill cover. Photo shows condition of jute mesh and access road. No new erosion or flow lines were present.

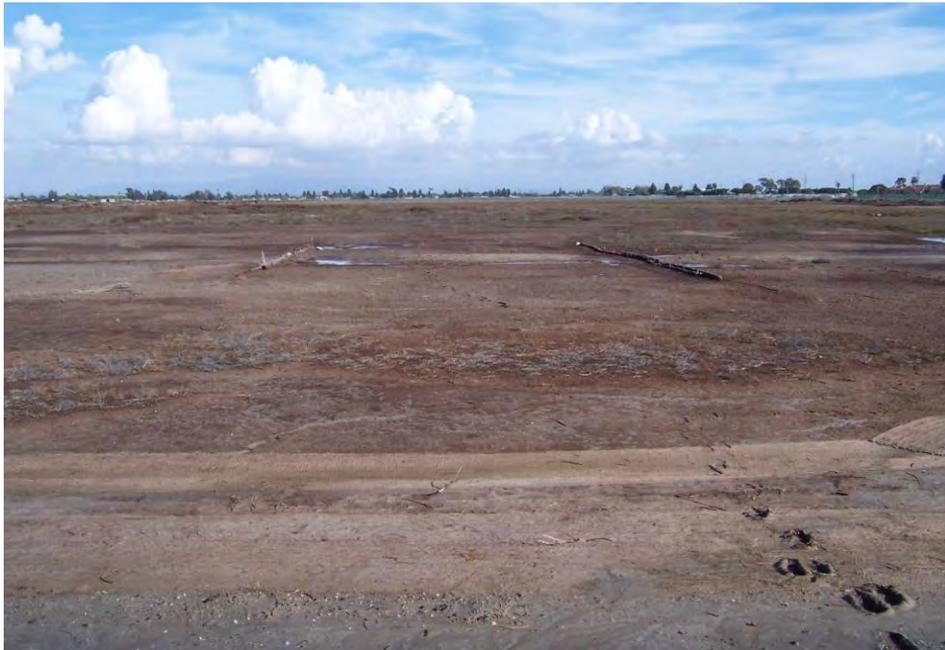
Compared with Post-Rain Inspection Dec 2014. Looking east from the south portion of west edge of landfill cover. Photo shows central and southern wattles and jute mesh. No ponding.

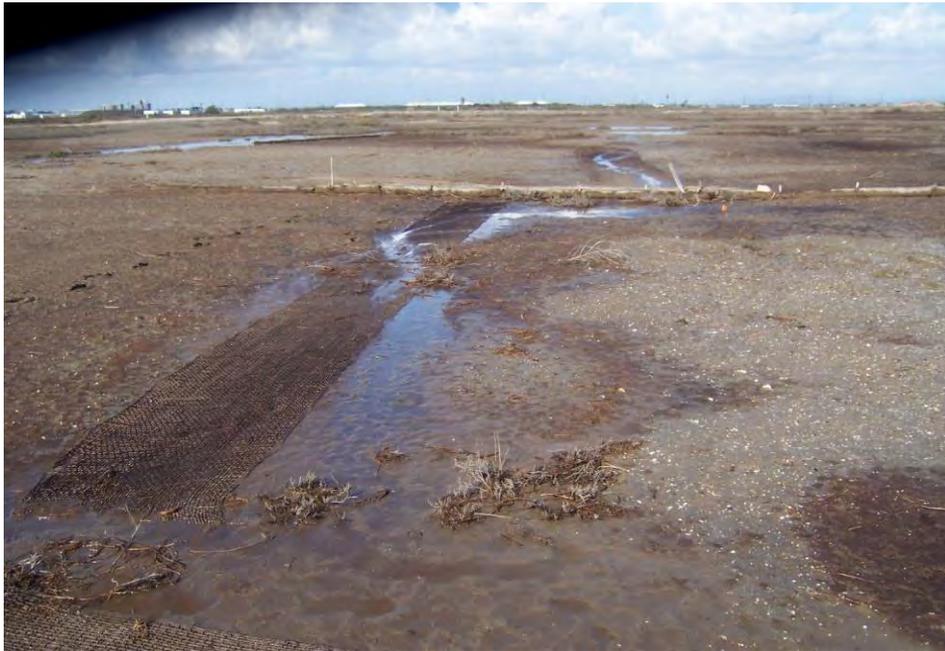
Photo 10: May 20, 2015 Post-Rain Inspection

Compared with Post-Rain Inspection Dec 2014. Looking northwest at 30 foot section of jute mesh installed between central and southern sections of wattles. No ponding.

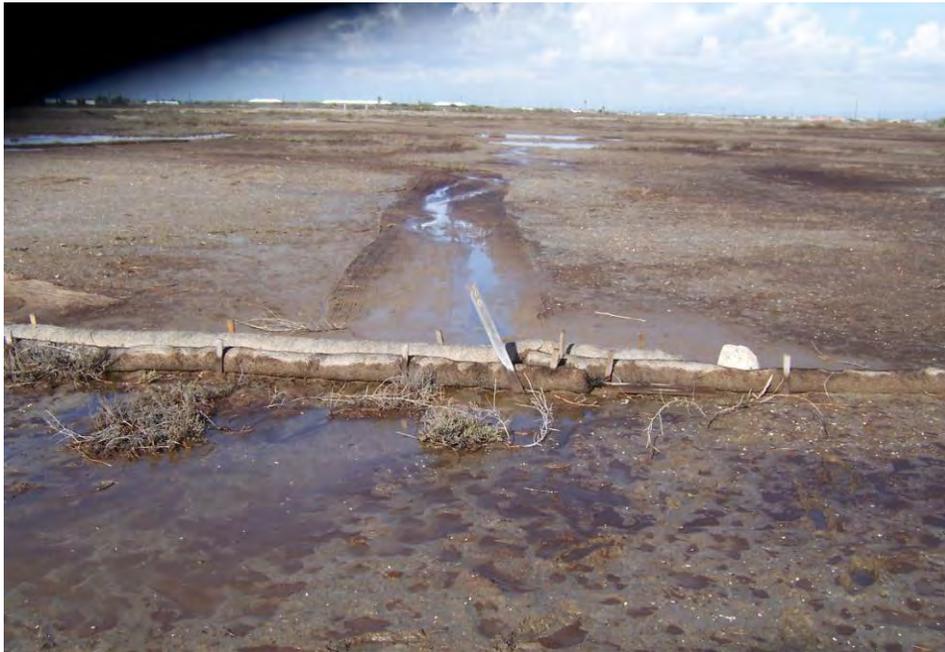
Compared with Post-Rain Inspection Dec 2014. Looking north, past the central straw wattle, in the direction of the west section of jute mesh. No ponding.

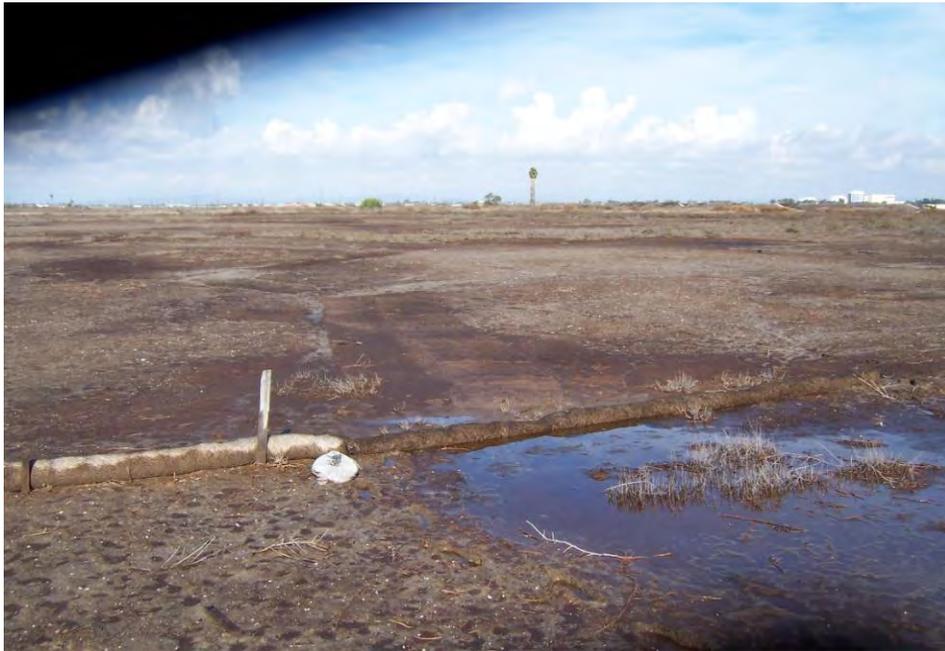
Photo 12: May 20, 2015 Post-Rain Inspection

Compared with Post-Rain Inspection Dec 2014. Looking north at east section of jute mesh located north of the central straw wattle. No ponding.

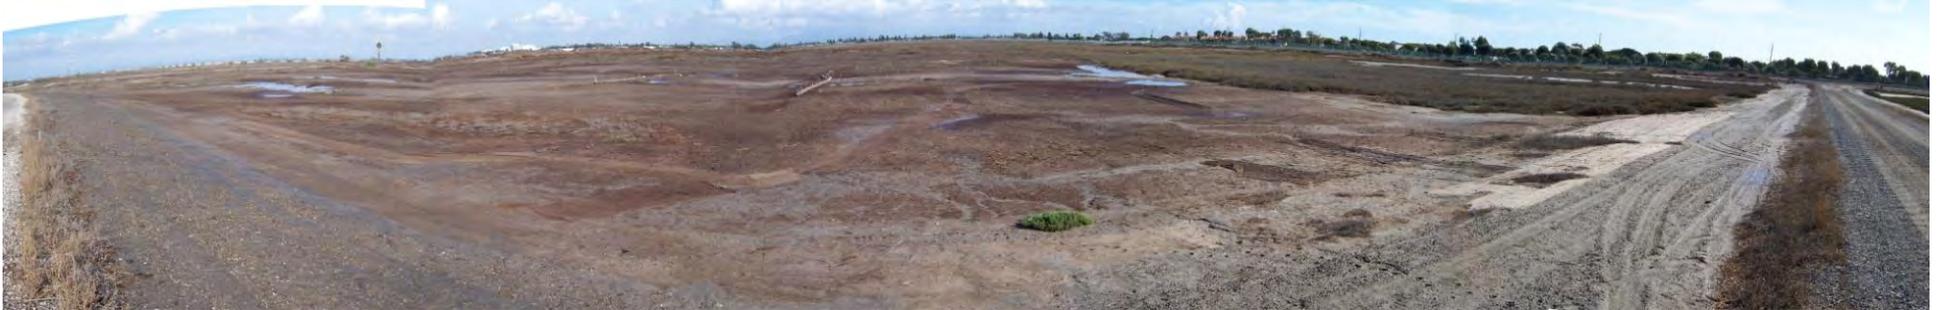
Photo 13: May 20, 2015 Post-Rain Inspection

Compared with Post-Rain Inspection Dec 2014. Looking east from south portion of west edge of the landfill cover. Photo shows western 1/3rd of the landfill cover. No ponding.

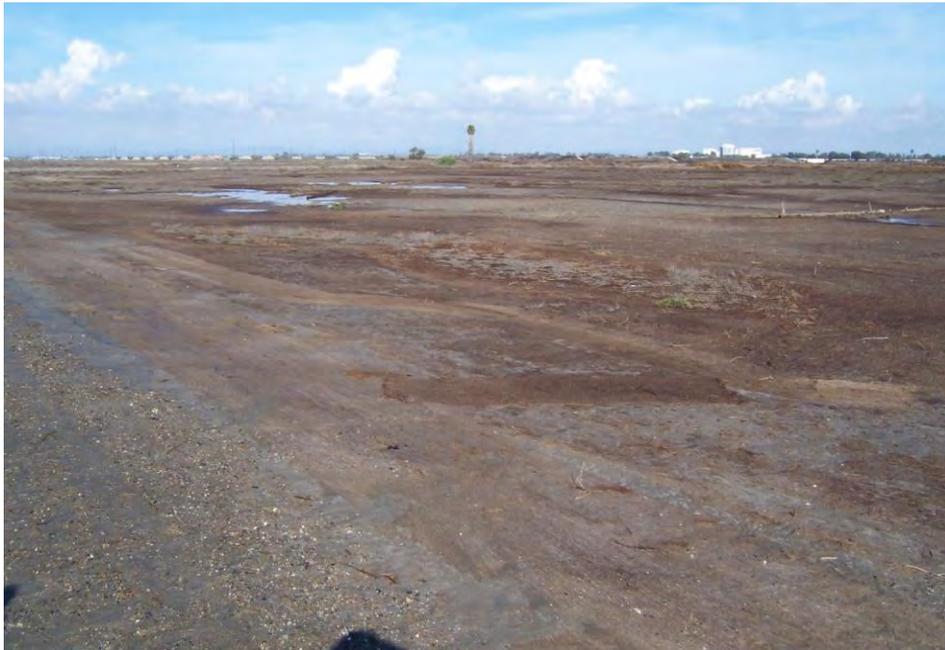
Photo 14: May 20, 2015 Post-Rain Inspection

Compared with Post-Rain Inspection Dec 2014. Looking northeast from south portion of west edge of landfill cover towards the west central margin of the landfill cover. No ponding.

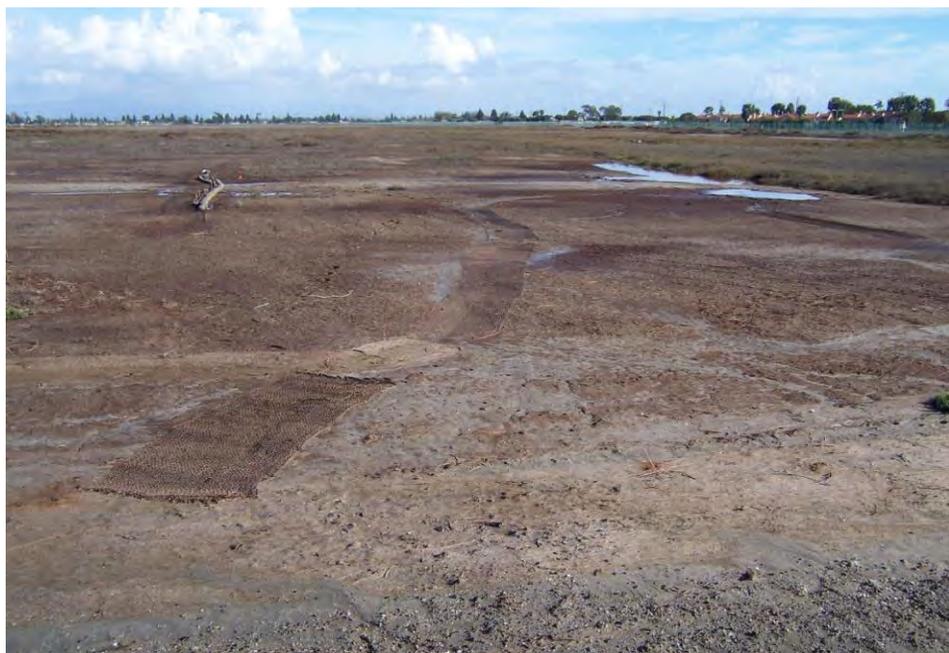
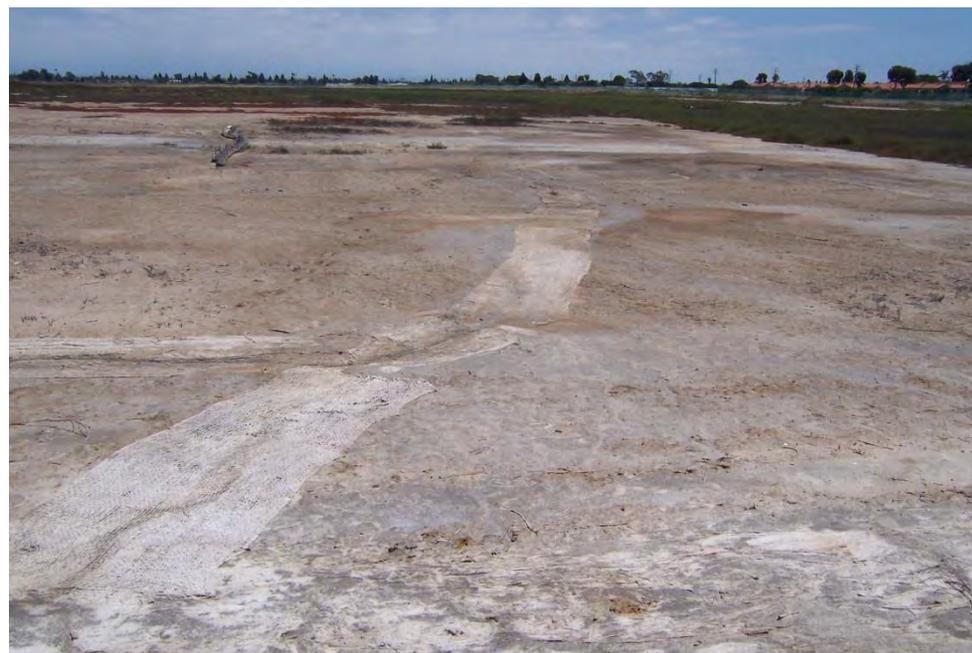
Photo 15: May 20, 2015 Post-Rain Inspection

Compared with Post-Rain Inspection Dec 2014. Looking east, along the southern edge of the landfill cover.
No ponding.

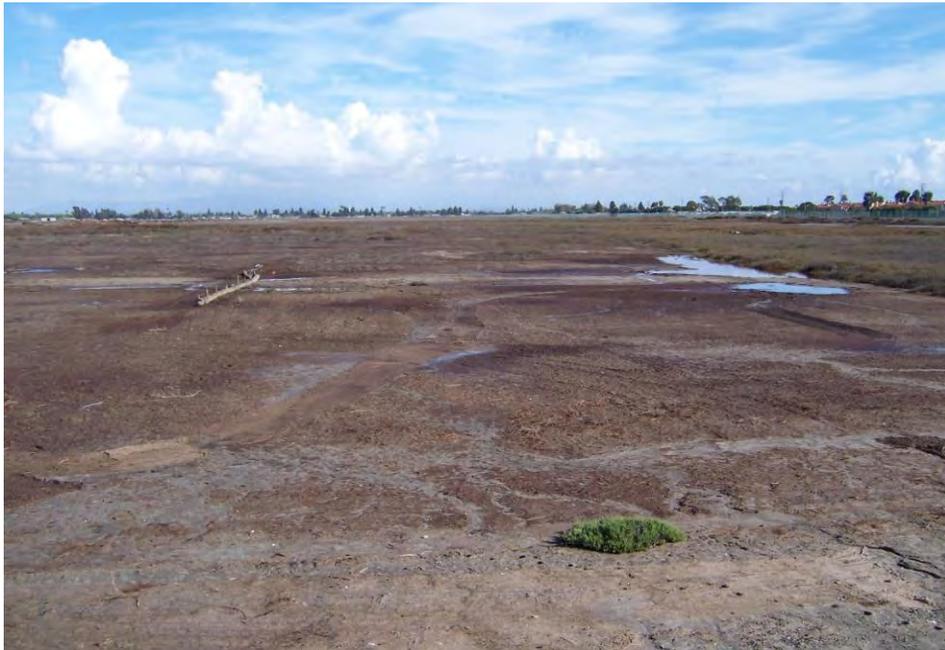
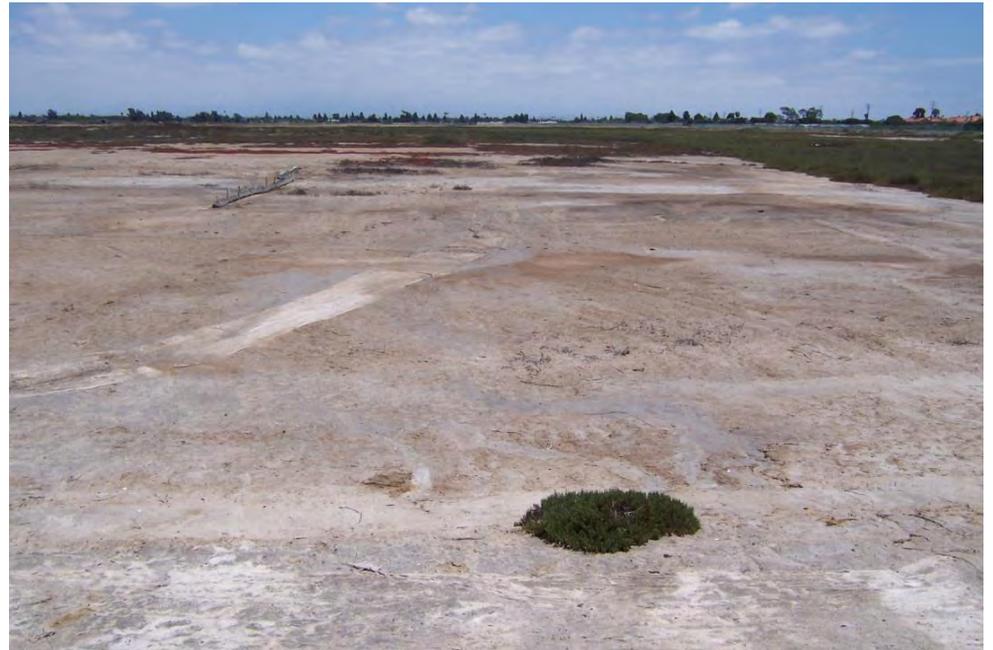
Photo 16: May 20, 2015 Post-Rain Inspection

Compared with Post-Rain Inspection Dec 2014. Looking southeast, along the southern edge of the landfill cover. No ponding.

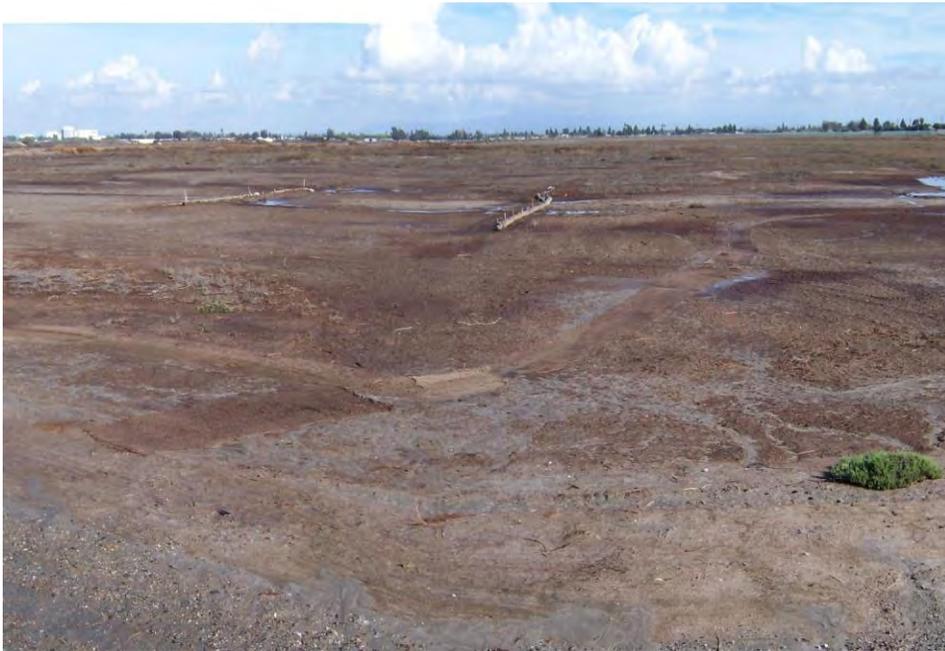
Photo 17: May 20, 2015 Post-Rain Inspection

Compared with Post-Rain Inspection Dec 2014. Looking northeast, from the southwest corner of the landfill.
Photo shows jute mesh, wattles, and vegetation conditions in the western portion of the landfill.

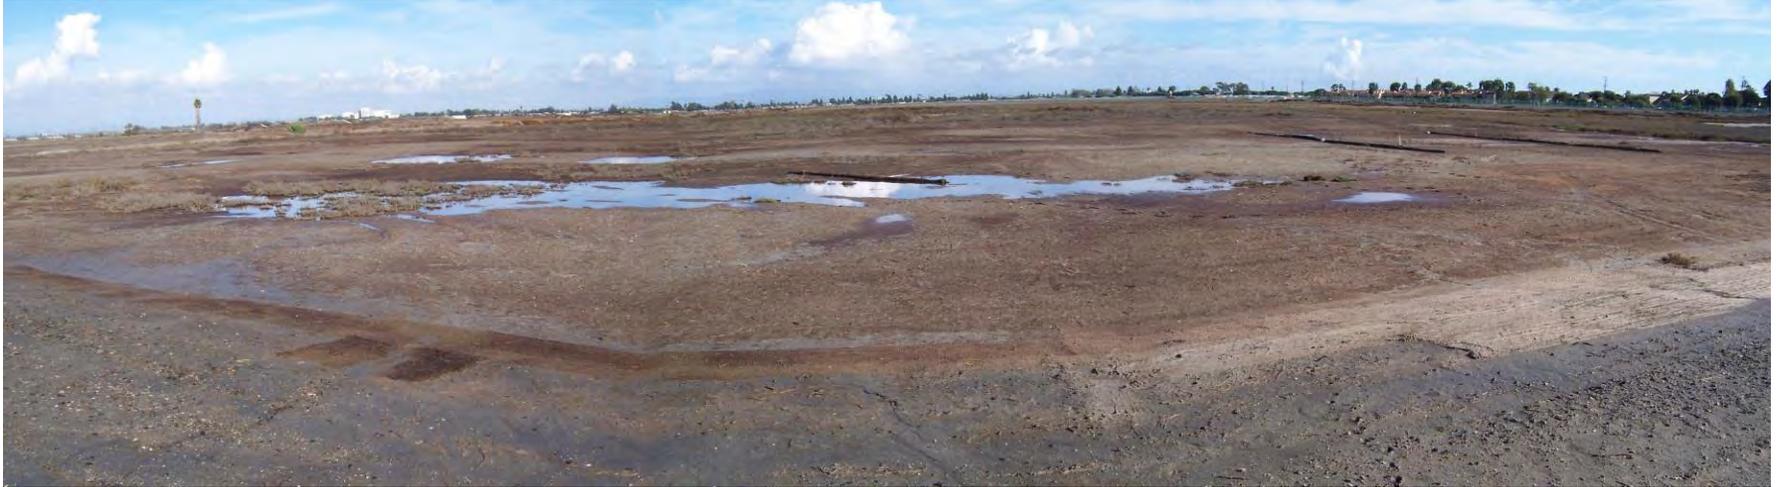
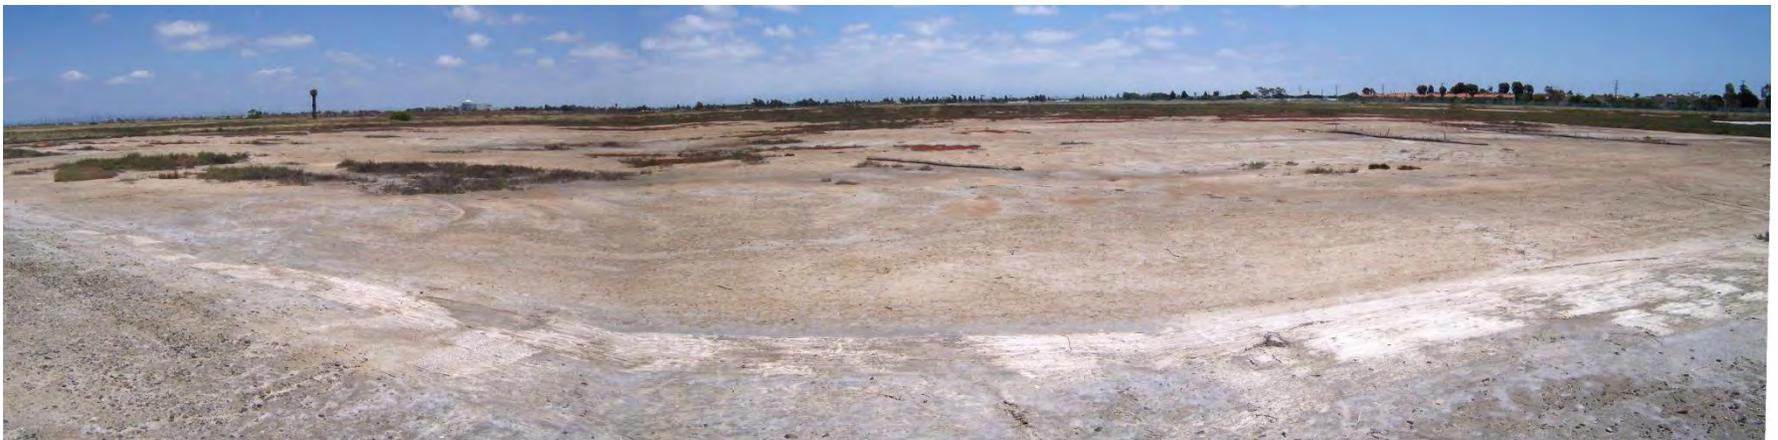
Photo 18: May 20, 2015 Post-Rain Inspection
Photo looking east at the central western margin of the landfill.

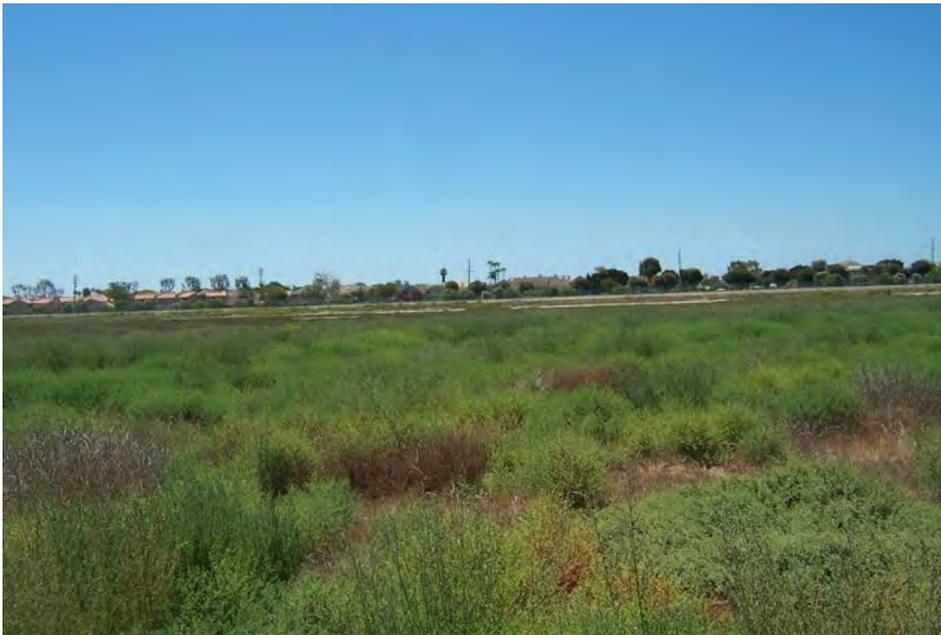
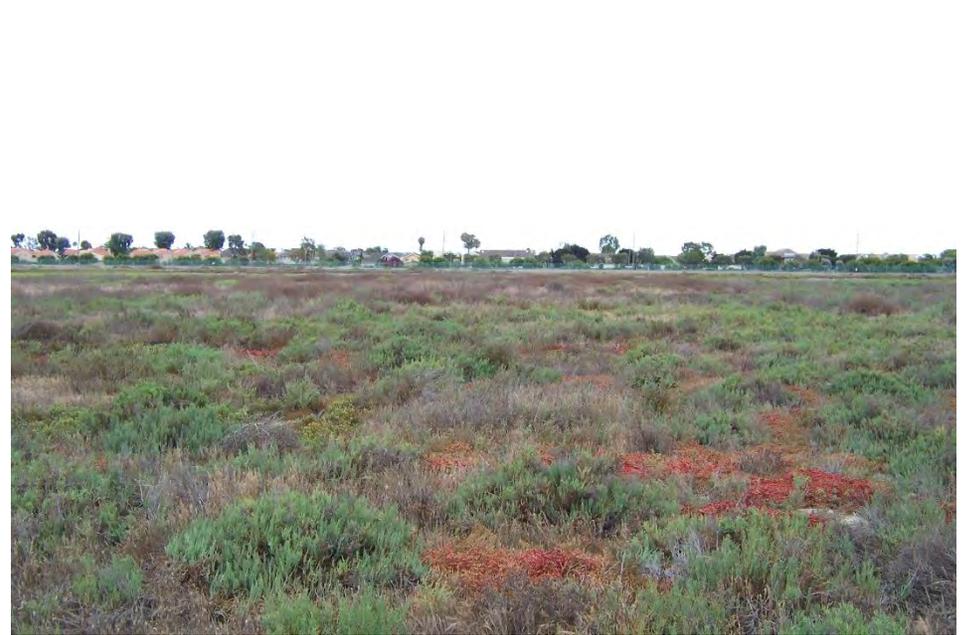
Compared with Post-Rainy Season Inspection July 2014. Looking south from north-central area of the landfill.
Photo shows 75-100% vegetation coverage in eastern 2/3rds of landfill cover. No ponding.

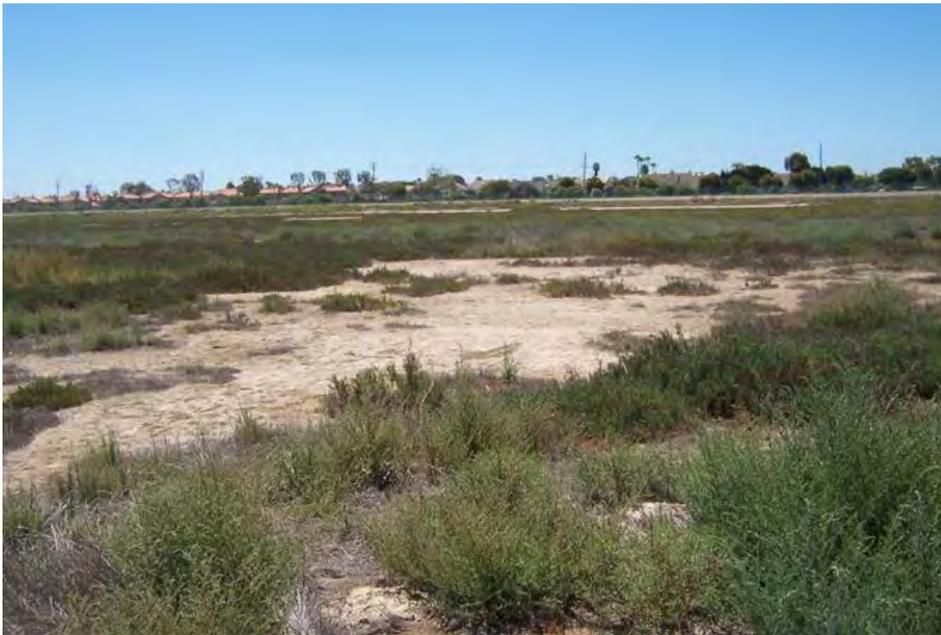
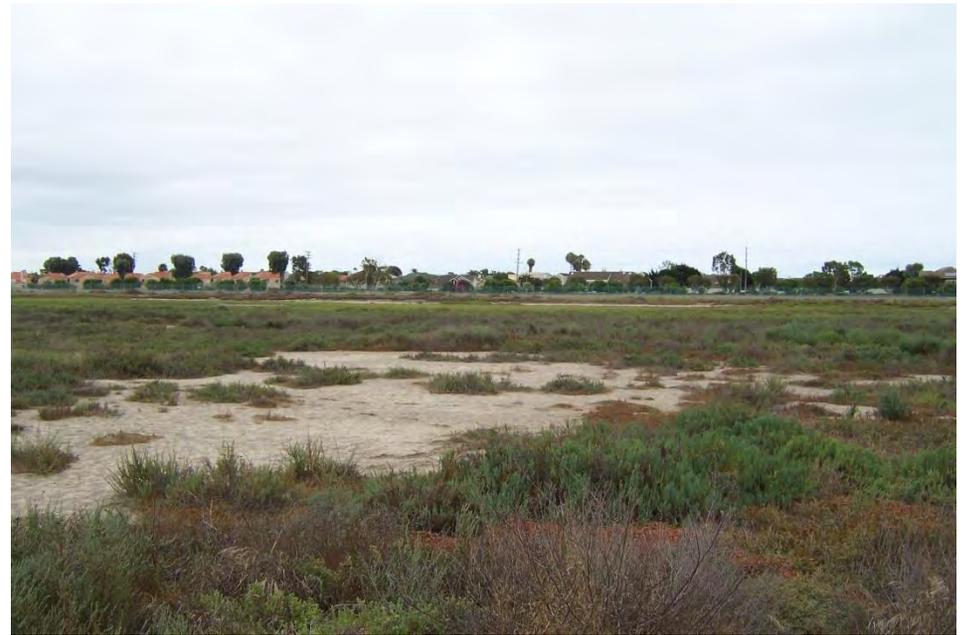
Photo 2: July 23, 2015 Post-Rainy Season Inspection

Compared with Post-Rainy Season Inspection July 2014. Looking south from central portion of the landfill cover.
Small bare patch near middle of site. No ponding.

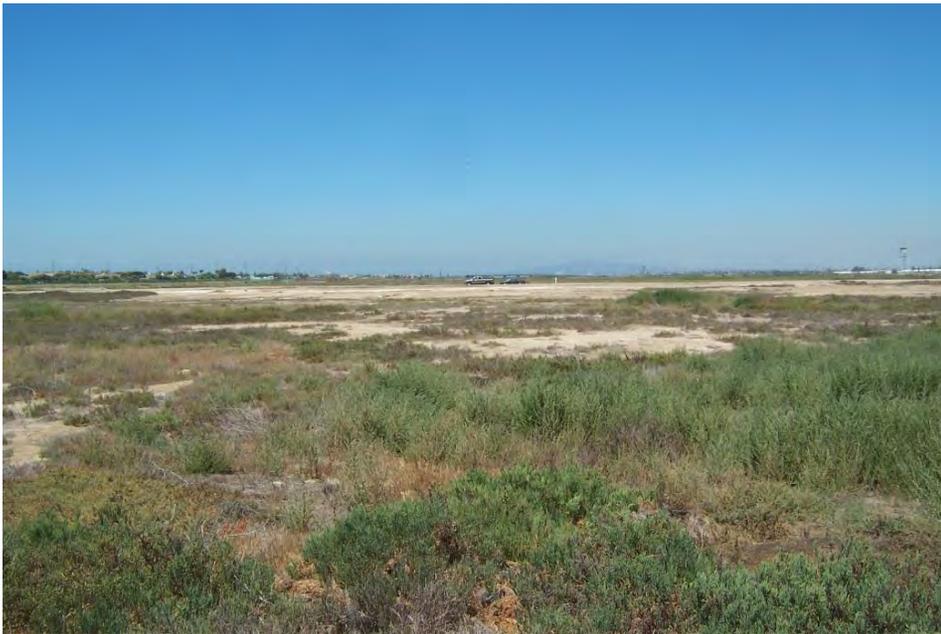
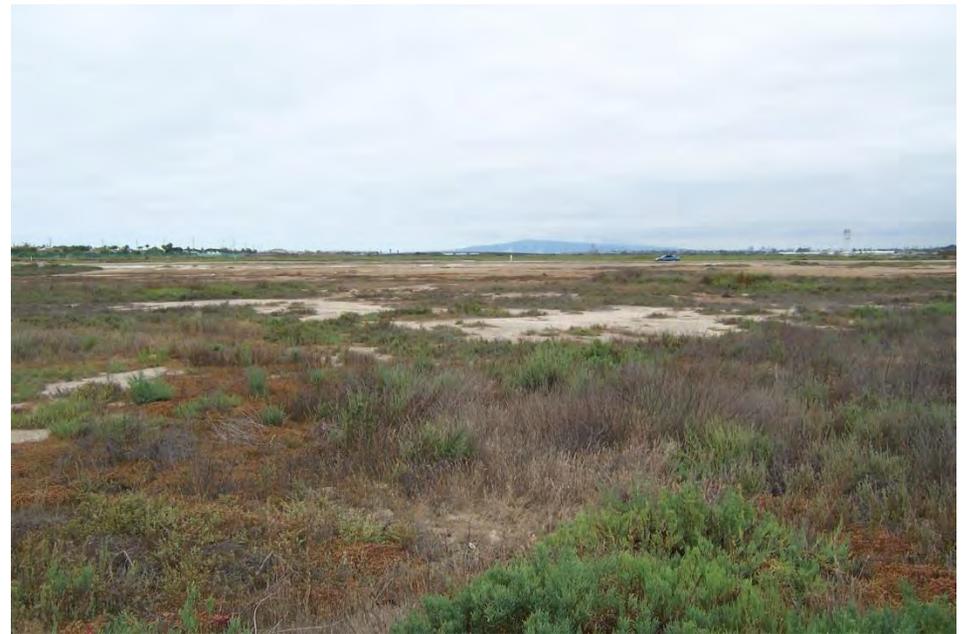
Photo 3: July 23, 2015 Post-Rainy Season Inspection

Compared with Post-Rainy Season Inspection July 2014. Looking west from central portion of the landfill. Typical view west of center of site – low groundcover, occasional shrub, bare areas in the western 1/3rd of the landfill in the distance. No ponding.

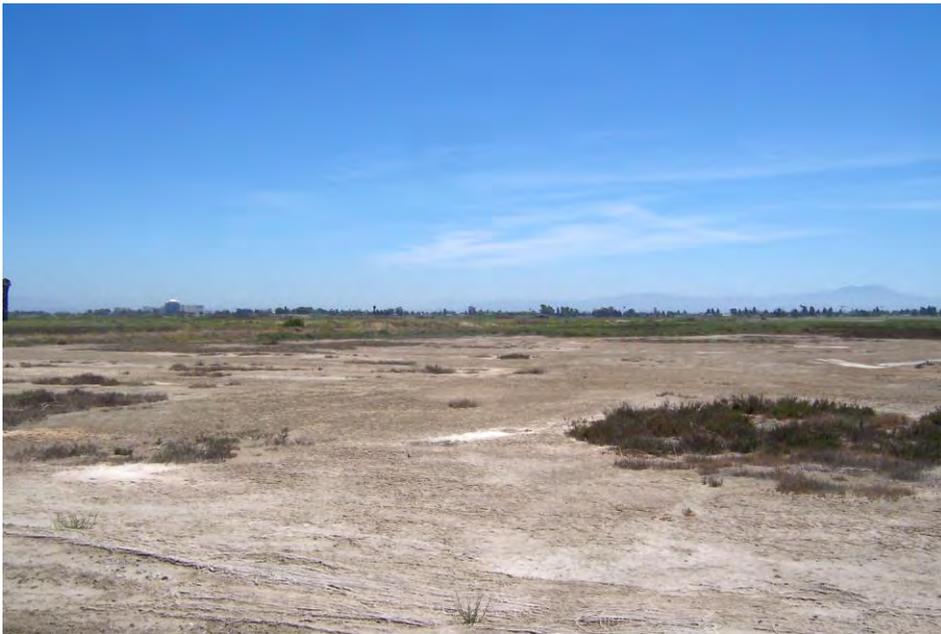
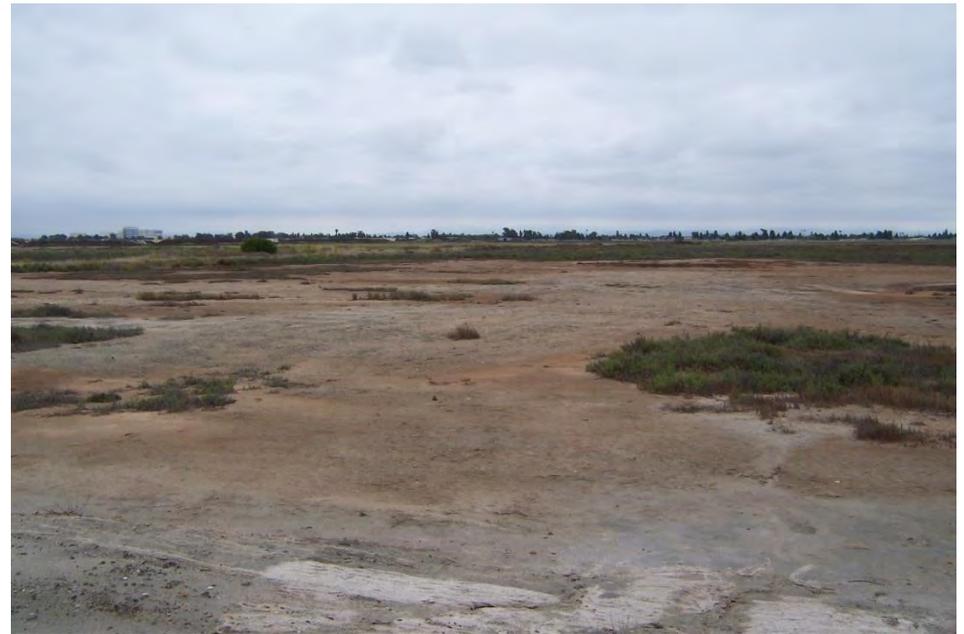
Photo 4: July 23, 2015 Post-Rainy Season Inspection

Compared with Post-Rainy Season Inspection July 2014. Looking east, from the northern portion of the west edge of the landfill. No ponding.

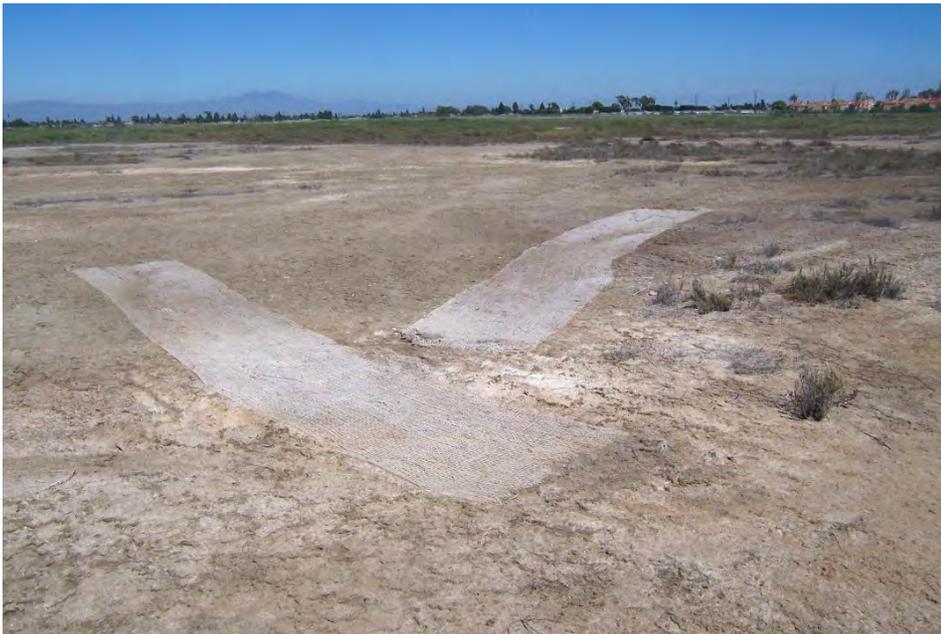
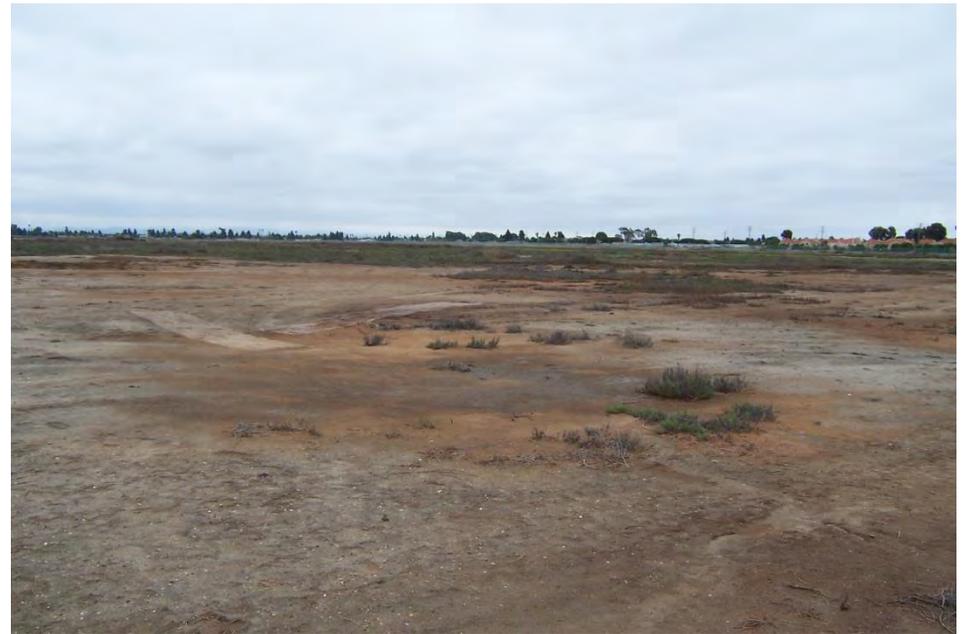
Photo 5: July 23, 2015 Post-Rainy Season Inspection

Compared with Post-Rainy Season Inspection July 2014. Looking southeast at two 25 foot sections of jute mesh installed in the north portion of the western 1/3rd of the landfill. No ponding.

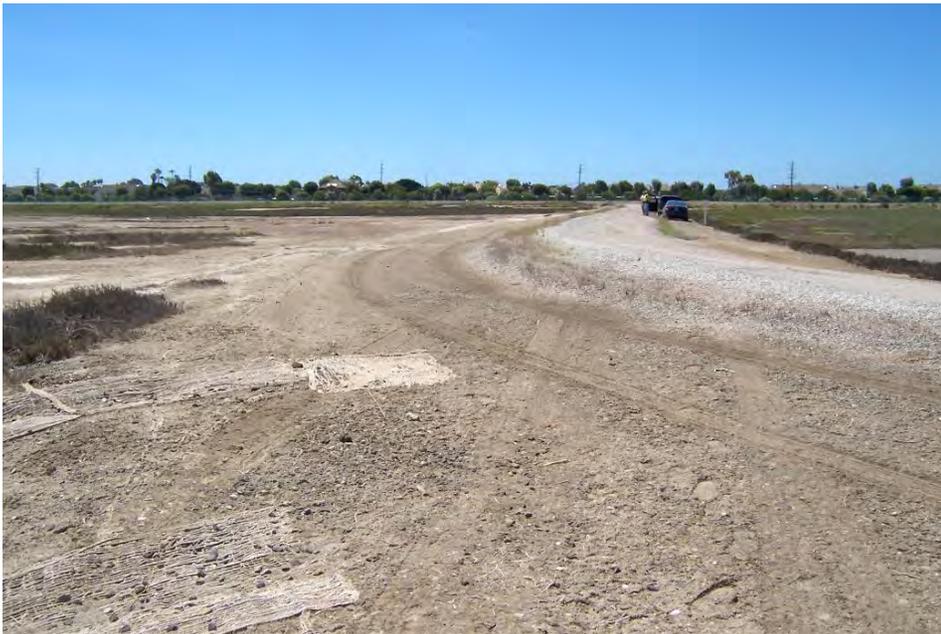
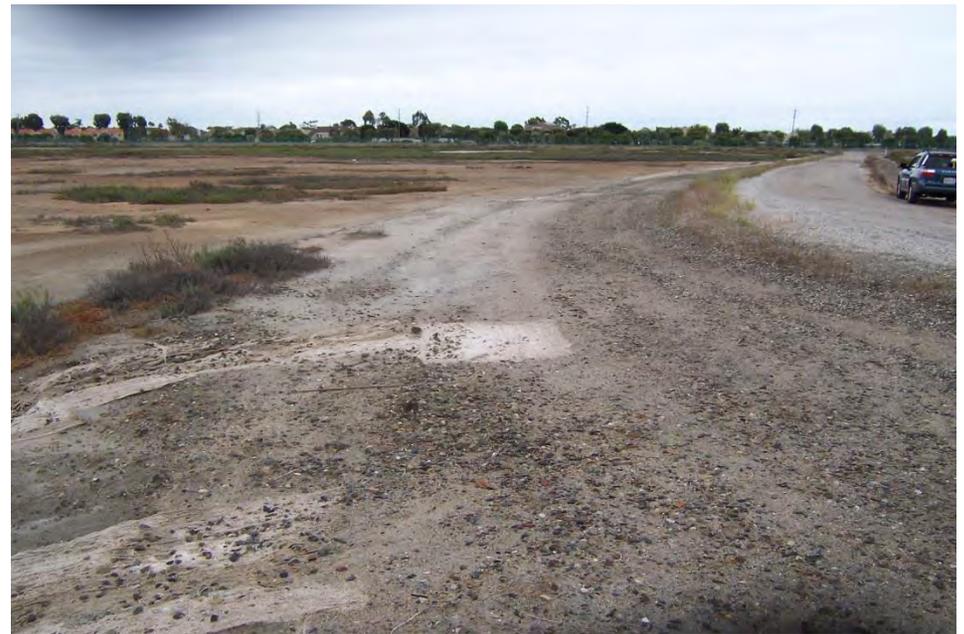
Photo 6: July 23, 2015 Post-Rainy Season Inspection

Compared with Post-Rainy Season Inspection July 2014. Looking south from northwestern corner of landfill cover, adjacent to access road. Photo shows areas of vegetation cover and condition of access road.

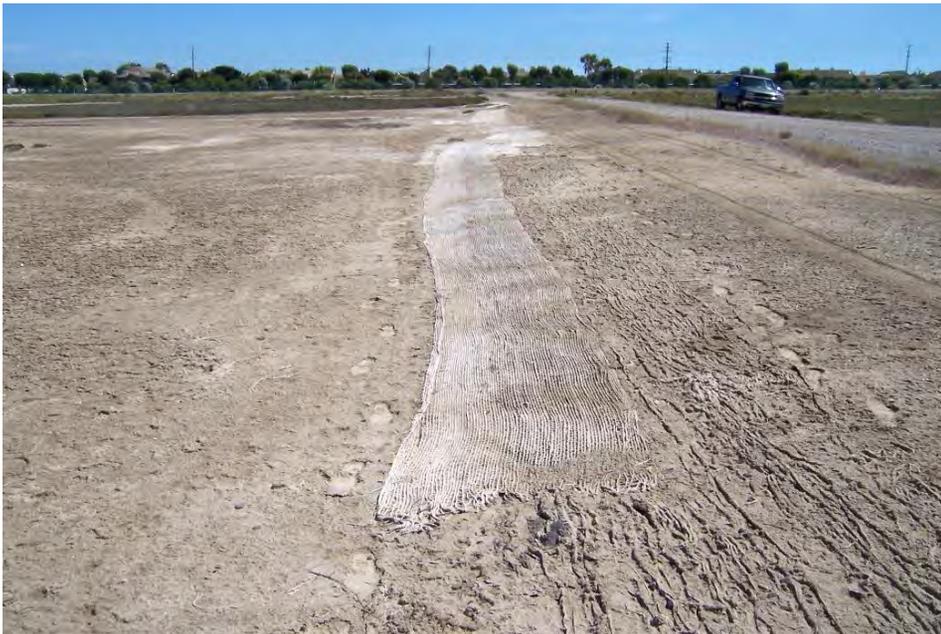
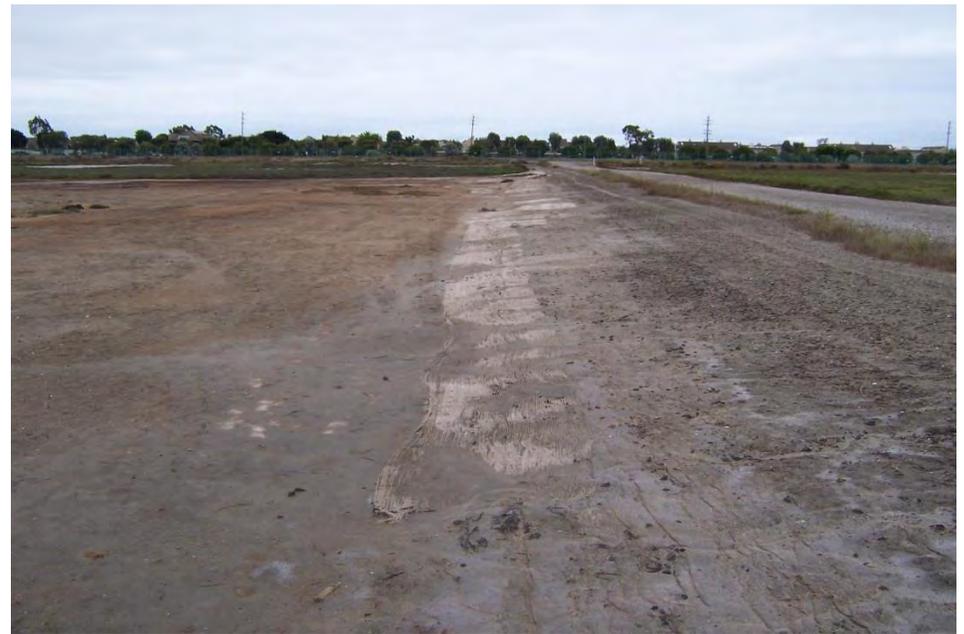
Photo 7: July 23, 2015 Post-Rainy Season Inspection

Compared with Post-Rainy Season Inspection July 2014. Looking south along central portion of west edge of landfill at a 100 foot section of jute mesh installed on the slope parallel to the access road. No new erosion or flow lines were present.

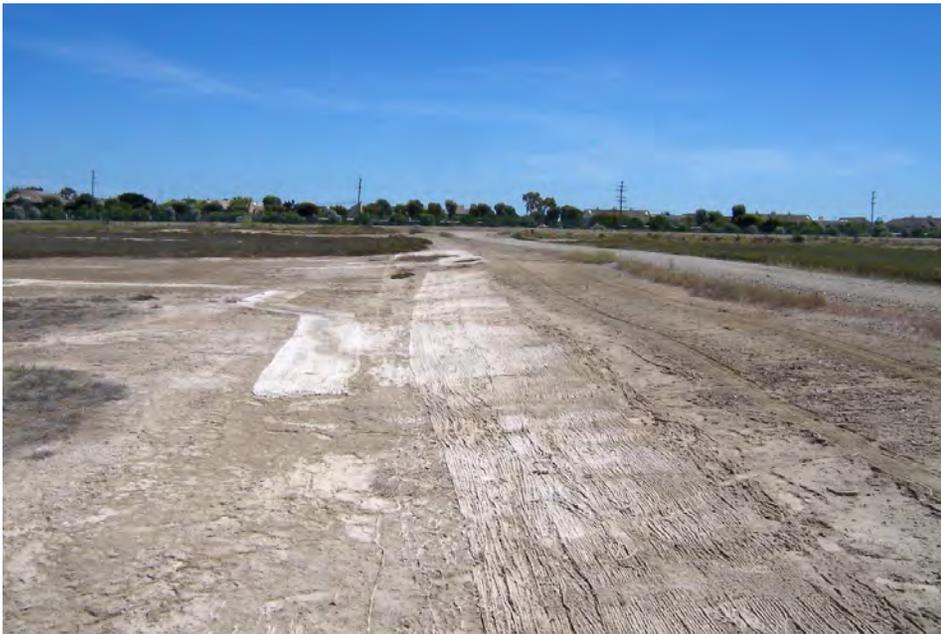
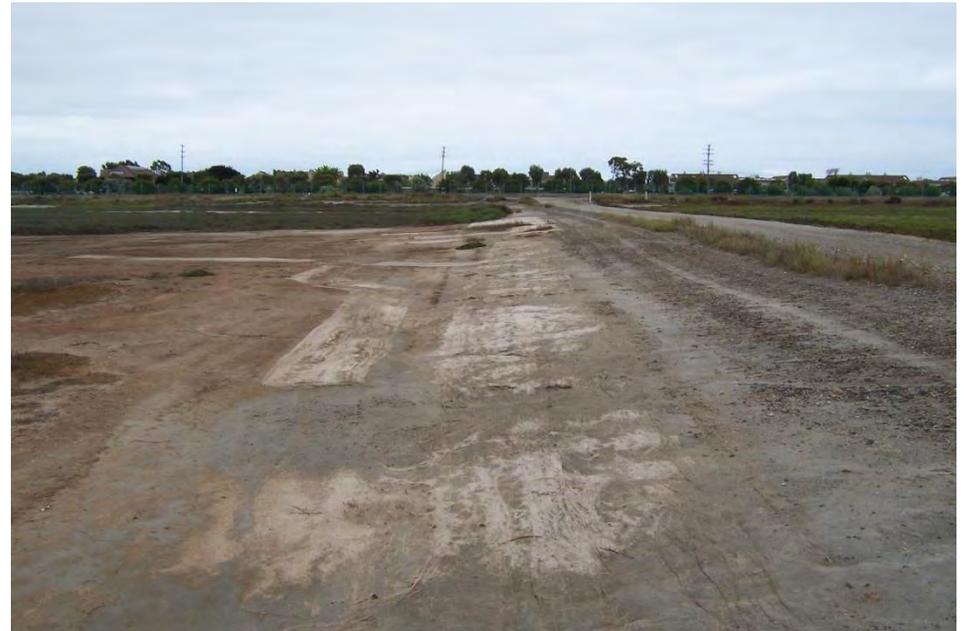
Photo 8: July 23, 2015 Post-Rainy Season Inspection

Compared with Post-Rainy Season Inspection July 2014. Looking south along southern portion of west edge of landfill cover. Photo shows condition of jute mesh and access road. No new erosion or flow lines were present.

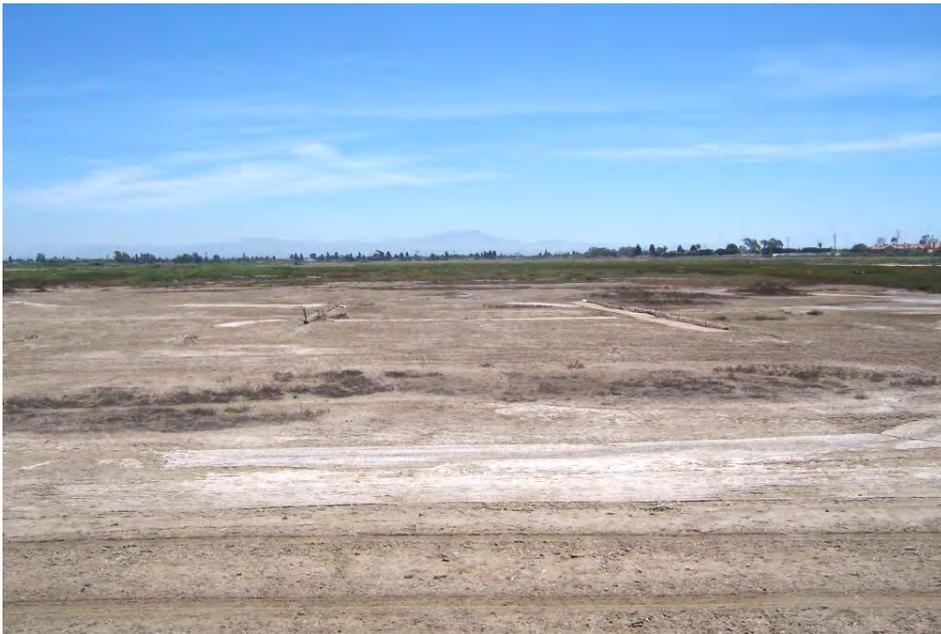
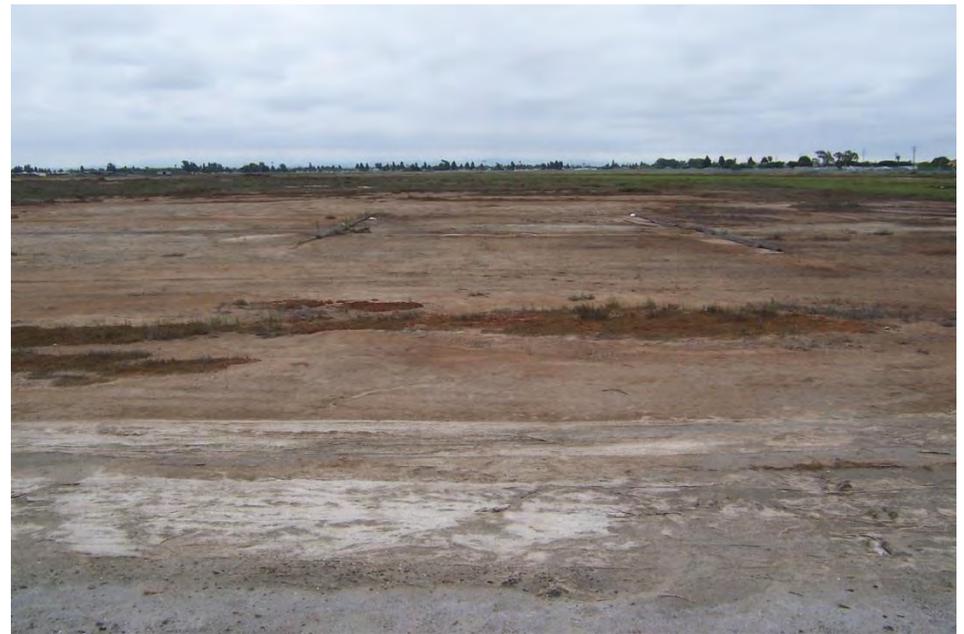
Photo 9: July 23, 2015 Post-Rainy Season Inspection

Compared with Post-Rainy Season Inspection July 2014. Looking east from the south portion of west edge of landfill cover. Photo shows central and southern wattles and jute mesh. No ponding.

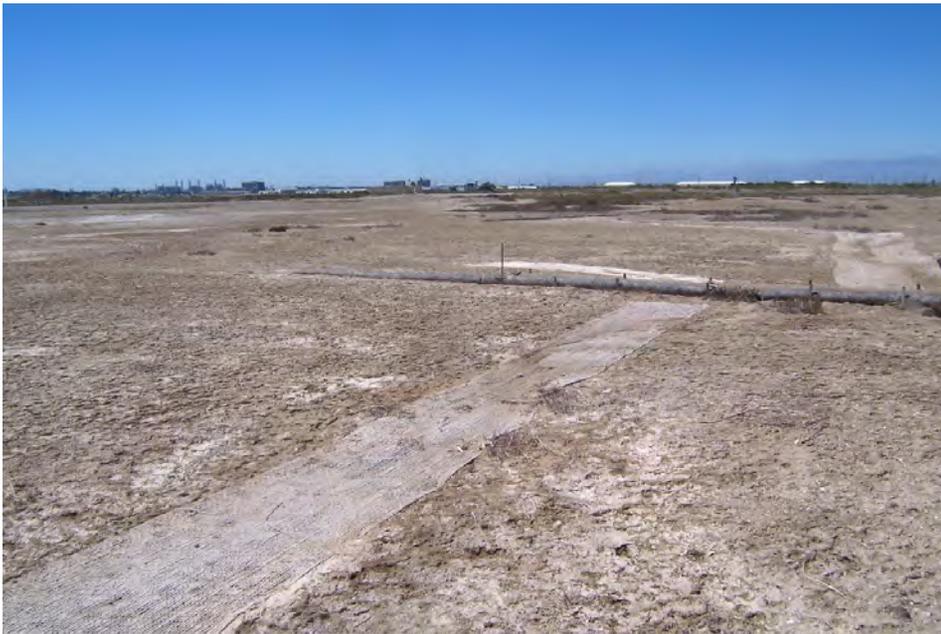
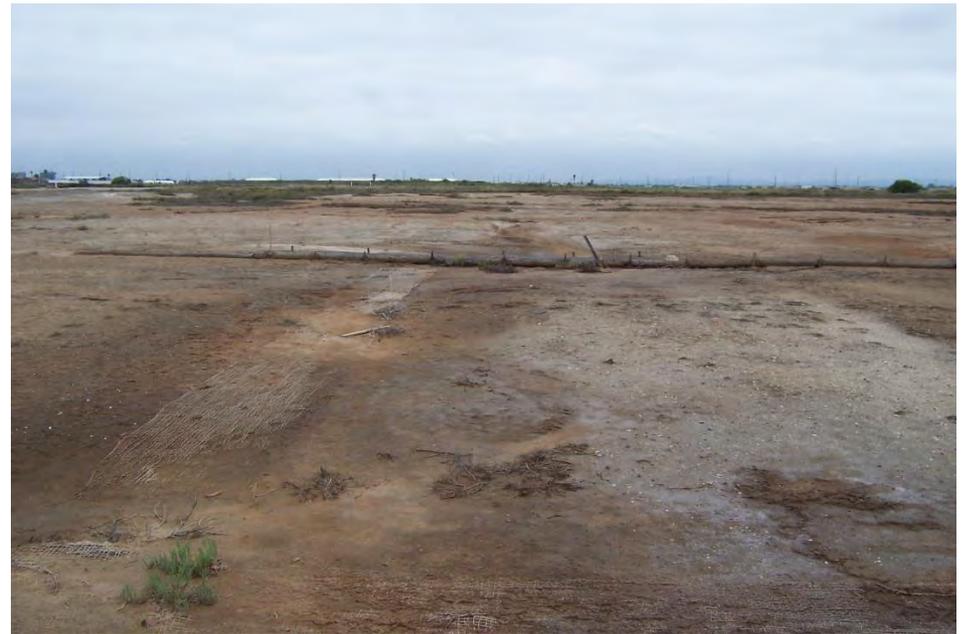
Photo 10: July 23, 2015 Post-Rainy Season Inspection

Compared with Post-Rainy Season Inspection July 2014. Looking northwest at 30 foot section of jute mesh installed between central and southern sections of wattles. No ponding.
