**FALL 2014 AND WINTER 2015
ANNUAL POST-CLOSURE INSPECTION AND MAINTENANCE REPORT**

**INSTALLATION RESTORATION PROGRAM SITE 7 AREA 1
(FORMER STATION LANDFILL)
NAVAL WEAPONS STATION SEAL BEACH, SEAL BEACH, CALIFORNIA**

November 2015

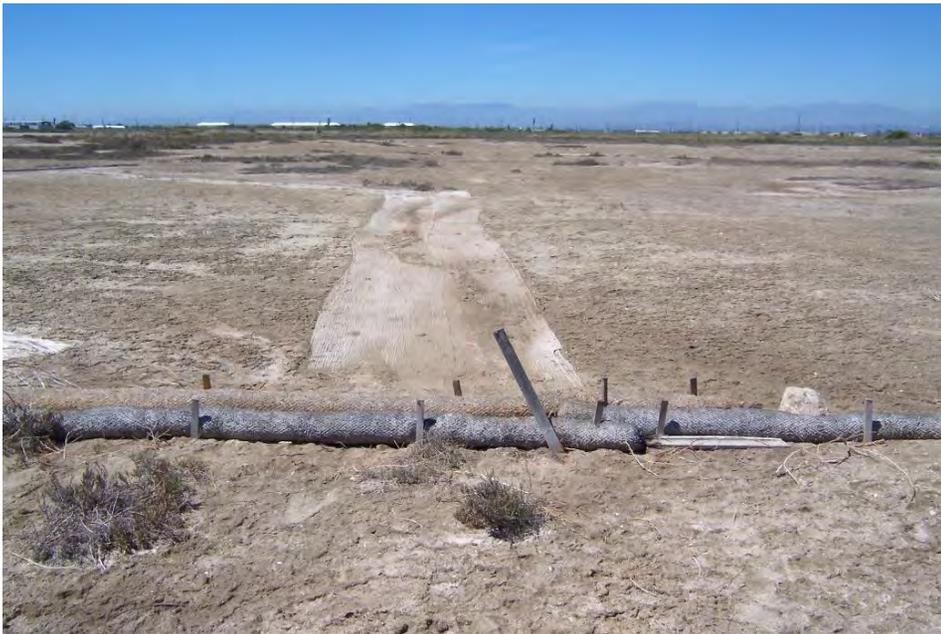
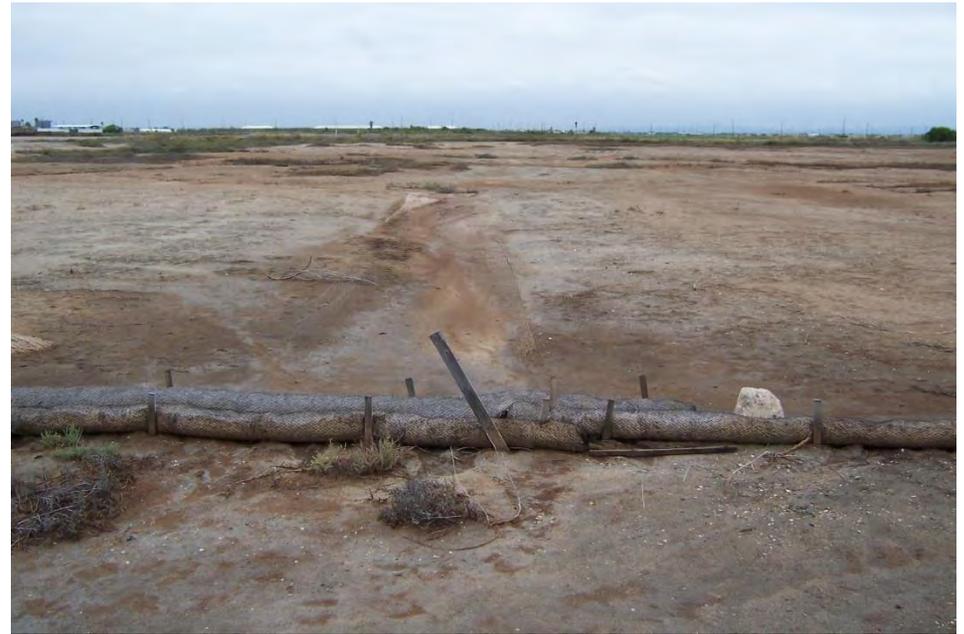
Photo 11: July 23, 2015 Post-Rainy Season Inspection

Compared with Post-Rainy Season Inspection July 2014. Looking north, past the central straw wattle, in the direction of the west section of jute mesh. No ponding.

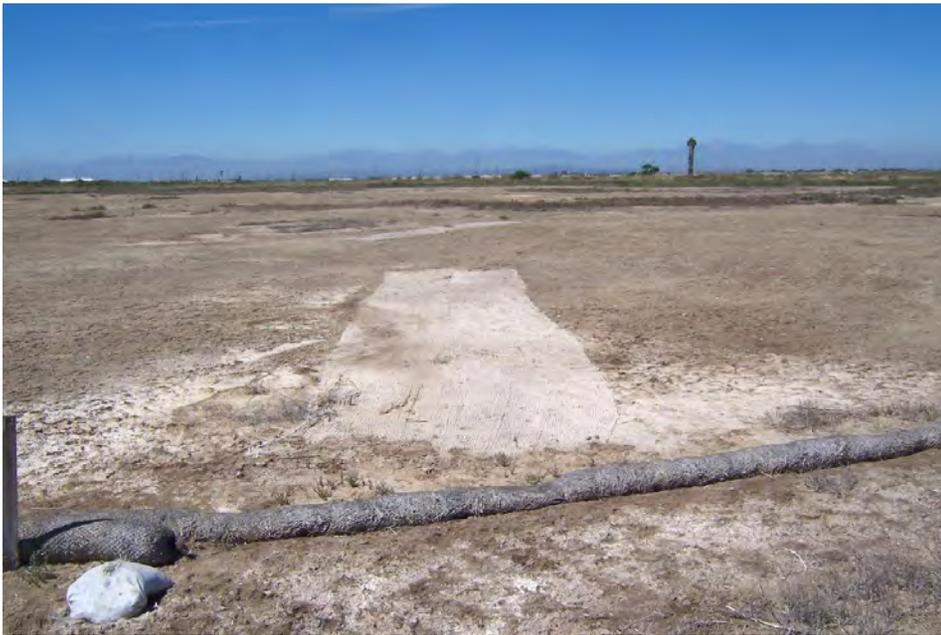
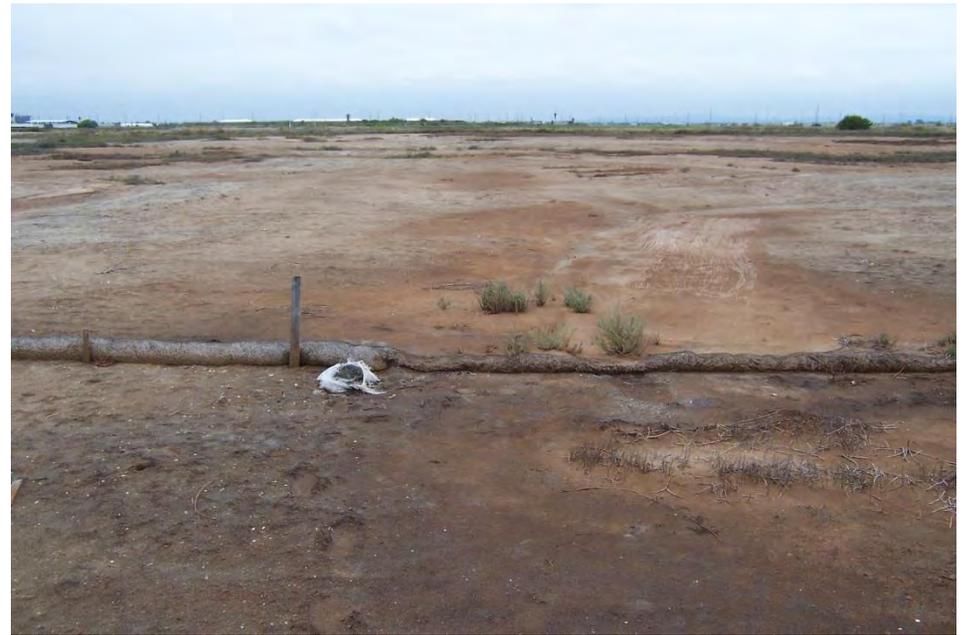
Photo 12: July 23, 2015 Post-Rainy Season Inspection

Compared with Post-Rainy Season Inspection July 2014. Looking north at east section of jute mesh located north of the central straw wattle. No ponding.

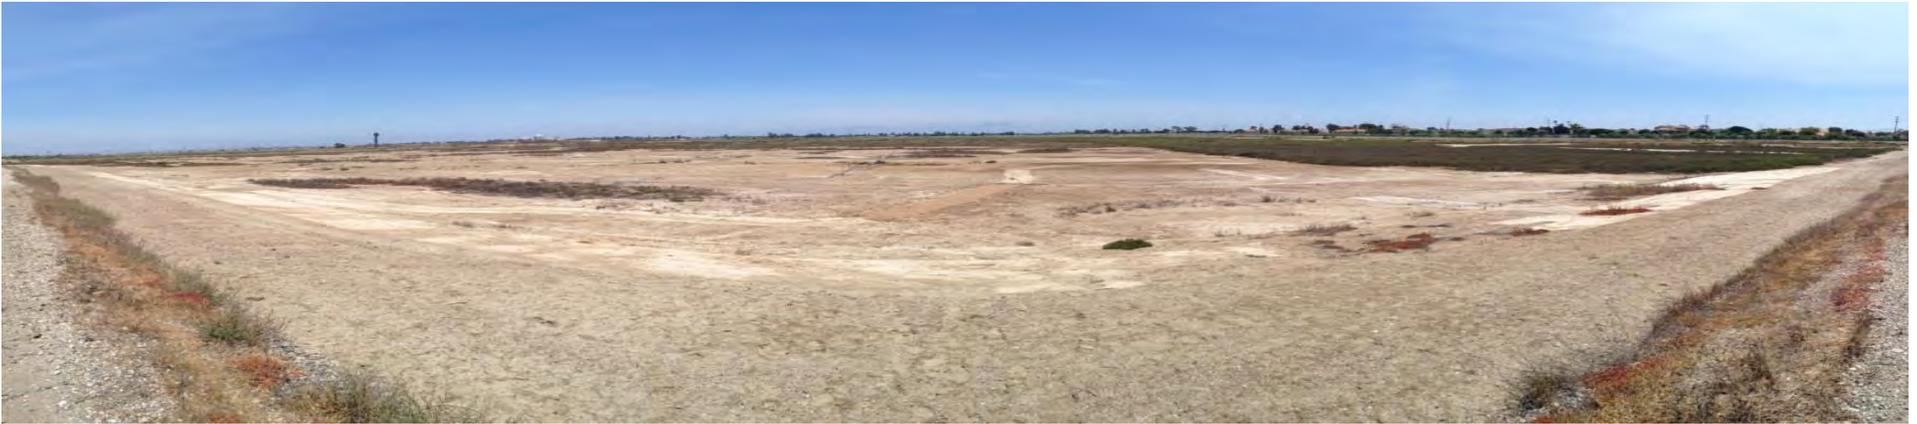
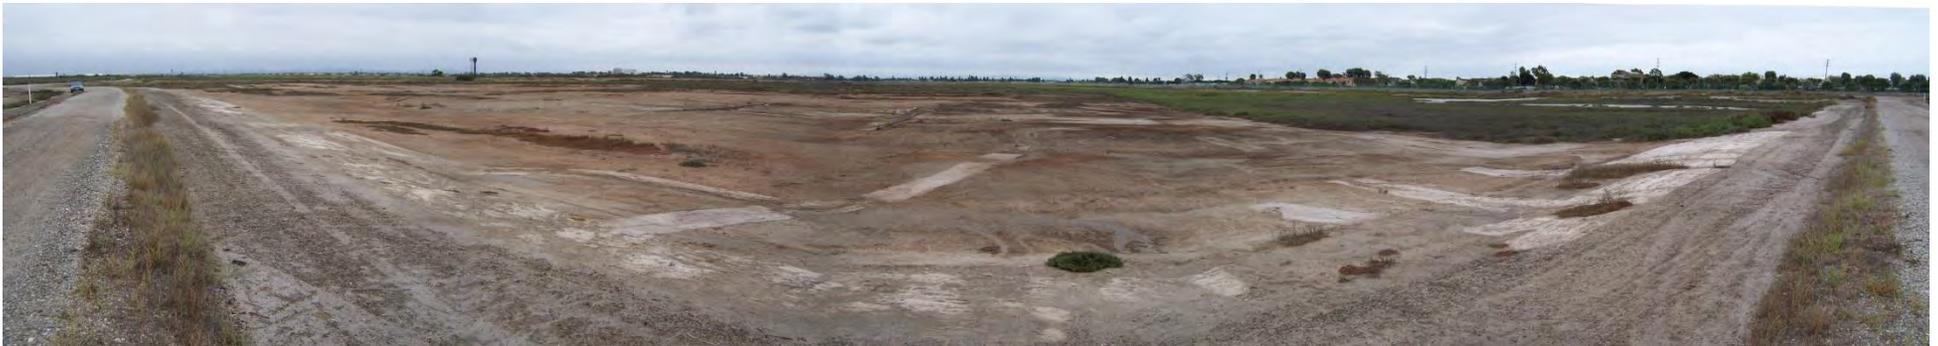
Photo 13: July 23, 2015 Post-Rainy Season Inspection

Compared with Post-Rainy Season Inspection July 2014. Looking east from south portion of west edge of the landfill cover. Photo shows western 1/3rd of the landfill cover. No ponding.

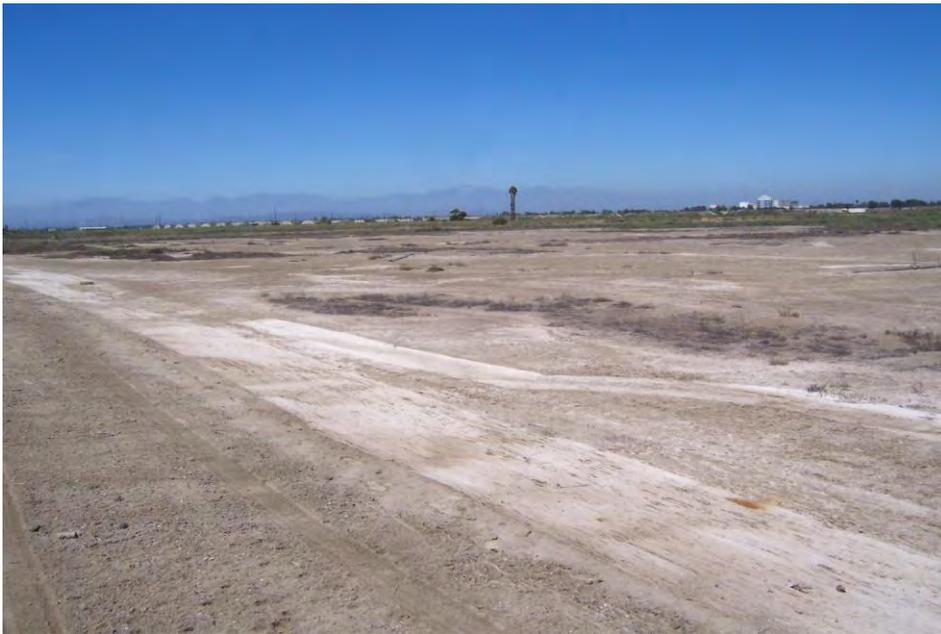
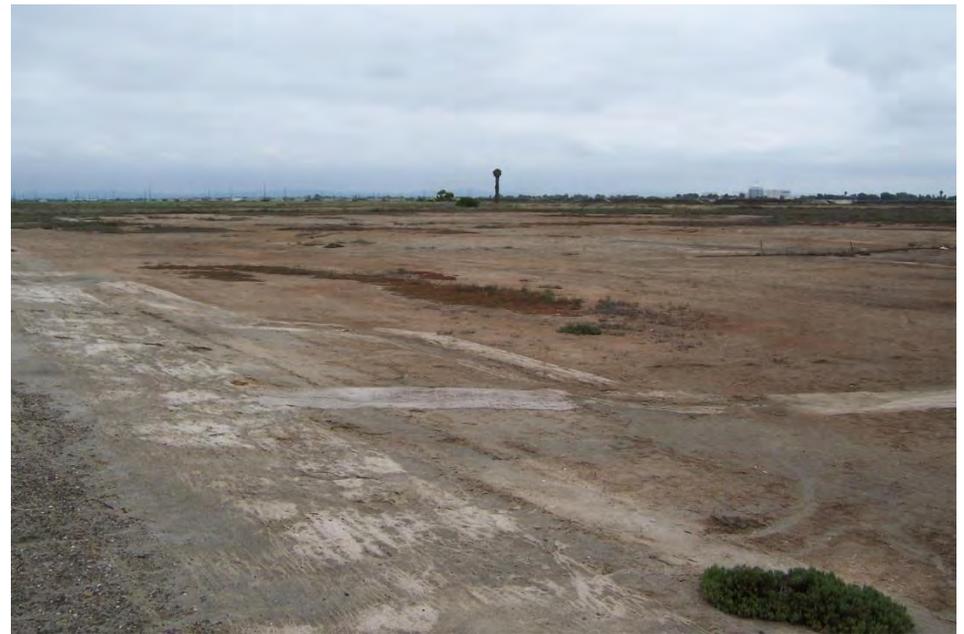
Photo 14: July 23, 2015 Post-Rainy Season Inspection

Compared with Post-Rainy Season Inspection July 2014. Looking northeast from south portion of west edge of landfill cover towards the west central margin of the landfill cover. No ponding.

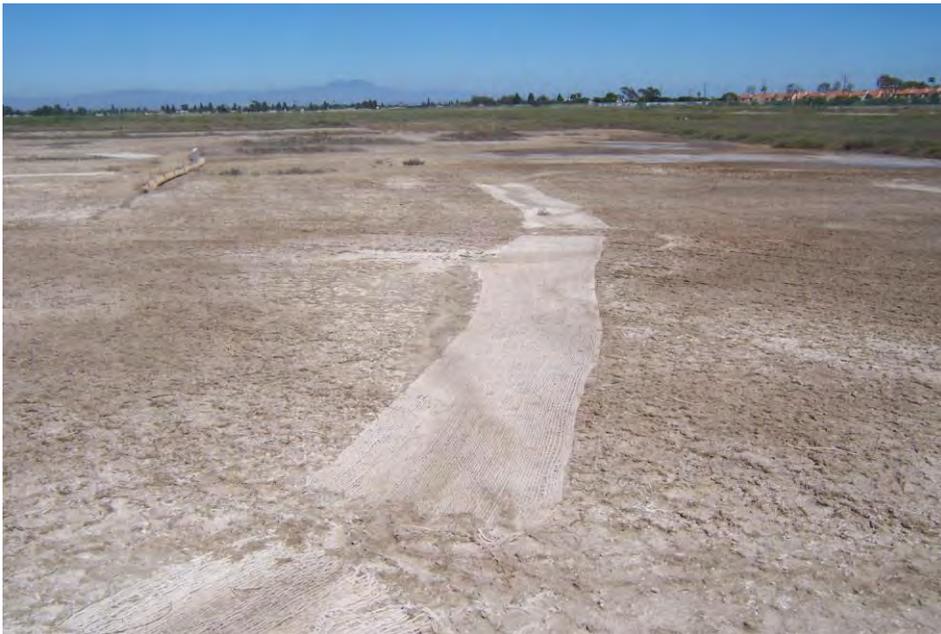
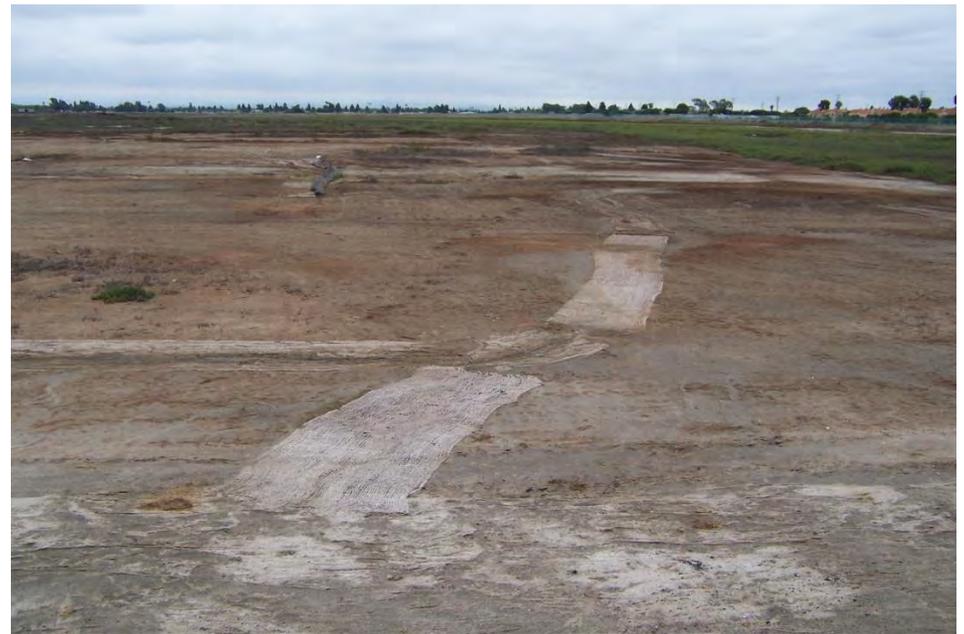
Photo 15: July 23, 2015 Post-Rainy Season Inspection

Compared with Post-Rainy Season Inspection July 2014. Looking east, along the southern edge of the landfill cover. No ponding.

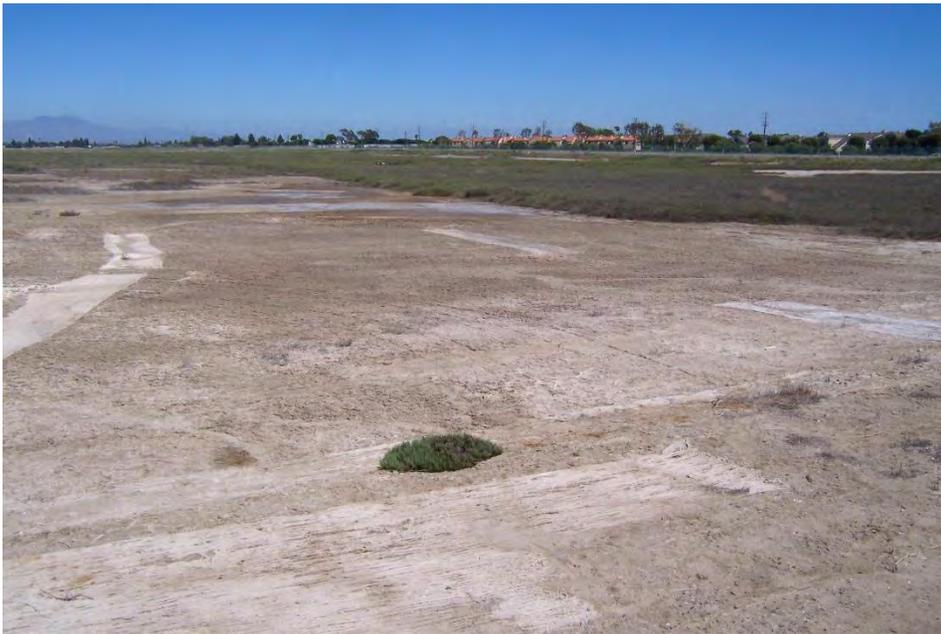
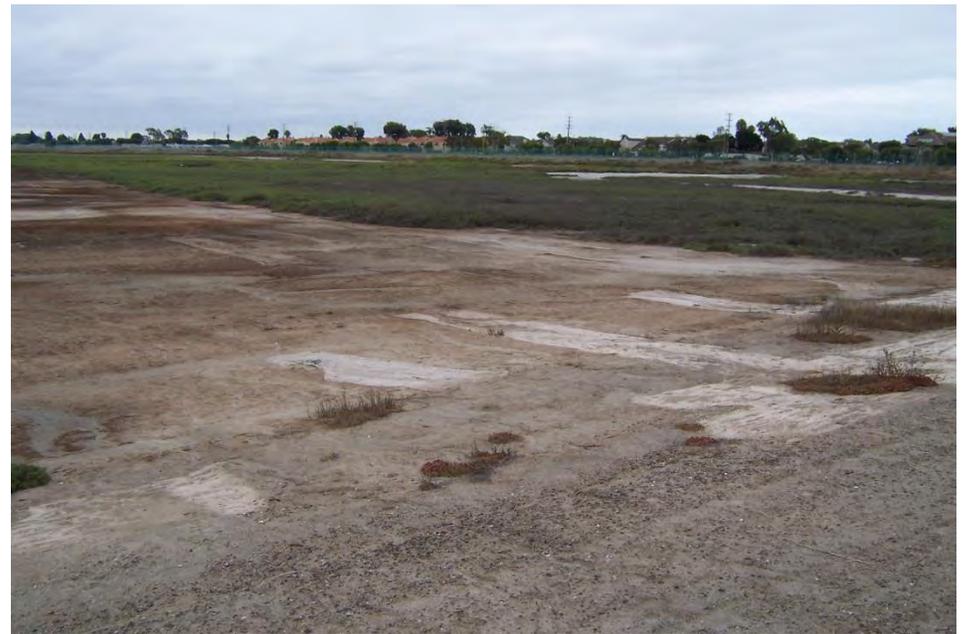
Photo 16: July 23, 2015 Post-Rainy Season Inspection

Compared with Post-Rainy Season Inspection July 2014. Looking southeast, along the southern edge of the landfill cover. No ponding.

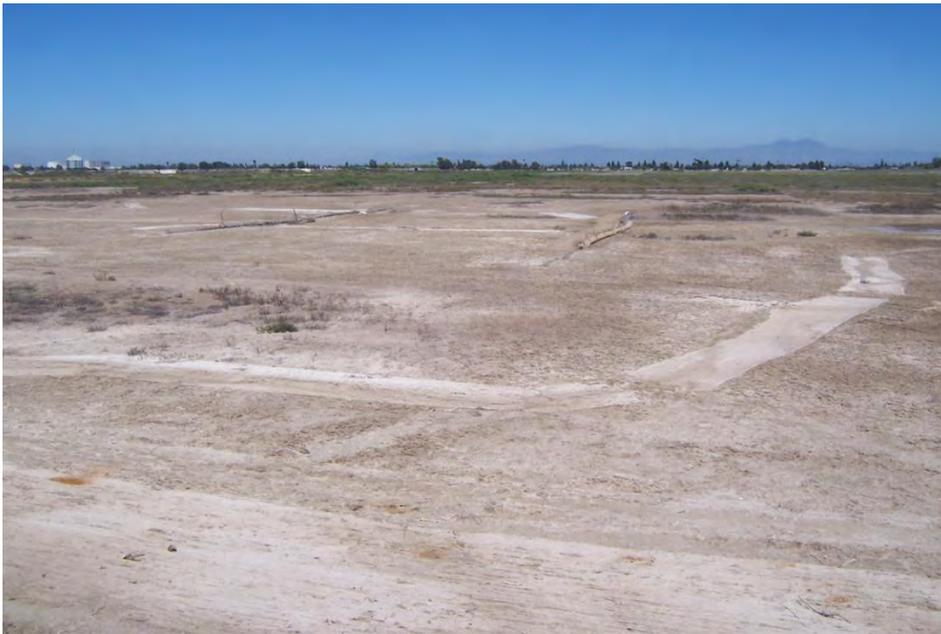
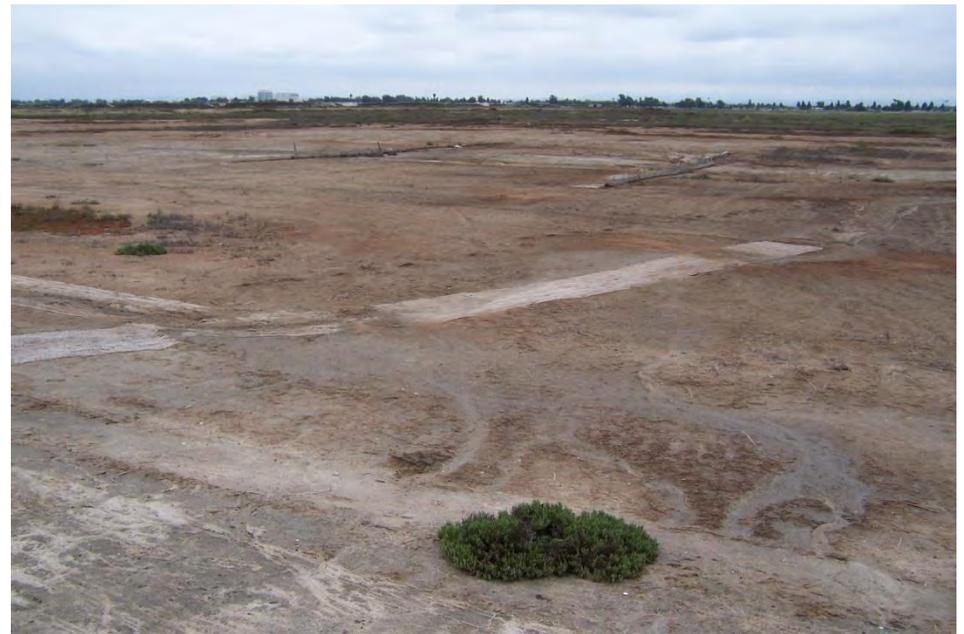
Photo 17: July 23, 2015 Post-Rainy Season Inspection

Compared with Post-Rainy Season Inspection July 2014. Looking northeast, from the southwest corner of the landfill. Photo shows jute mesh, wattles, and vegetation conditions in the western portion of the landfill.

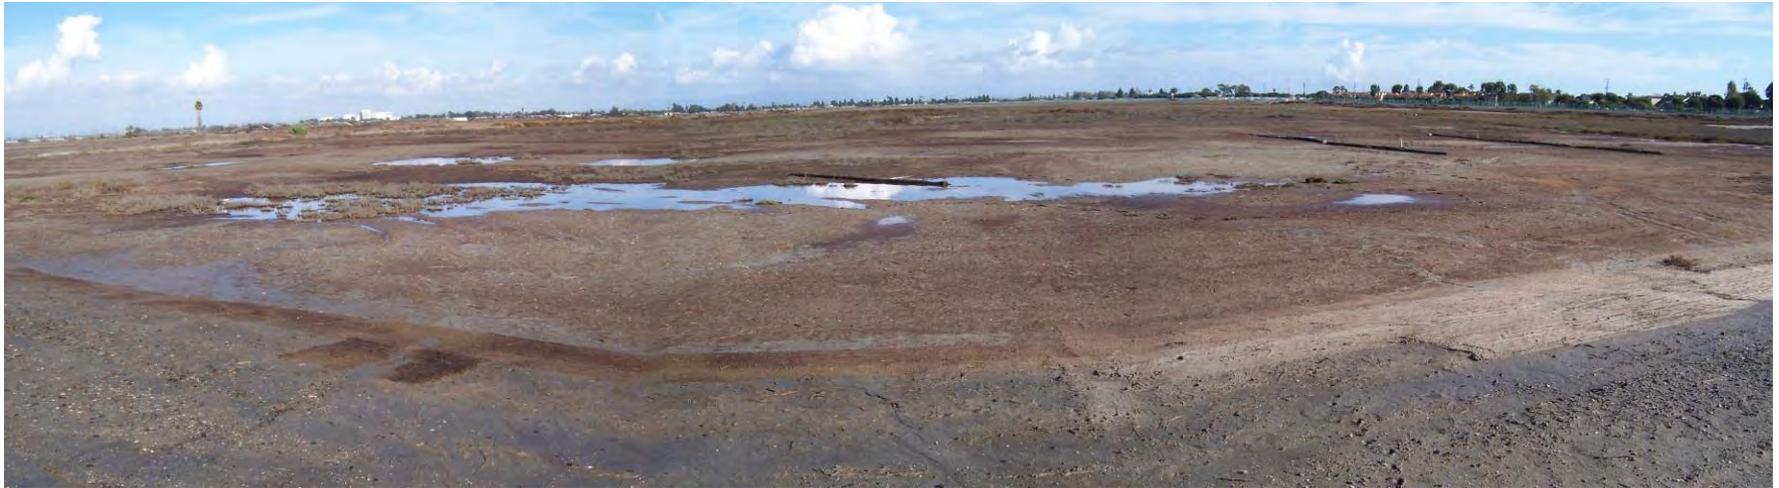
Photo 18: July 23, 2015 Post-Rainy Season Inspection
Photo looking east at the central western margin of the landfill.
